PLAZA DE ARMAS BUILDING ROOFING ASSESSMENT

SUBMITTED TO
CITY ARCHITECT'S OFFICE
ASSET MANAGEMENT DEPARTMENT
CITY OF SAN ANTONIO

JUNE 1, 2007

ROOFING ASSESSMENT

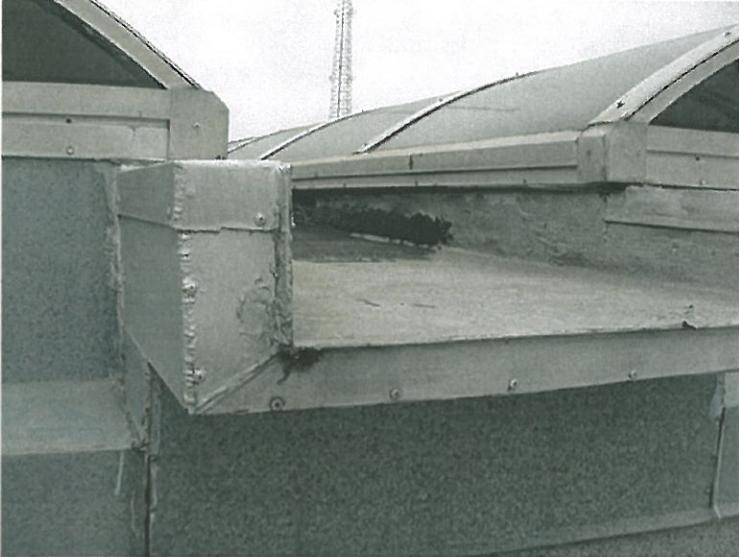
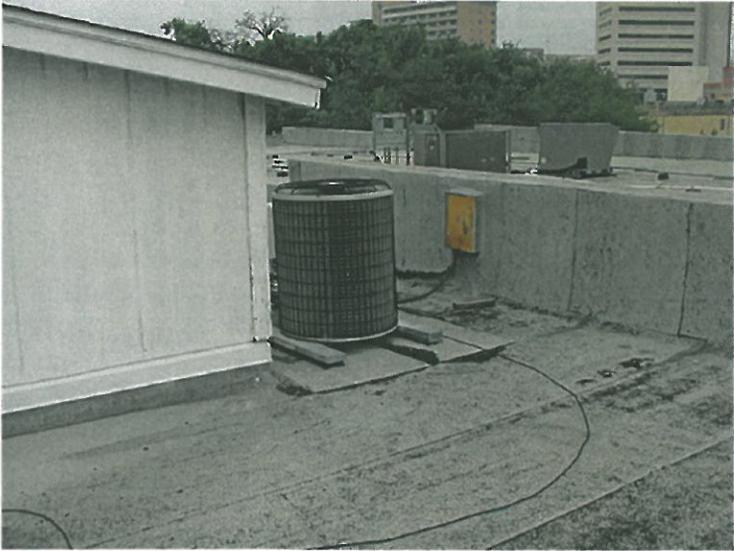
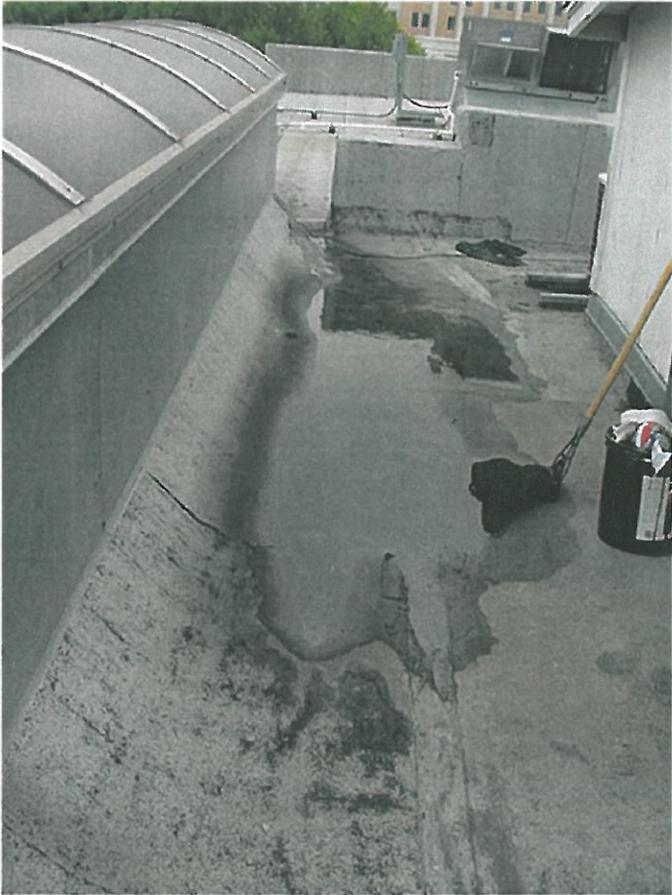
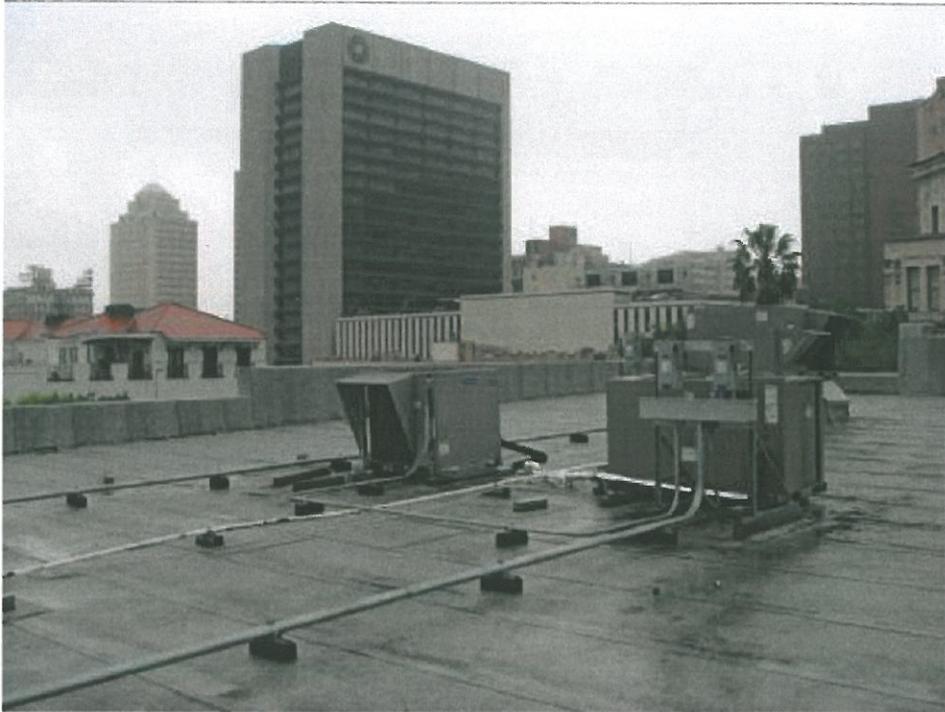
Condition – Deterioration of granular roof surface, roof membrane, electrical panel stands as well as pitch pans. The roof area closest to the roof access has standing water. Metal flashing at skylights to roof are open and show signs of attempted repair. Areas around roof top curbs show signs of roof patch or repair. Electrical conduit at some locations is lacking proper anchoring, and wiring is exposed.

Remove all existing roofing, wood nailers and related metal flashing.

Replace all existing roofing, roof curbs and metal flashing. Create roof slopes as needed.

Replace all rusted kendorf for electrical panel stands and place all exposed electrical wire into conduit and on proper skids.

Cap all existing parapet roof conditions with sloped metal flashing.

Cover all parapet walls with continuous metal wall panel flashing.

Replace asphalt shingle roof and replace and paint all rotten wood siding at roof penthouse.

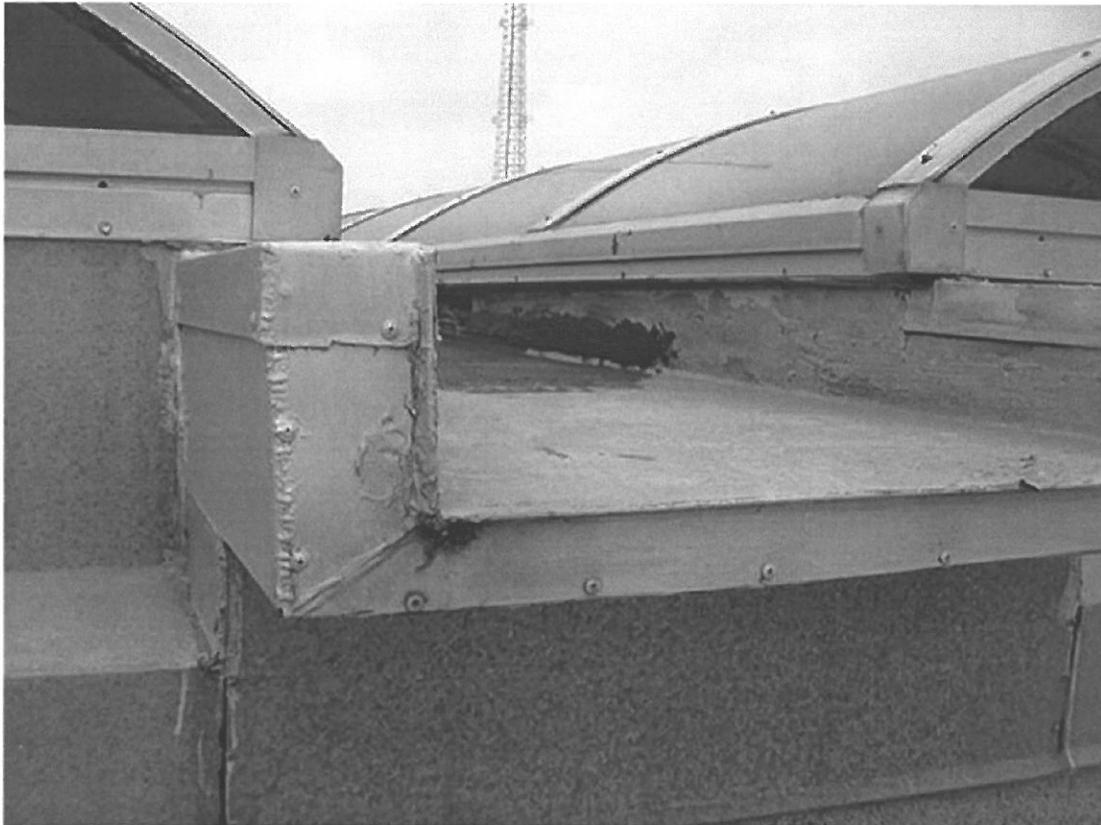
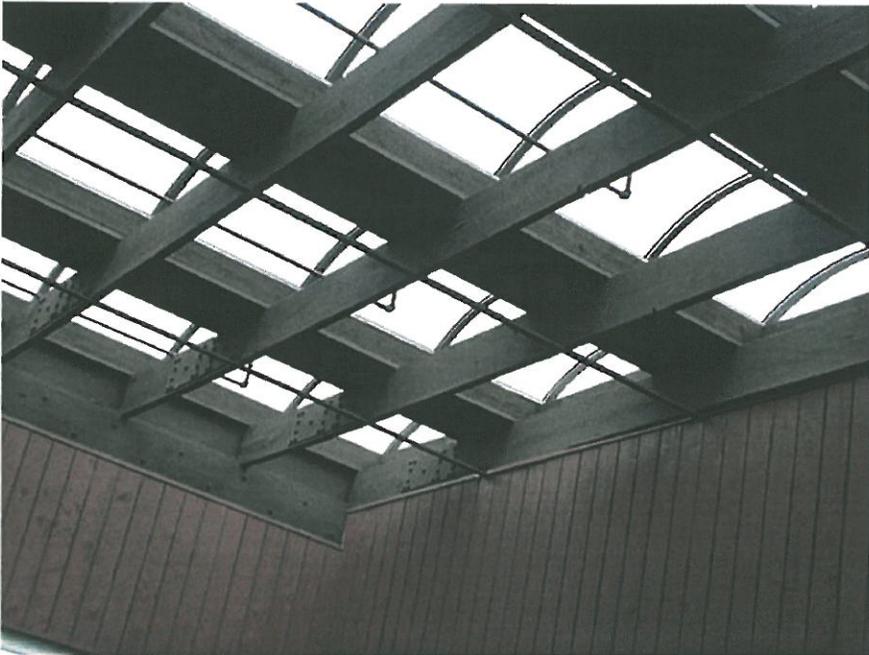
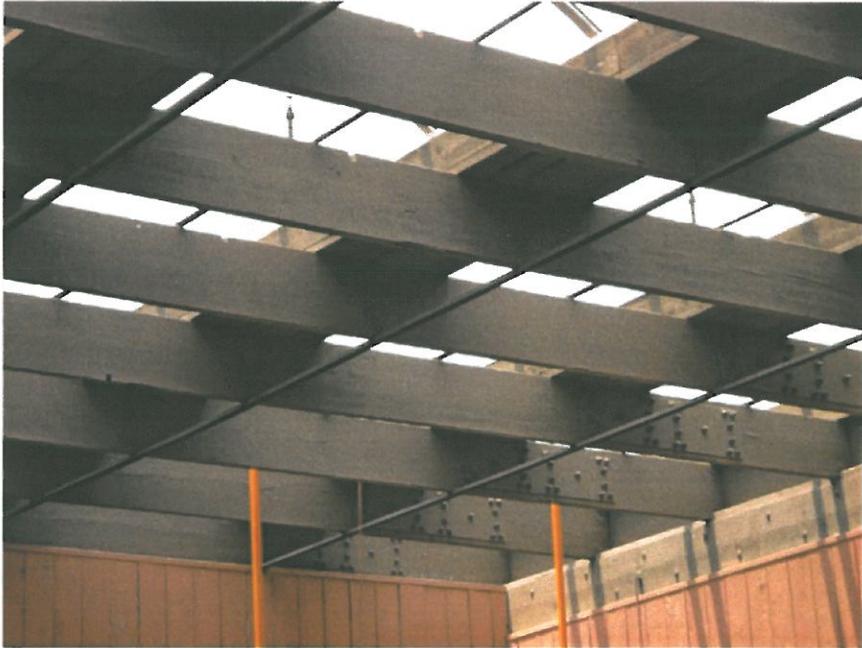
Existing large skylights are gaining too much heat and leaking.

Condition – Aluminum frames in fair condition, glazing in fair condition, Flashing around skylights is in bad condition with signs of attempted repairs. At least one of the barrel vault skylights is showing signs of being warped. This could be the frame or it could be structural. Currently there is an active water leak in one of the trough sections in between the skylights.

Replace skylights with like design except reduce heat gain by using a double or triple layer white translucent acrylic material.

Replace existing sloped gutter areas with like design except increase slope and refine joints so as to avoid water leaks.

Perhaps utilize a radiant barrier paint on all framing members.

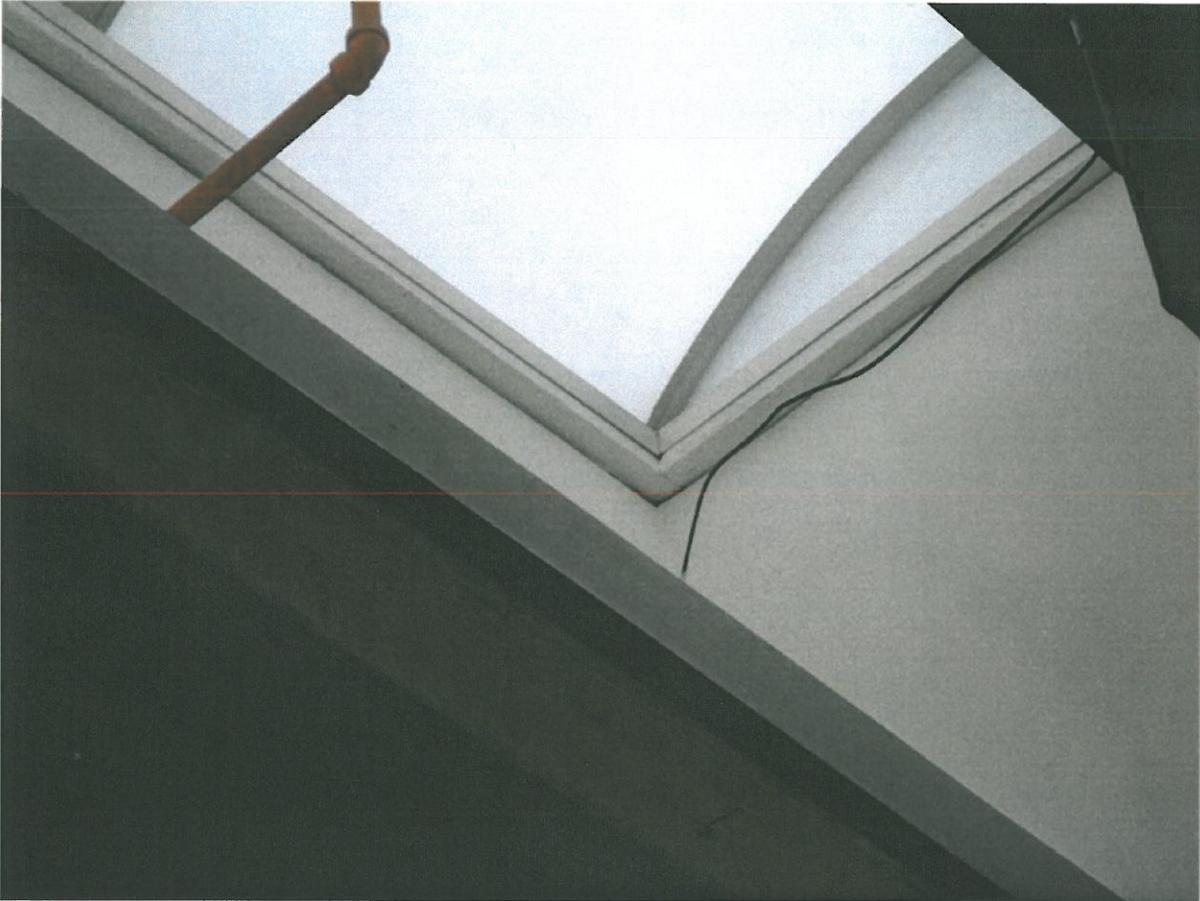
Existing small skylights are in need of new curbs.

Condition – Aluminum frames in fair condition, glazing in fair condition, Flashing around skylights is in bad condition with signs of attempted repairs. The existing curbs that appear to be made of 2x4 wood framing are deficient and are in very bad condition.

Replace skylights with like design except reduce heat gain by using a double or triple layer white translucent acrylic material.

Perhaps utilize a radiant barrier paint on all framing members.

Provide new skylights, new curb, and metal flashing , replacing the existing with like design. Utilize a more energy efficient glazing in order to reduce radiant heat gain.

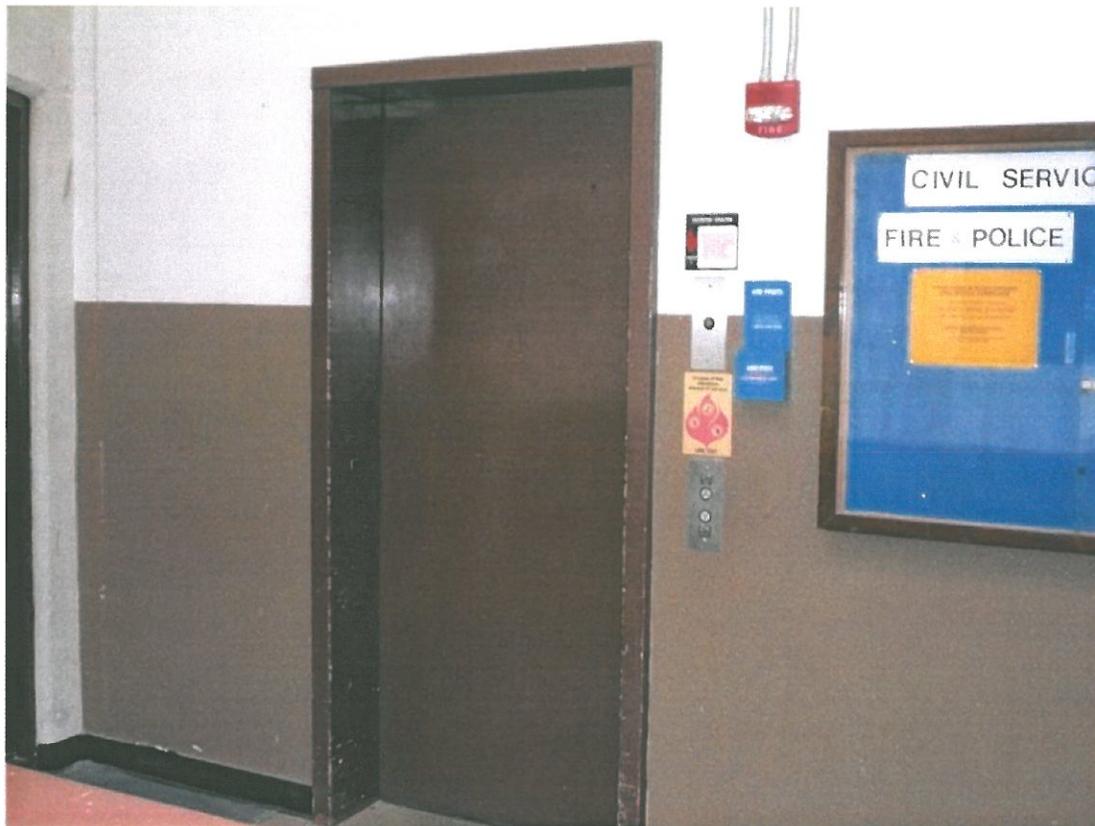
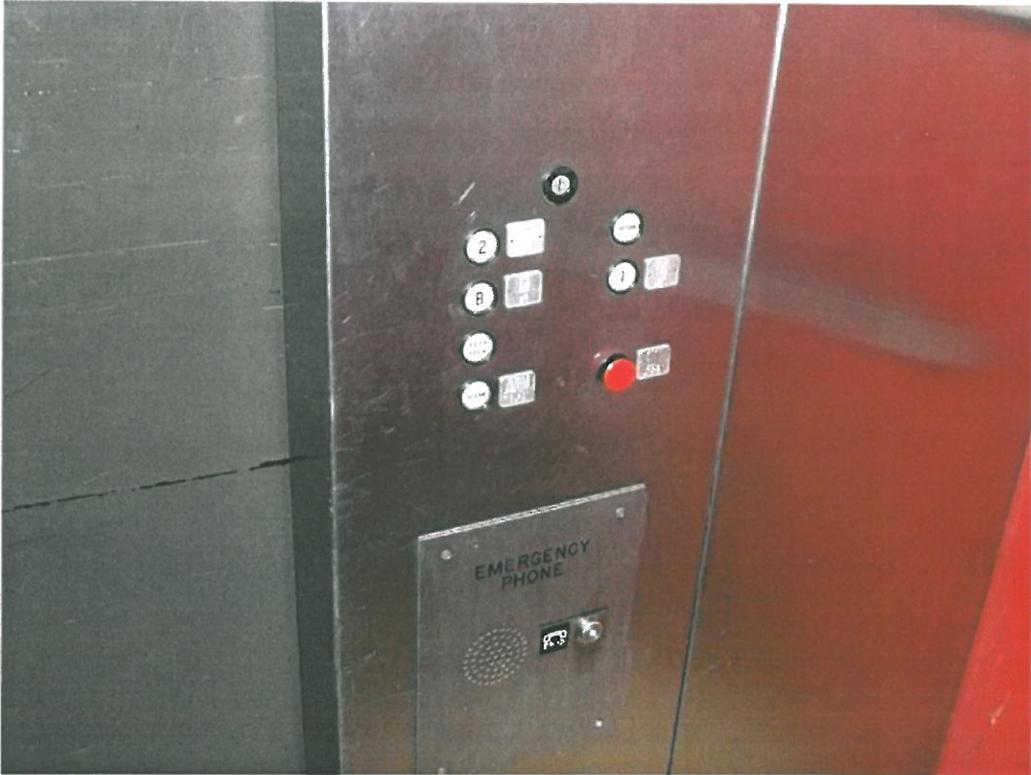
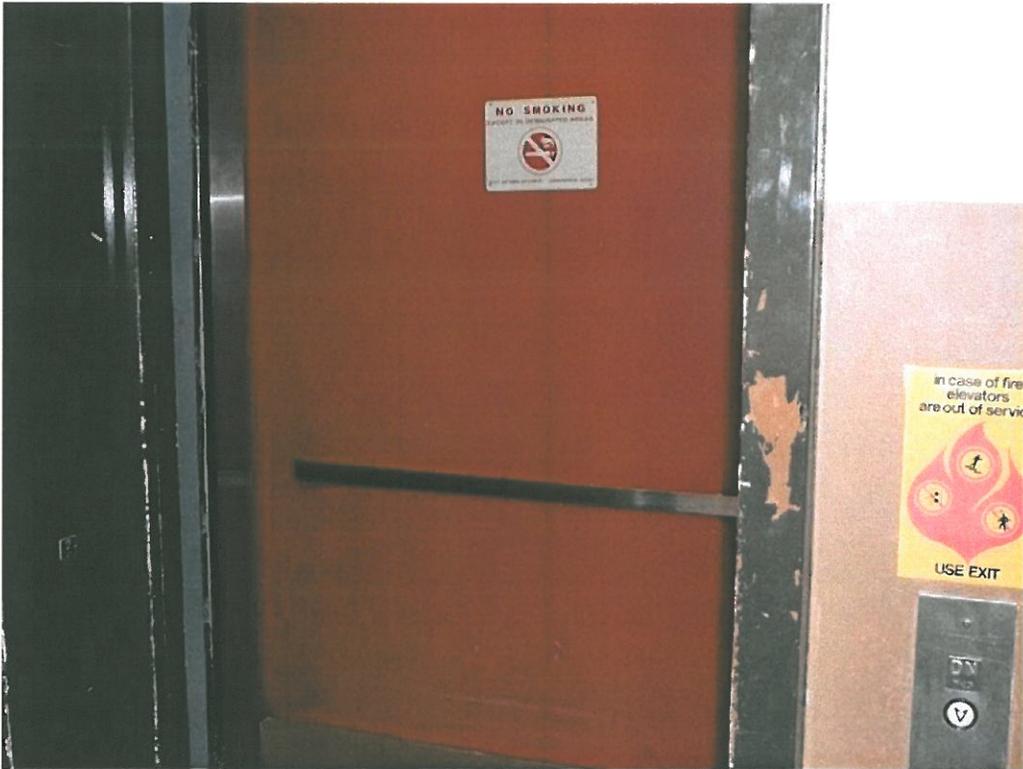
Condition – Interior of cab is an outdated and worn stainless steel with red plastic laminate. The Hall call buttons and Hall lanterns are outdated and not visually obvious and do not meet current ADA requirements. The raised brail characters are worn and are not mounted at standard height. In talking with the company that maintains the elevator now, he relayed that the cab is in fairly good condition , but it could use a new pump unit and controls.

Purchase a modernization kit for the elevator cab and it's related electronic controls.

After detailed investigation by an elevator technician the existing pump may be refurbished and the purchase of a new pump unit may be optional.

Paint outside of elevator door so as to accentuate its renovation.
