October 24, 2013

Project No: 1308297ARG

**RE: LIMITED ASBESTOS AND LEAD BASED PAINT SURVEY FOR THE KAMPMANN/SOLOMON/HALFF HOUSE #245, HEMISFAIR PARK HISTORICAL HOMES, LOCATED IN SAN ANTONIO, TEXAS**

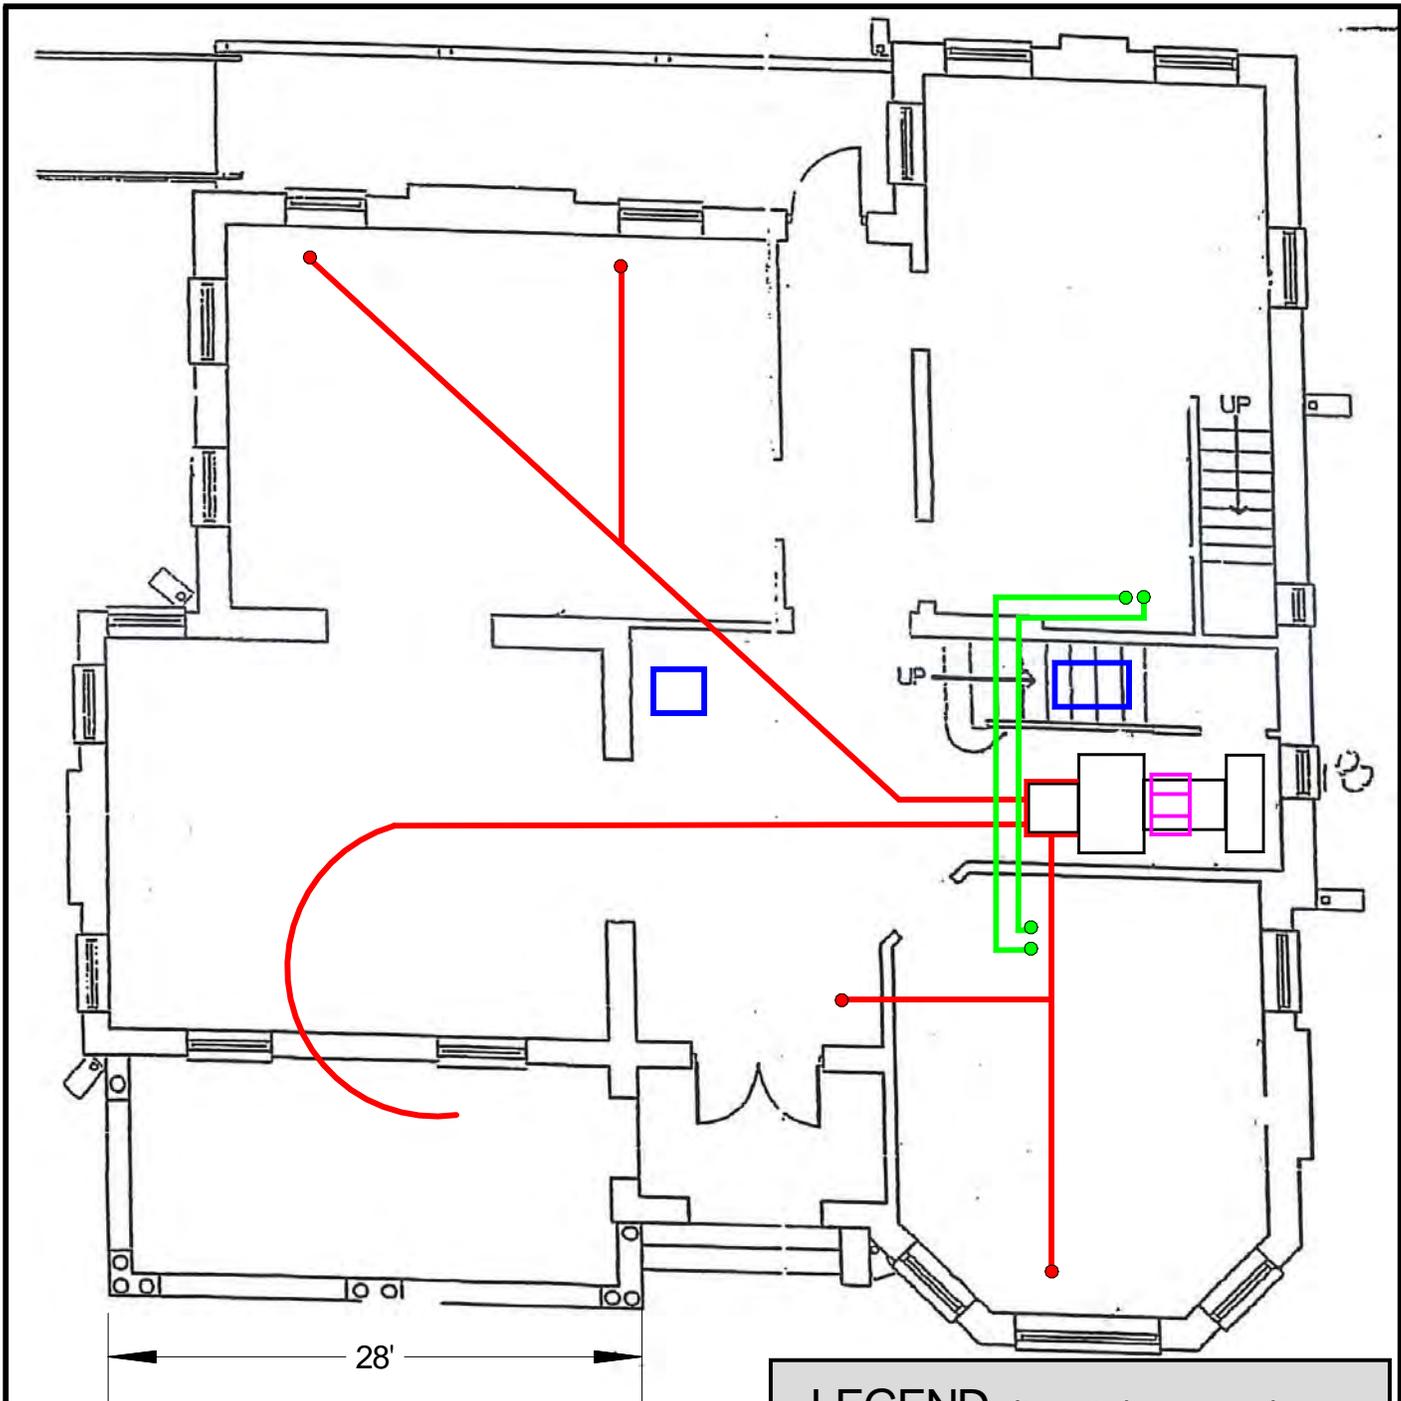
- Crawl Space Access Holes
- Item 2: HVAC Black Duct Mastic  
118 Linear Feet
- ▭ Item 3: White Vibration Damper - One
- Item 4: Pipe TSI Black Mastic  
46 Linear Feet

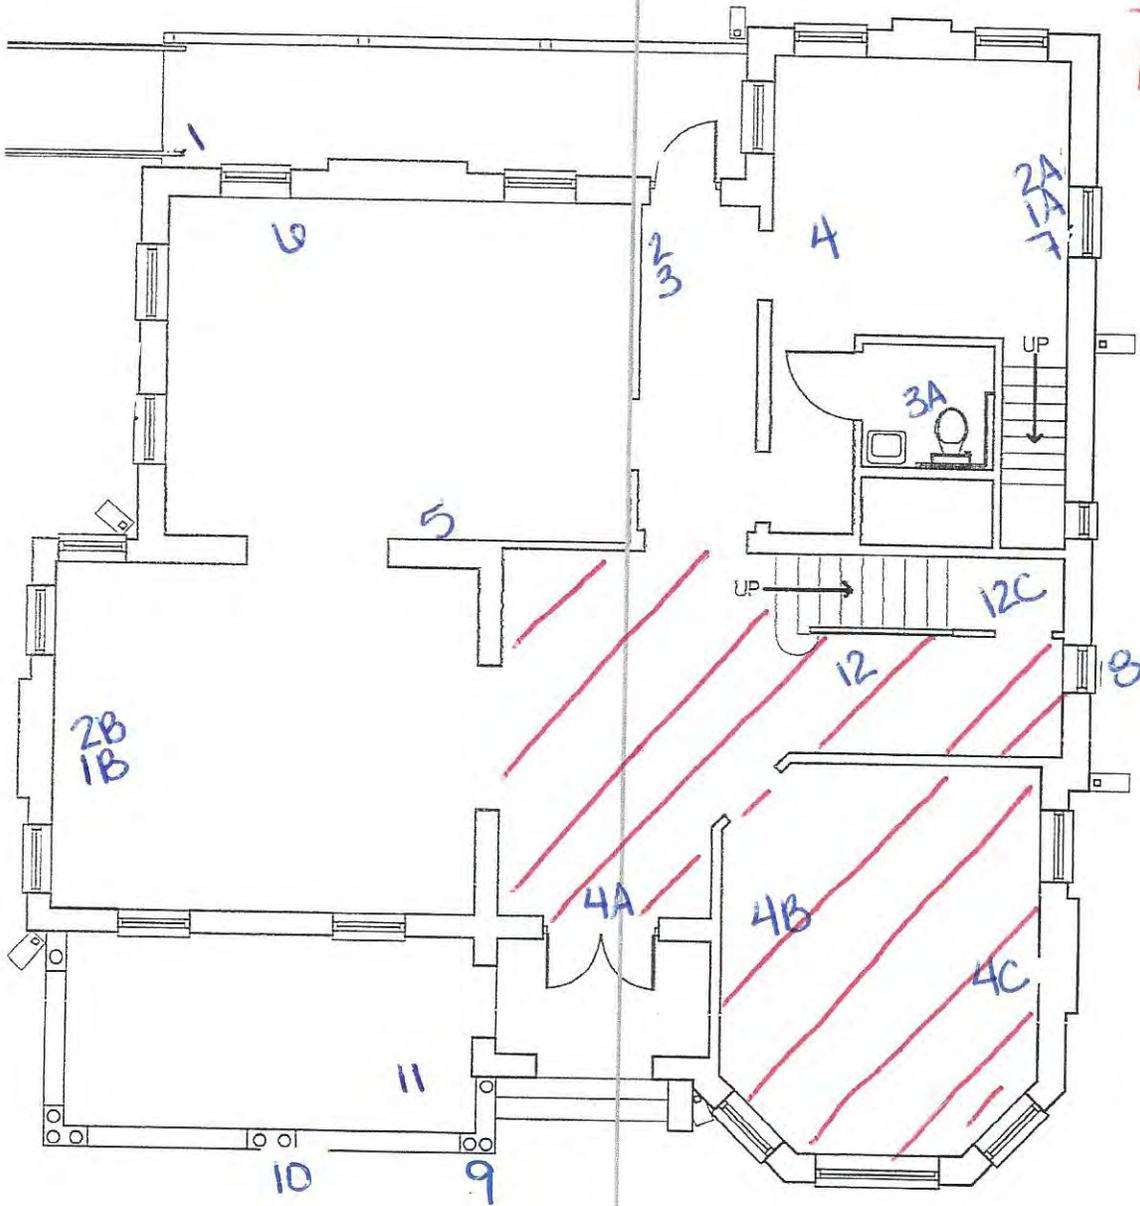
FIRST FLOOR PLAN  
1/8" = 1'-0"

LEGEND  
III - ACM  
Joint  
Compound
