**LA VILLITA RESTAURANT RFP EXHIBIT 9
RESTAURANT (CATEGORY A & B) BUILDINGS
INFORMATION**

**MAVERICK PLAZA CONCESSION BUILDING
1982**

Bolivar Hall, c. 1939

Dosch-Rische House, c. 1880

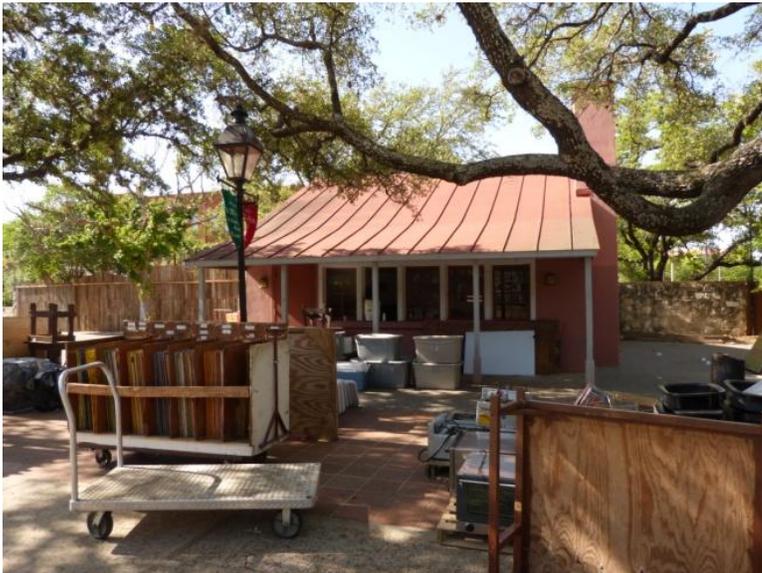
BUILDING 26

GENERAL ASSESSMENT RATING: 4-Good

Walls. Plastered and painted CMU walls are in good condition.

Roof. Metal roof appears to be in good condition.

Windows and doors. Good condition.

Air-conditioning and heating. Not applicable, windows provide ventilation and operators reportedly bring portable fans to keep workers cool; permanent ventilation for worker comfort should be considered.

Plumbing. Kitchen sink with hot and cold water; drain reported to work well. Hot water provided by 6-gallon electric low-boy water heater. Ice bin drain functions, but foot pedal drain operator no longer works.

Electrical. Electrical appears to be in good working order. Counter-mounted receptacle near sink is not GFCI type.

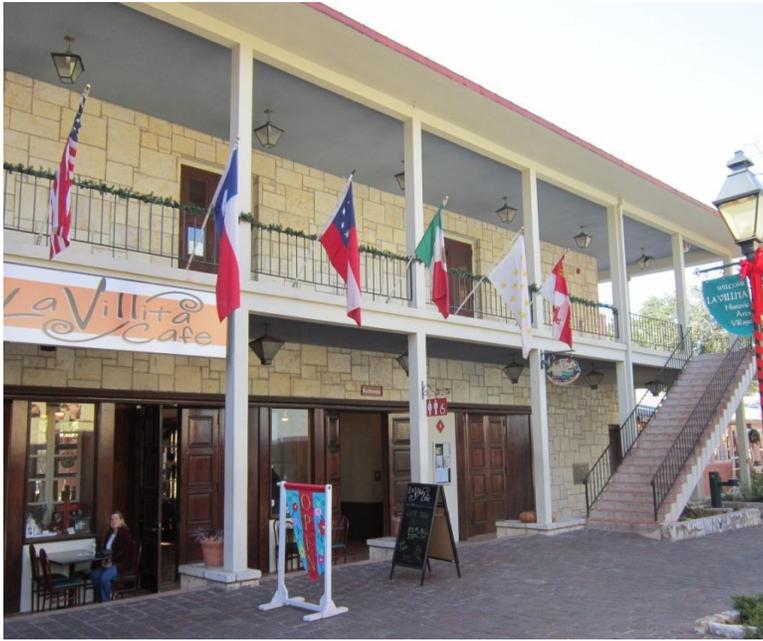
BUILDING 9: Bolivar Hall

GENERAL ASSESSMENT RATING: 3-Fair

Walls. Limestone veneer over concrete frame. Stone in fair condition.

Roof. Painted standing seam metal. Not accessible for inspection.

Windows and doors. Doors in fair condition but need refinishing. Windows from 1939 are neither weather-stripped nor have energy-efficient glass. Windows do not fit tightly and allow considerable air infiltration.

Floors. First-floor clay tiles are heavily worn and need extensive maintenance or replacement; on second story, floors are clay tile in offices and oak in museum; both areas in fair to good condition.

Ceilings. First-floor ceilings are varnished cypress boards in fair condition; would be improved by stripping and refinishing. Second-floor ceilings are plaster and in good condition.

Walls. Plaster walls in good condition; need painting.

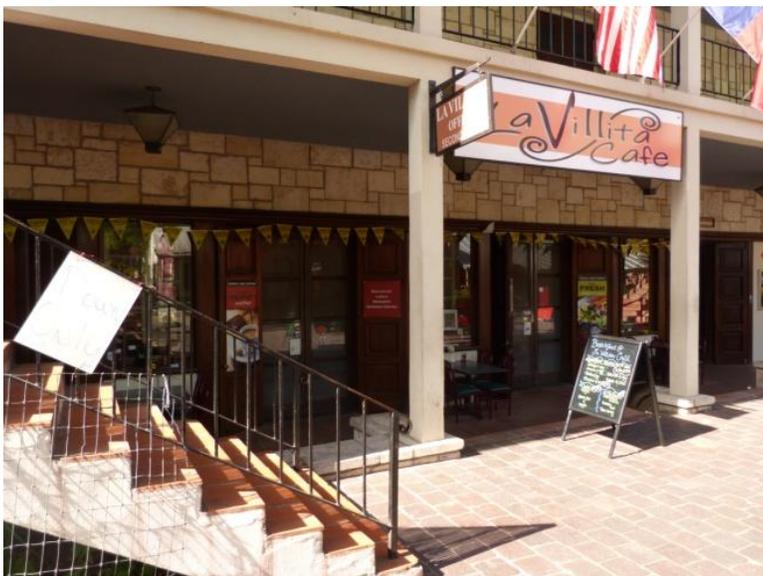
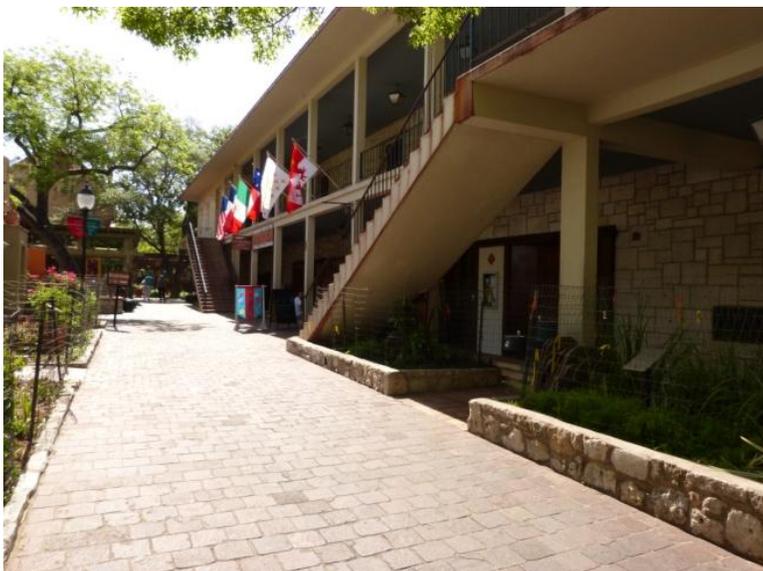
Deteriorated clay tile exterior stairs need to be replaced. Handrails are not provided as required by current code.

Handrails and guardrails at stairs to and balconies on second floor are not high

enough according to current code. Explore replacing with safer handrails that are acceptable to HDRC.

Public restrooms at ground level need complete renovation. They are open every day while other restrooms are only open for events. Restrooms seem old and are very dirty and smelly. Clay tile floors are not appropriate for restroom flooring, as they absorb moisture/urine and hold smells. Need better ventilation and new fixtures. Restroom layout not in accordance with TAS standards.

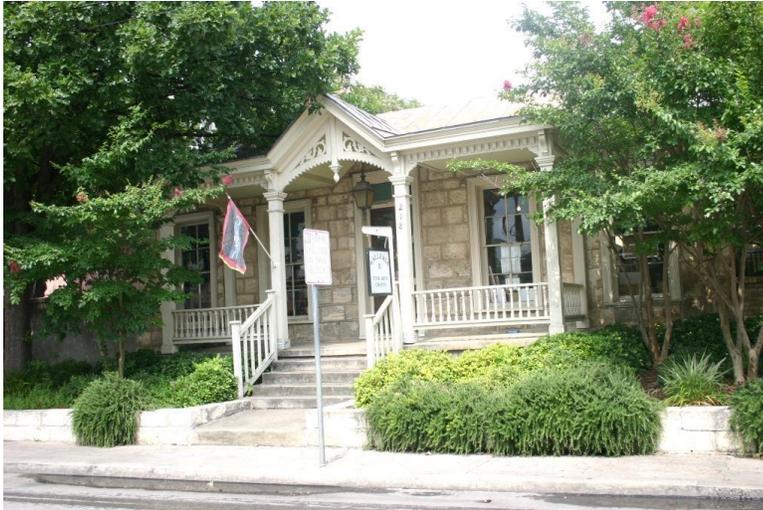
BUILDING 20

GENERAL ASSESSMENT RATING: 3-Fair

Walls. Stone walls are in good condition with a few cracks. Miscellaneous repointing required.

Windows and doors. Wooden window frames and sash need to be reworked to repair sash weights and provide proper locking mechanisms. Doors acceptable.

Walls. Walls are painted plaster and partially covered by tenant's pegboards. The plaster is flaking and delaminating between the top of the pegboard and the ceiling at the front of the house and in the storeroom. Plaster needs to be replaced.

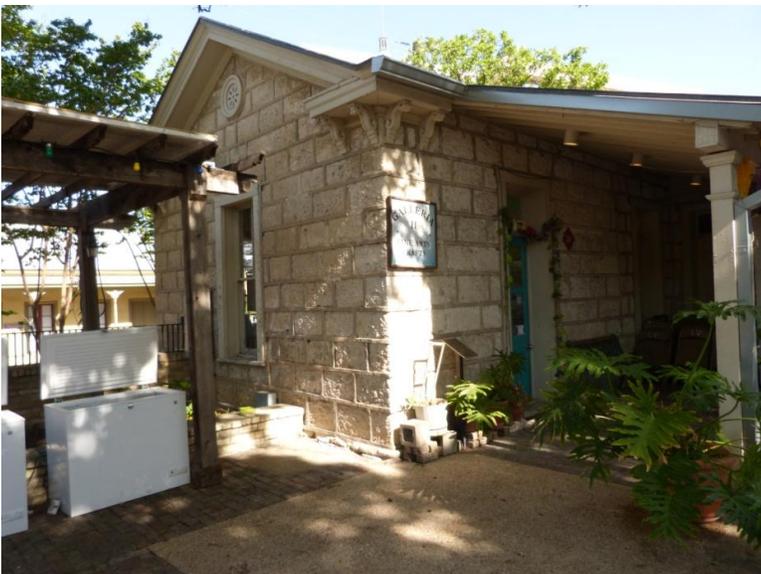
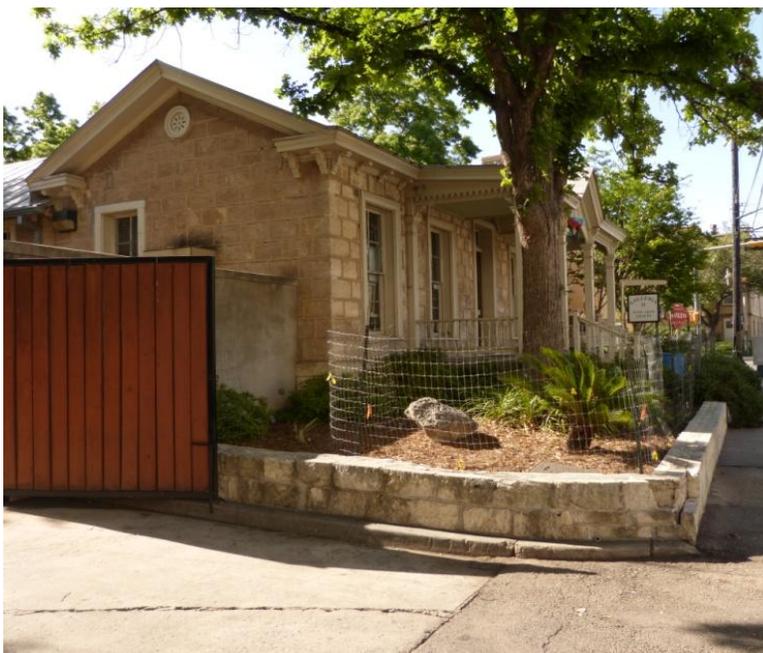
Storage/mechanical room and gardener's room need new flooring and finish to protect historic structure as well as general renovation of walls, ceilings, windows and doors. Unused restaurant

exhaust should be removed and walls patched inside and out.
Asphalt paving at the base of wall on north side of building should be replaced with gravel or paving on sand and regraded to slope away from building to allow water to evaporate from soil around limestone wall.
Limestone base of building wall and soft limestone walls need repointing.
