**RE: Forensic Study of Existing Foundation Components
Sterling Building
1432-1434 E. Commerce Street
San Antonio, Texas**

**THE STERLING BUILDING
1432 TO 1434 E. COMMERCE STREET
SAN ANTONIO, TEXAS**

PROJECT NO. ASR14-003-00

March 10, 2014

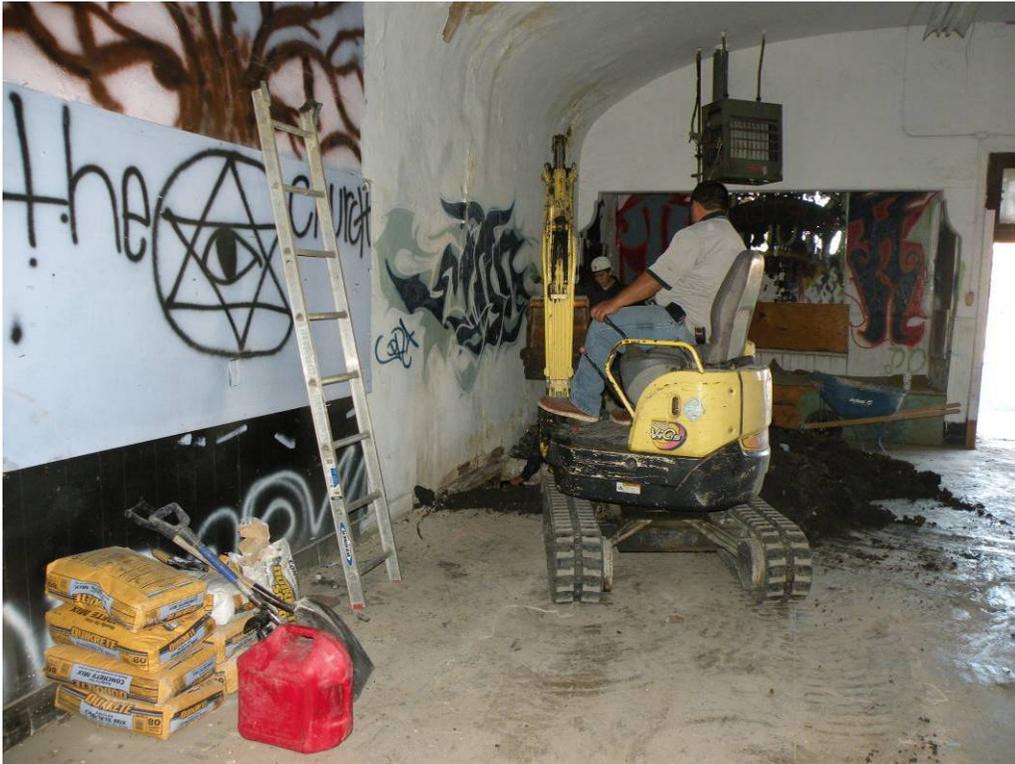
Test Pit TP-1 was excavated adjacent to the west wall of Suite 1432 to a depth of approximately 63-inches as shown in Photograph 1. Within this excavation, we observed foundation conditions that indicate Suites 1432 and 1434 have independent foundation systems.

PHOTOGRAPH 1 - GENERAL VIEW OF TEST PIT TP-1 EXCAVATION WITHIN SUITE 1432.

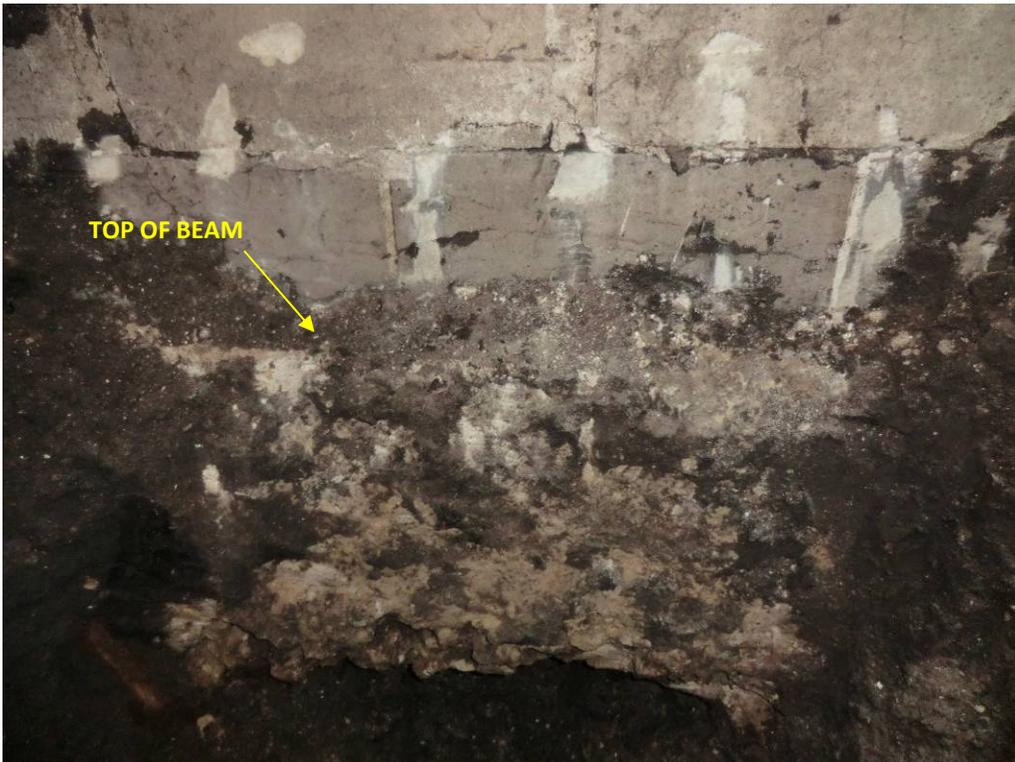
- As observed from TP-1, the east wall of Suite 1434 is comprised of CMU block units that are supported on a 2-ft deep continuous concrete grade beam as shown in Photographs 1, 2, and 3. Each block is 20-inches long by 8-inches wide by 8 inches tall.

PHOTOGRAPH 2 – GENERAL VIEW OF CONCRETE GRADE BEAM SUPPORTING CMU BLOCK WALL OF SUITE 1434 AS OBSERVED FROM TP-1.

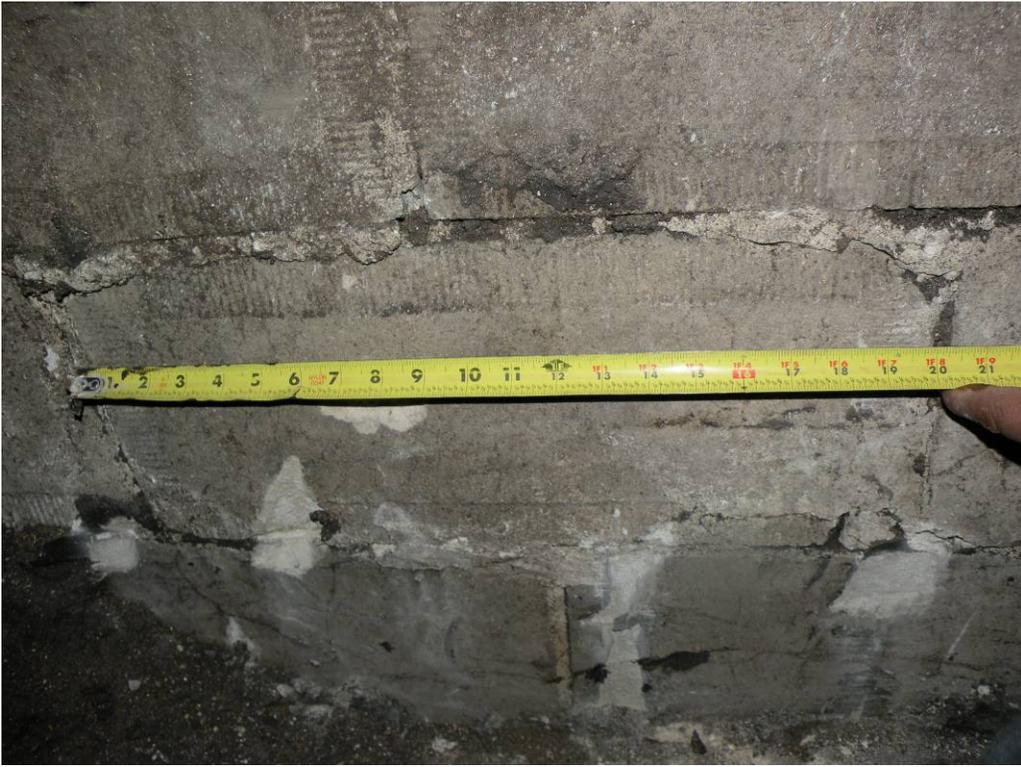
PHOTOGRAPH 3 – CLOSE-UP VIEW OF 20-INCH LONG CMU BLOCK OBSERVED IN TP-1.

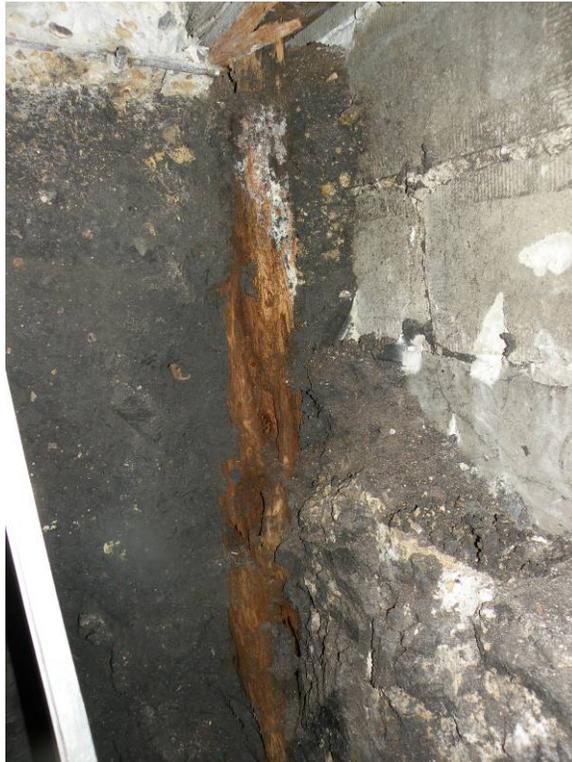
- At the southwest corner of TP-1, a 4-1/2 ft tall cedar post was encountered beneath the wood-framed wall of Suite 1432 as shown in Photograph 4.
- The cedar post is in poor condition due to rot decay. Large voids, approximately 4 inches in long and 2 inches wide, were encountered within the post as shown in Photograph 5.
- There is a cast in-place concrete footing located beneath the post; however, the post is no longer in contact with the top of the footing as shown in Photograph 6. An approximately 2-inch gap was measured between the bottom of the post and the top of the footing.
- The beam and sill plate of the wood framed wall was found to be in poor condition with indications of rot and possible termite damage as shown in Photographs 7 and 8.

- The cedar posts supporting the load bearing walls and archway columns exhibit severe decay and are no longer capable of properly supporting these structures. We believe these portions of the structure cannot be repaired economically and may need to be retrofitted or demolished.

PHOTOGRAPH 4 – GENERAL VIEW OF CEDAR POST AT SOUTHWEST CORNER OF TP-1.

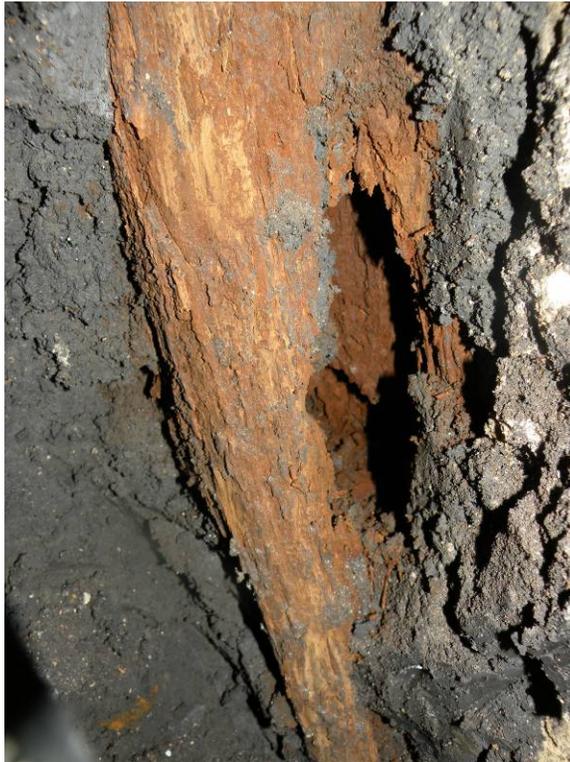
PHOTOGRAPH 5 – GENERAL VIEW OF VOID WITHIN CEDAR POST OBSERVED IN TP-1.

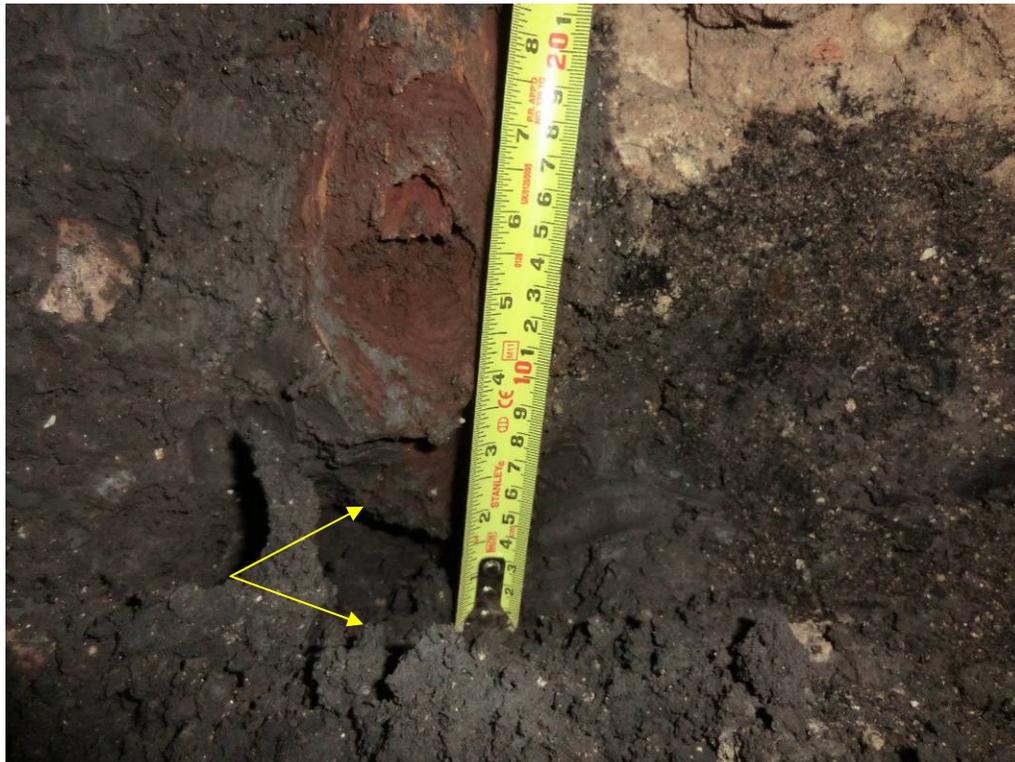
PHOTOGRAPH 6 – CLOSE-UP VIEW OF GAP BETWEEN THE BOTTOM OF THE CEDAR POST AND TOP OF THE CONCRETE FOOTING.

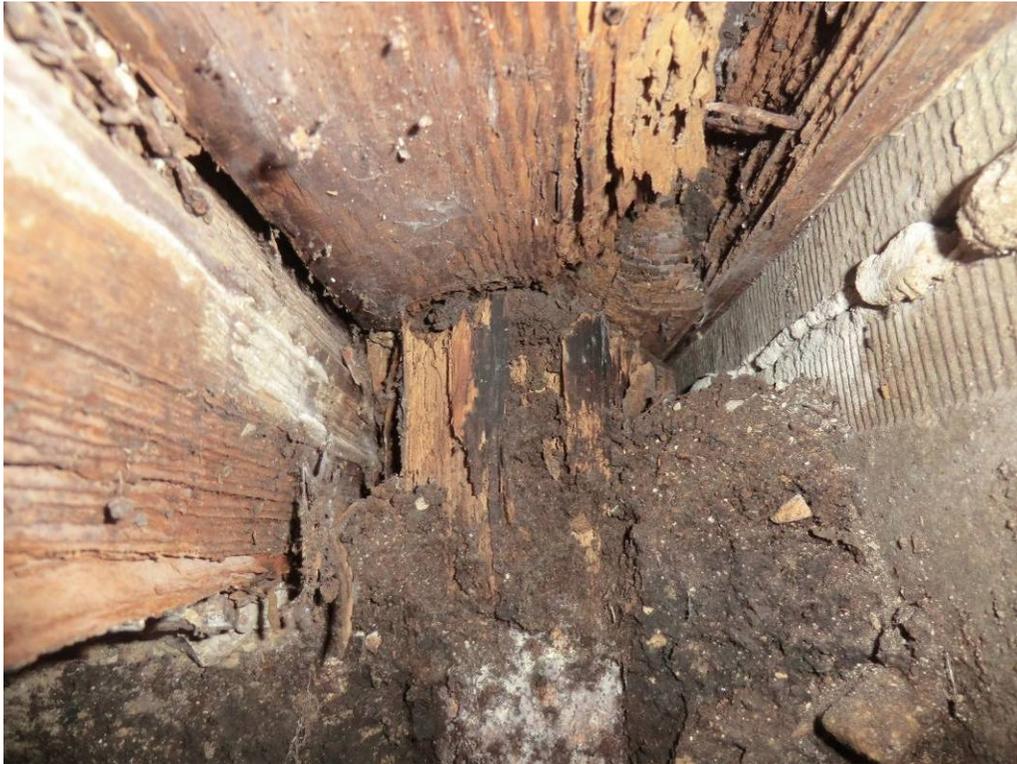
PHOTOGRAPH 7 – CLOSE-UP VIEW OF THE TOP OF THE CEDAR POST BENEATH WOOD BEAM AT BASE OF THE WEST WALL OF SUITE 1432.

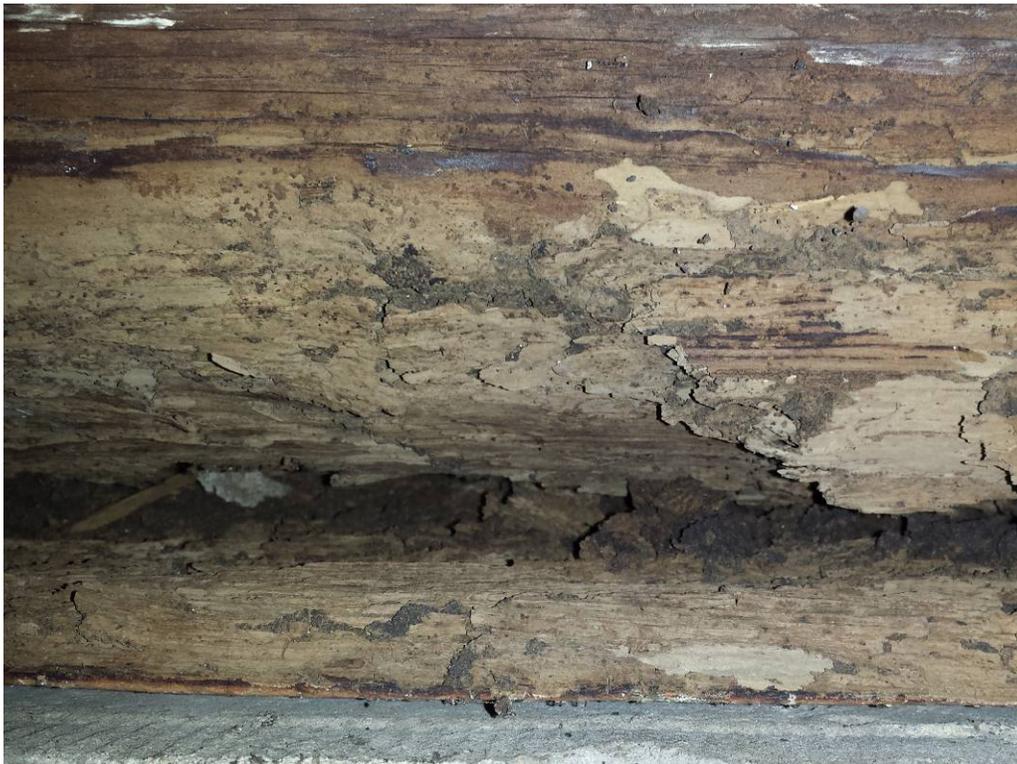
PHOTOGRAPH 8 – CLOSE-UP VIEW OF WOOD DECAY AT BASE OF WEST WALL OF SUITE 1432 AS VIEWED WHILE LOOKING UP ALONG BASE OF WALL.

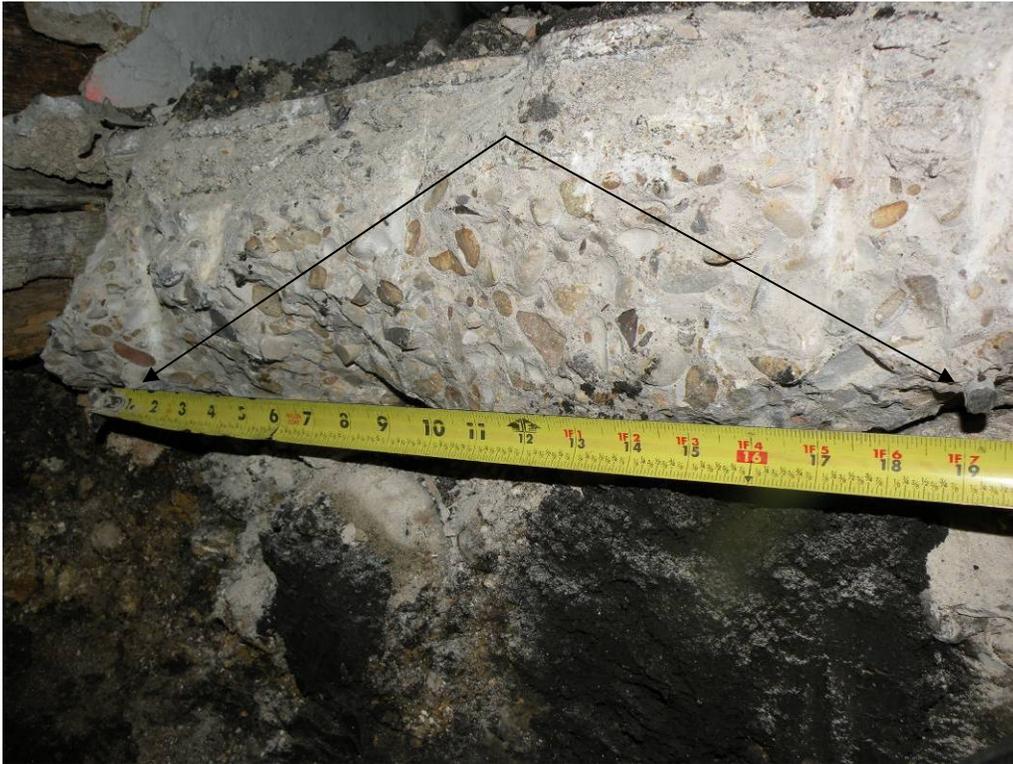
PHOTOGRAPH 9 – CLOSE-UP VIEW OF REINFORCING STEEL LOCATED AT BOTTOM OF FLOOR SLAB IN TP-1. REINFORCING STEEL IS SPACED APPROXIMATELY 18-INCHES ON CENTER, EACH WAY.

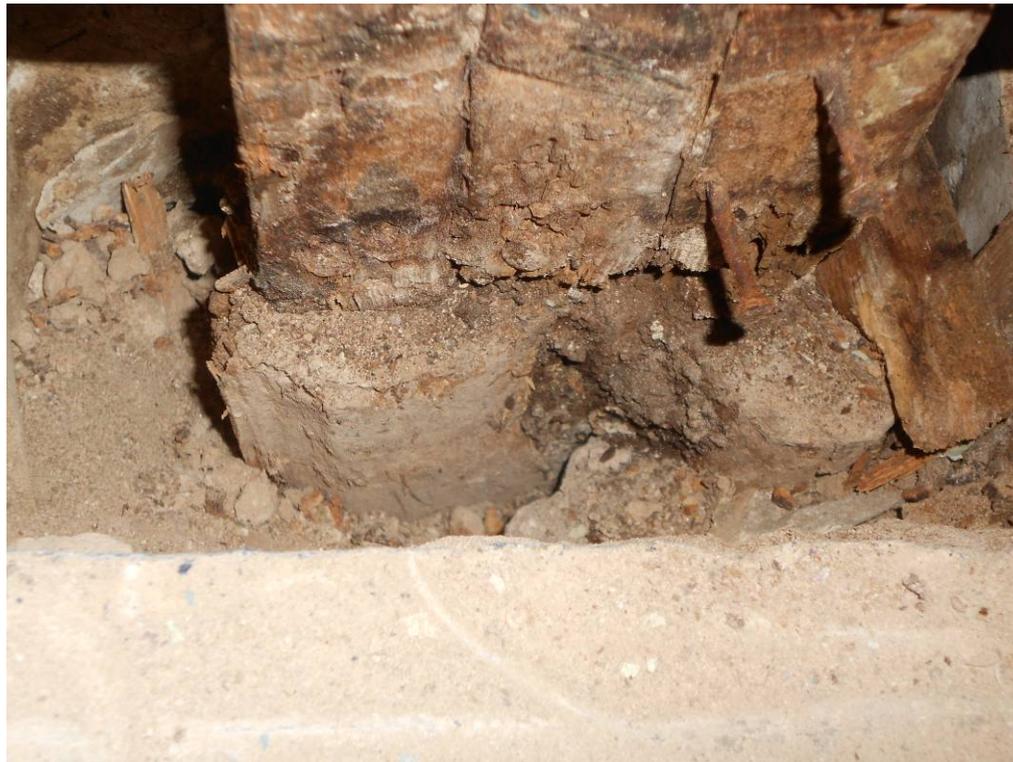
- A portion of the paneling and trim molding was removed from the 3rd archway from the north wall to determine if the footing could be observed at the base of the column. As shown in Photograph 10, the 2-inch x 4-inch framed column is supported on a cedar post.

PHOTOGRAPH 10 – CLOSE-UP VIEW OF CEDAR POST SUPPORTING 2-INCH X 4-INCH FRAMED ARCH COLUMN IN SUITE 1432.

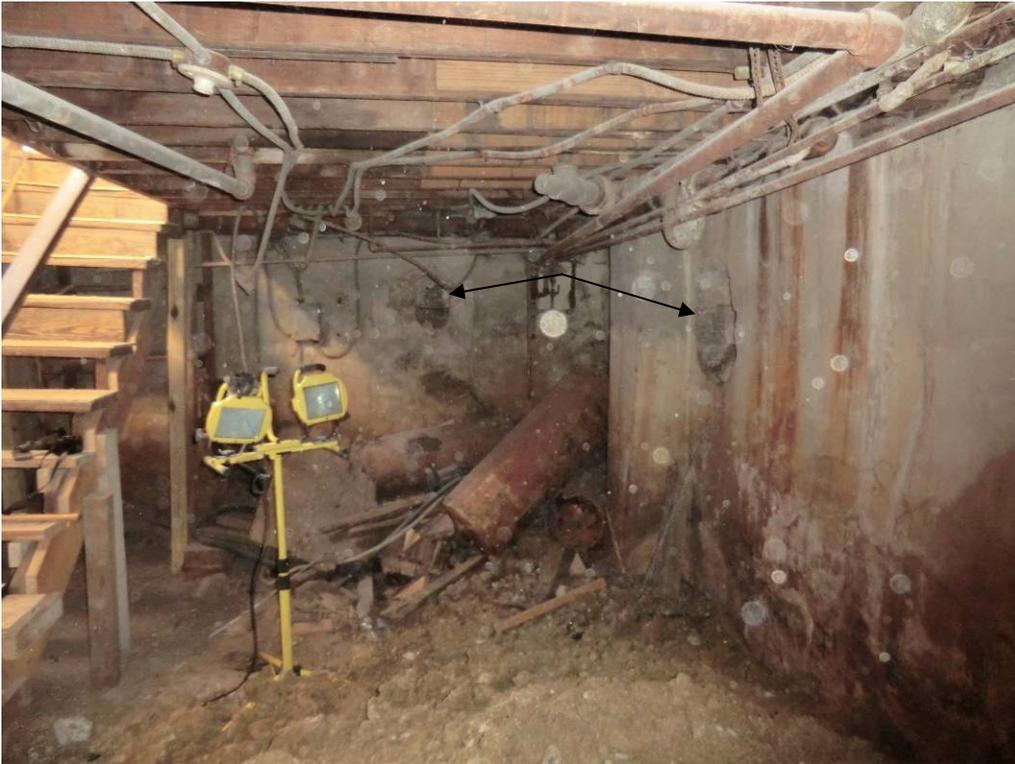
- The basement wall openings are pathways for transient water to move beneath the ground level floor slab into the basement.
- The utility lines may also be contributing to the water infiltration conditions within the basement. Further study is warranted to determine the condition of these lines given their proximity to the basement.

PHOTOGRAPH 11 – GENERAL VIEW OF PARTIAL BASEMENT WITHIN SUITE 1432 WITH MOISTURE STAINING AND WALL OPENINGS IN THE NORTH AND WEST CMU BLOCK WALLS.

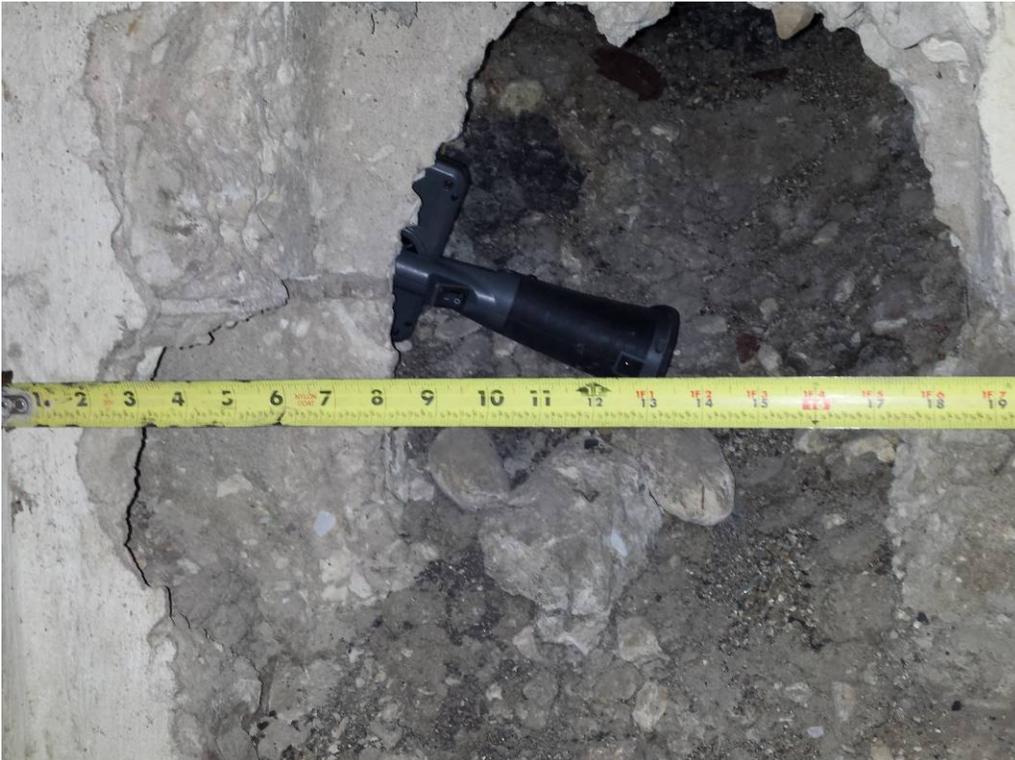
- Observations of the north wall opening revealed a void that extends approximately 2 ft north from the north face of the wall as shown in Photographs 12 and 13. A black coating was observed on the outside face of the wall indicating the presence of a moisture barrier.

PHOTOGRAPH 12 – CLOSE-UP VIEW OF NORTH WALL OPENING IN CMU BLOCK WALL.

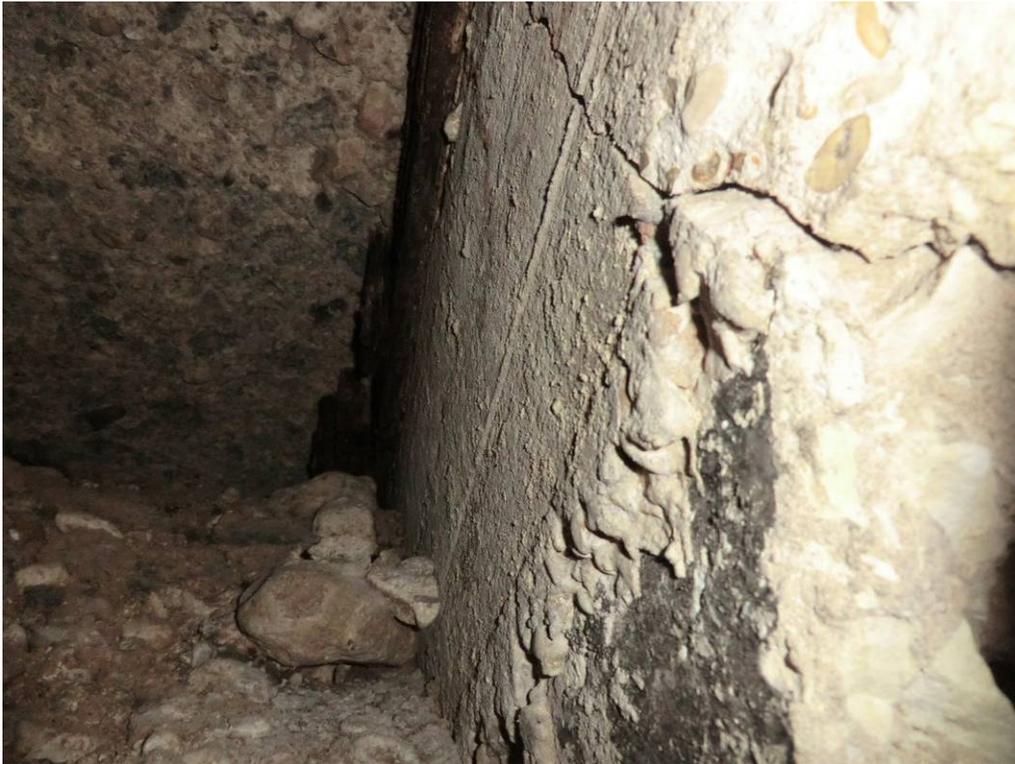
- A crack was observed extending up through the bond beam above the CMU block wall as shown in Photograph 13. The crack is approximately 1/16-inch wide.

PHOTOGRAPH 13 - CLOSE-UP VIEW OF VERTICAL CRACK IN NORTH WALL OPENING THAT EXTENDS THROUGH CONCRETE BOND BEAM. NOTE, BLACK COATING AT THE FOREFRONT OF THE PHOTOGRAPH MAY INDICATE THE PRESENCE OF A MOISTURE BARRIER.

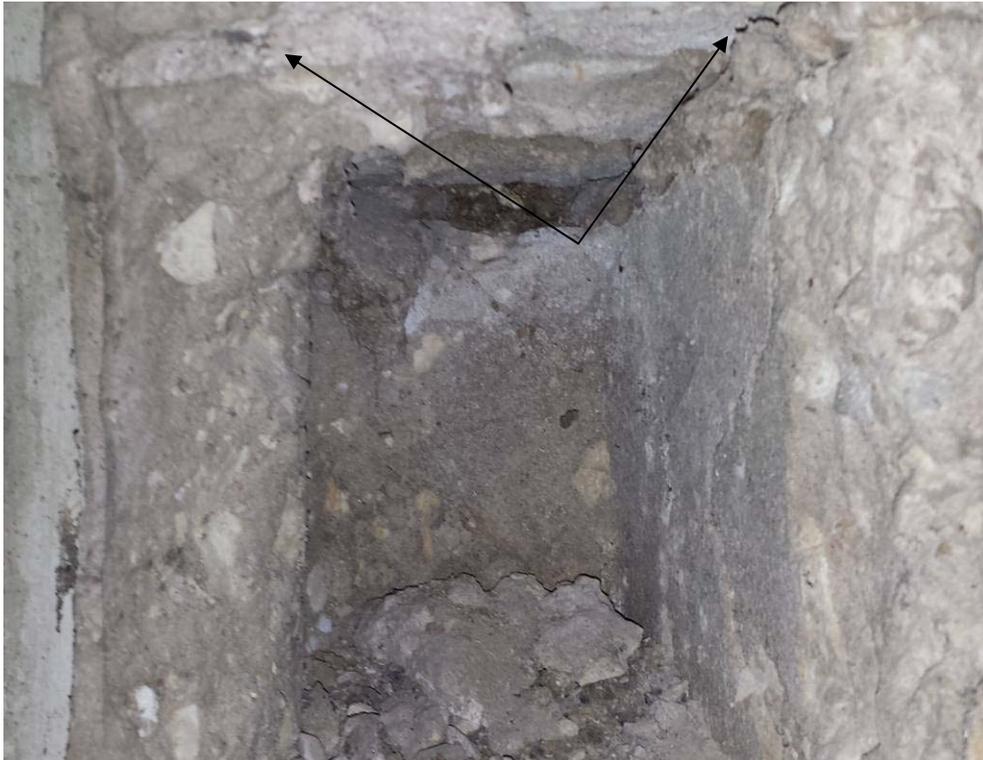
- Unfilled cells were encountered in the block as shown in Photograph 14.
- A 1-1/2 inch diameter cast iron pipe was observed beneath the floor slab of Suite 1432 approximately 2 ft north of the north basement wall. The type of utility that this pipe served could not be determined.

PHOTOGRAPH 14 – GENERAL VIEW OF UNFILLED CELL WITHIN CMU BLOCK AT NORTH WALL OPENING. ARROW INDICATES LOCATION OF BED JOINT BETWEEN COURSES.

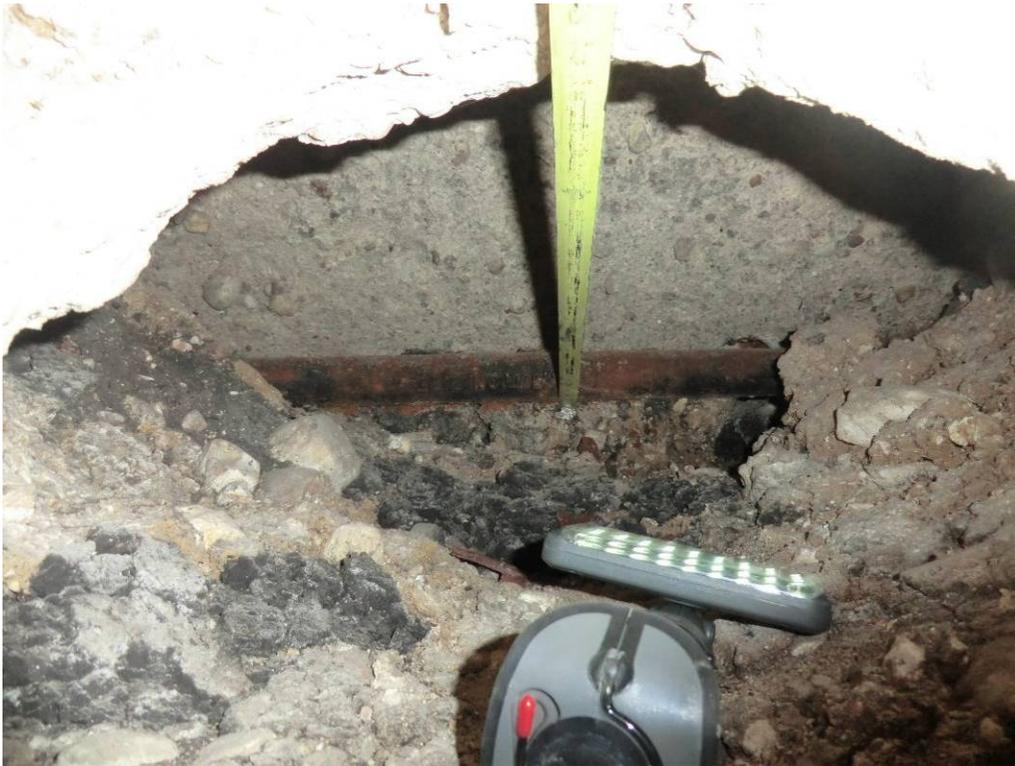
PHOTOGRAPH 15 - GENERAL VIEW OF CAST-IRON PIPE OBSERVED BELOW THE FLOOR SLAB AND APPROXIMATELY 2 FT NORTH OF THE NORTH BASEMENT WALL.

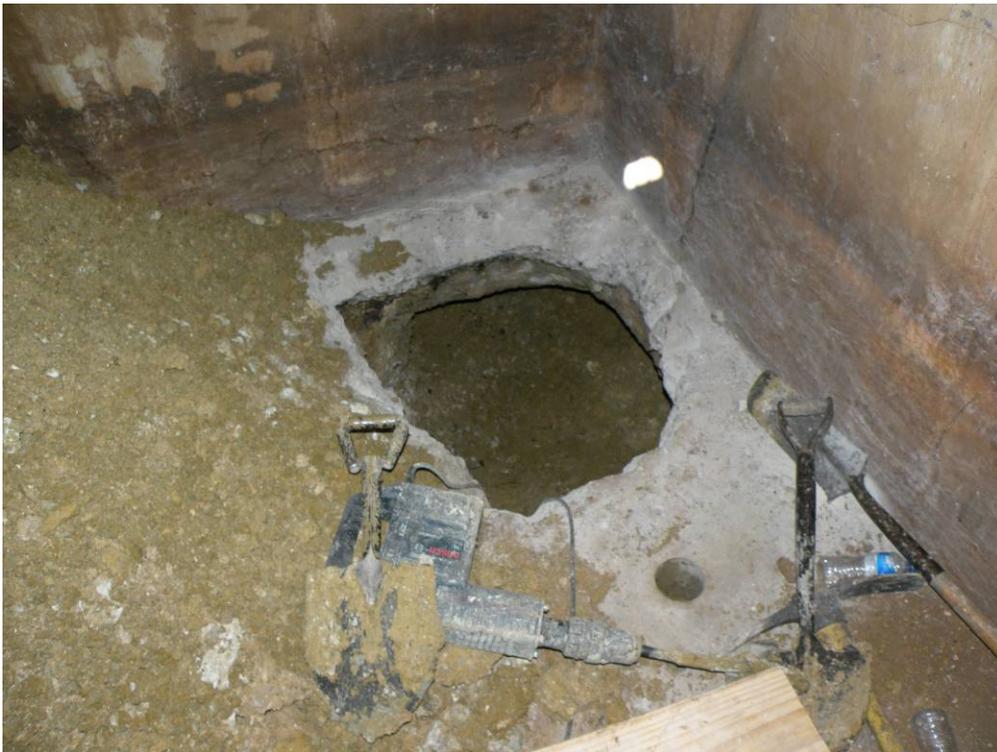
Groundwater was not encountered either during or immediately upon completion of our drilling operations. However, perched water was observed entering the basement test pit excavation TP-2 once the floor slab was chipped out from the test pit area exposing a water-bearing gravel seam. It is possible for groundwater to exist beneath this site at shallower depths on a transient basis following periods of precipitation. Fluctuations in groundwater levels occur due to variations in rainfall and surface water run-off.

PHOTOGRAPH 16 – GENERAL VIEW OF TP-2 AT NORTHEAST CORNER OF BASEMENT.

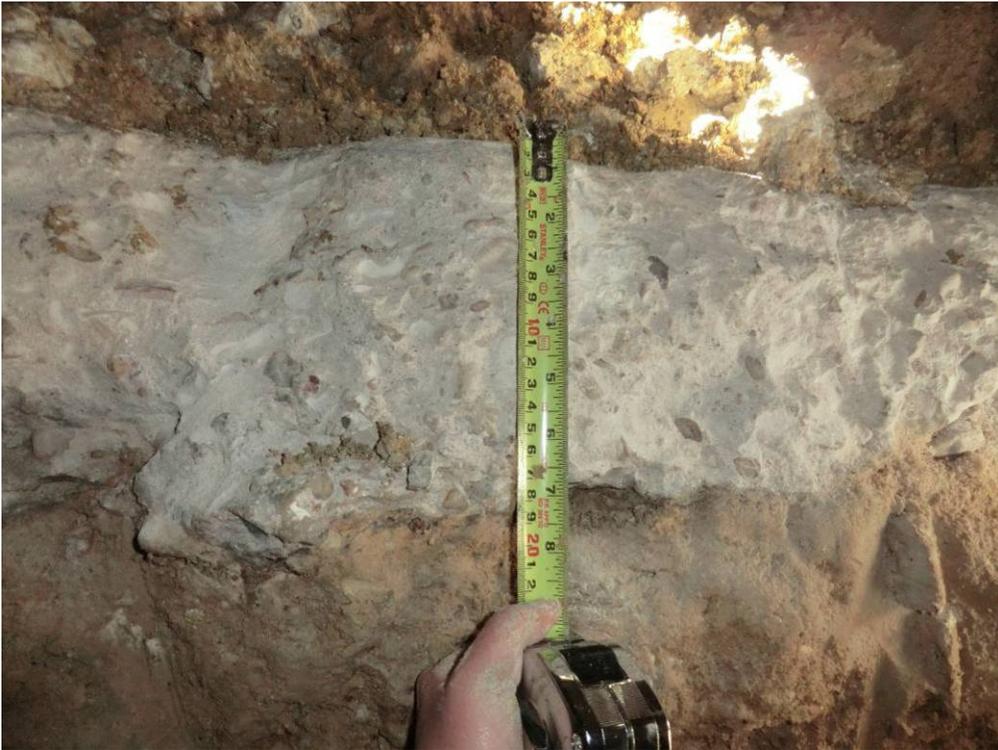
PHOTOGRAPH 17 – GENERAL VIEW OF BASEMENT SLAB THICKNESS MEASURED TO BE APPROXIMATELY 7-INCHES THICK.

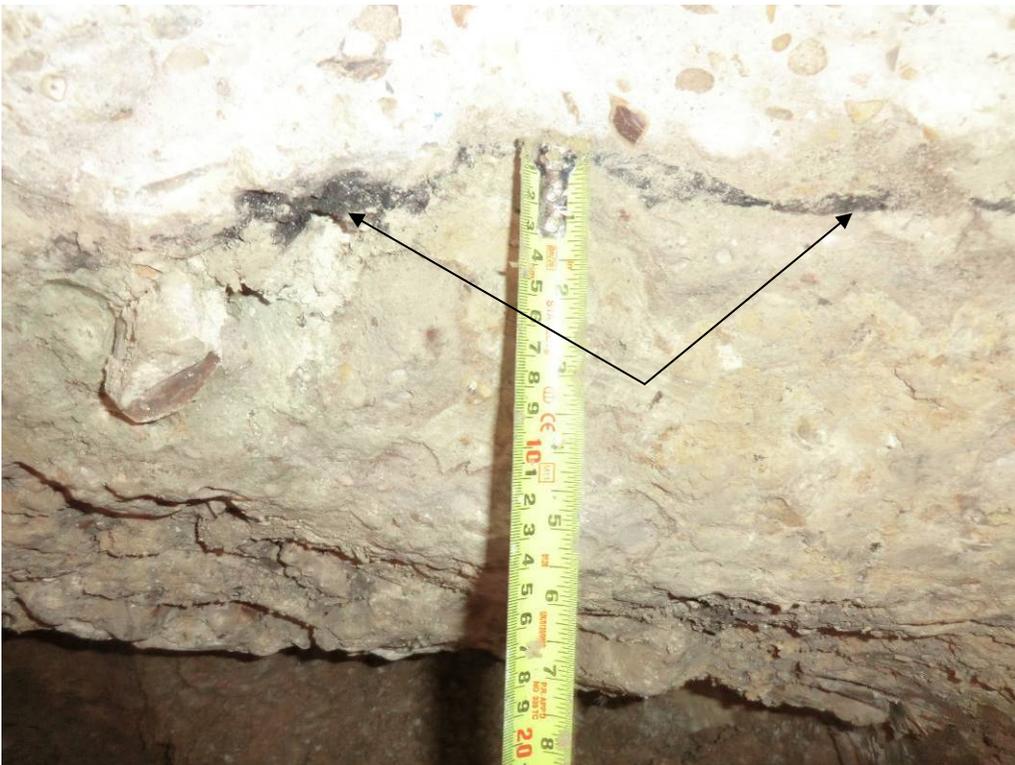
- A black coating was observed beneath the slab indicating the presence of a possible moisture barrier as shown in Photograph 18.
- The basement floor slab is reinforced with No. 4 bars spaced approximately 2-ft on-center, each way as shown in Photograph 19.

PHOTOGRAPH 18 – CLOSE-UP VIEW OF GRADE BEAM DEPTH BELOW SLAB MEASURING APPROXIMATELY 7-INCHES DEEP. NOTE, BLACK STAINING MAY INDICATE PRESENCE OF A MOISTURE BARRIER.

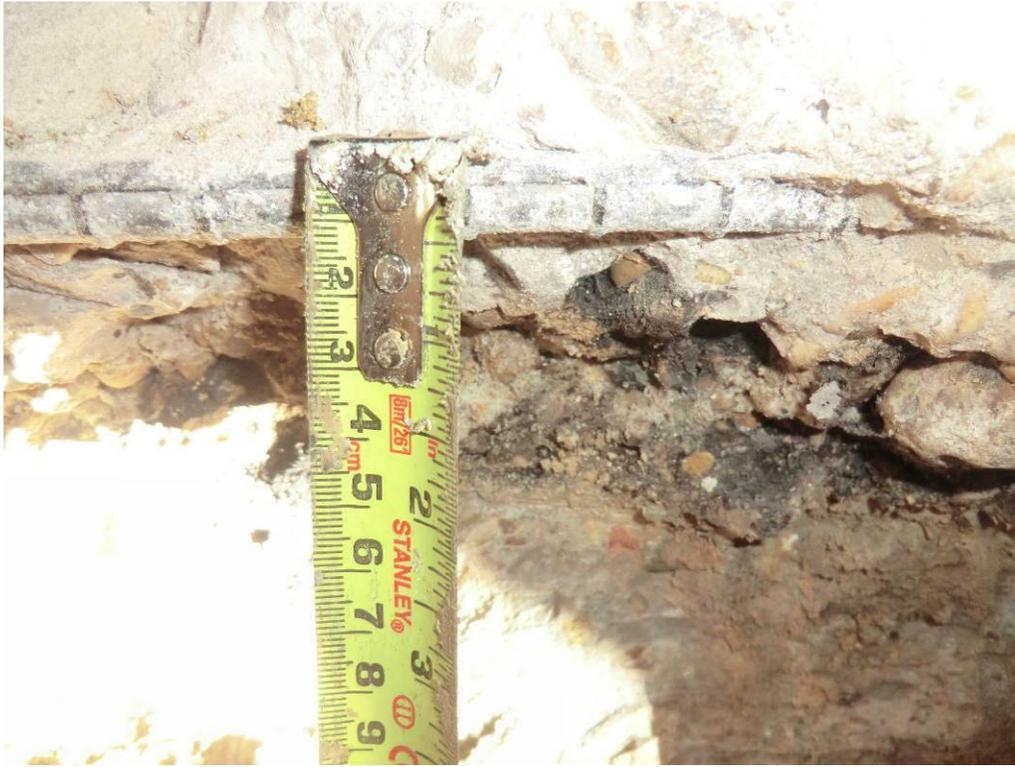
PHOTOGRAPH 19 – CLOSE-UP VIEW OF NO. 4 REINFORCING STEEL SPACED APPROXIMATELY 2-FEET ON CENTER, EACH WAY.

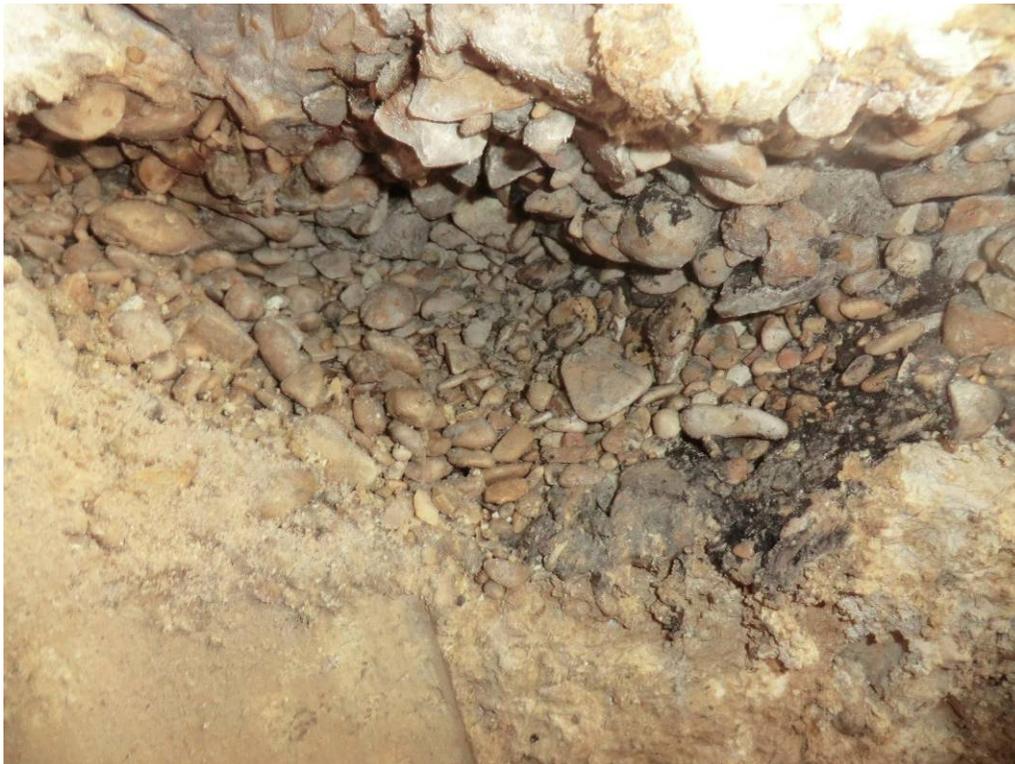
- The shallow spread footings supporting the cedar posts are within the active zone and are susceptible to shrink/swell movements of the clay soils.
- The gravel layer encountered beneath the basement floor slab is water bearing. Groundwater conditions can fluctuate with seasonal moisture changes.

PHOTOGRAPH 20 – CLOSE-UP VIEW OF GRAVEL FILL BENEATH BASEMENT FLOOR SLAB.

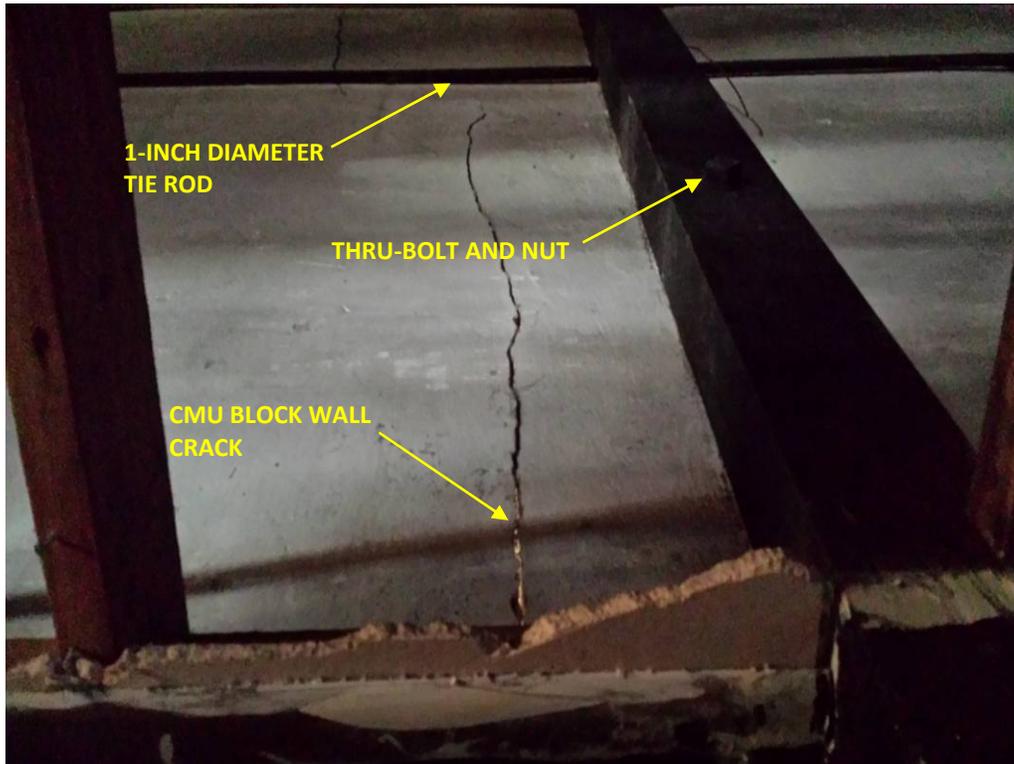
- Within Suite 1434, 4-inch x 6-inch wood posts were observed anchored to the exterior masonry wall with thru-bolts and nuts as shown in Photographs 21 and 22. The wood posts support a double, 2-inch x 12-inch rim joist as shown in Photograph 22.

- A horizontal tie rod was observed approximately 12 ft above the floor surface extending north-to-south along the inside face of the wall.
- Vertical cracks were observed in the CMU block wall varying up to about 3/8-inch in width as shown in Photograph 21.

PHOTOGRAPH 21 – GENERAL VIEW OF 4-INCH BY 6-INCH WOOD POST ANCHORED TO WEST CMU BLOCK WALL OF SUITE 1434 WITH THRU-BOLT AND NUT.

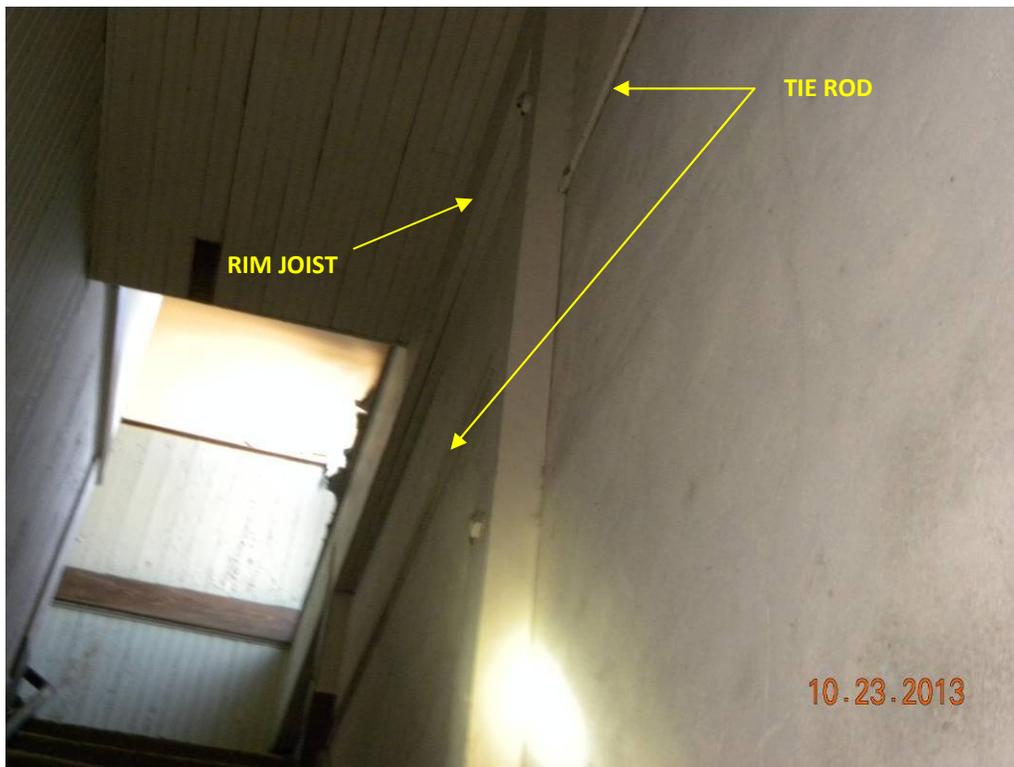
PHOTOGRAPH 22 – GENERAL VIEW OF 4-INCH BY 6-INCH WOOD POST ANCHORED TO WEST CMU BLOCK WALL IN STAIRCASE. NOTE, THE POST SUPPORTS A RIM JOIST CONSISTING OF TWO, 2-INCH BY 12-INCH MEMBERS. ARROW INDICATES LOCATION OF 1-INCH DIAMETER HORIZONTAL TIE ROD.

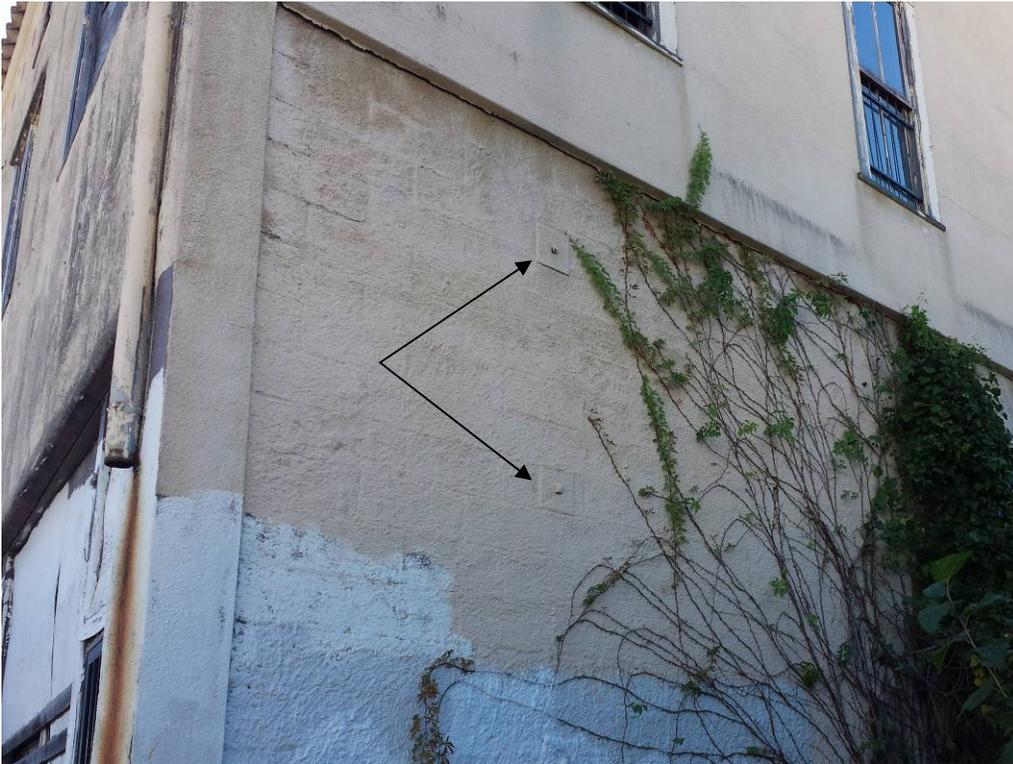
- Anchor plates were observed on the exterior of the west wall as shown in Photograph 23.
- Test Pit TP-3 was dug to a depth of approximately 4-feet as shown in Photograph 24.

PHOTOGRAPH 23 – GENERAL VIEW OF 8-INCH X 8-INCH ANCHORS PLATES LOCATED ON THE EXTERIOR OF THE WEST WALL OF SUITE 1434. THRU-BOLTS EXTEND THROUGH CMU WALL AND 4-INCH X 6-INCH WOOD POSTS LOCATED ON INSIDE FACE OF WALL.

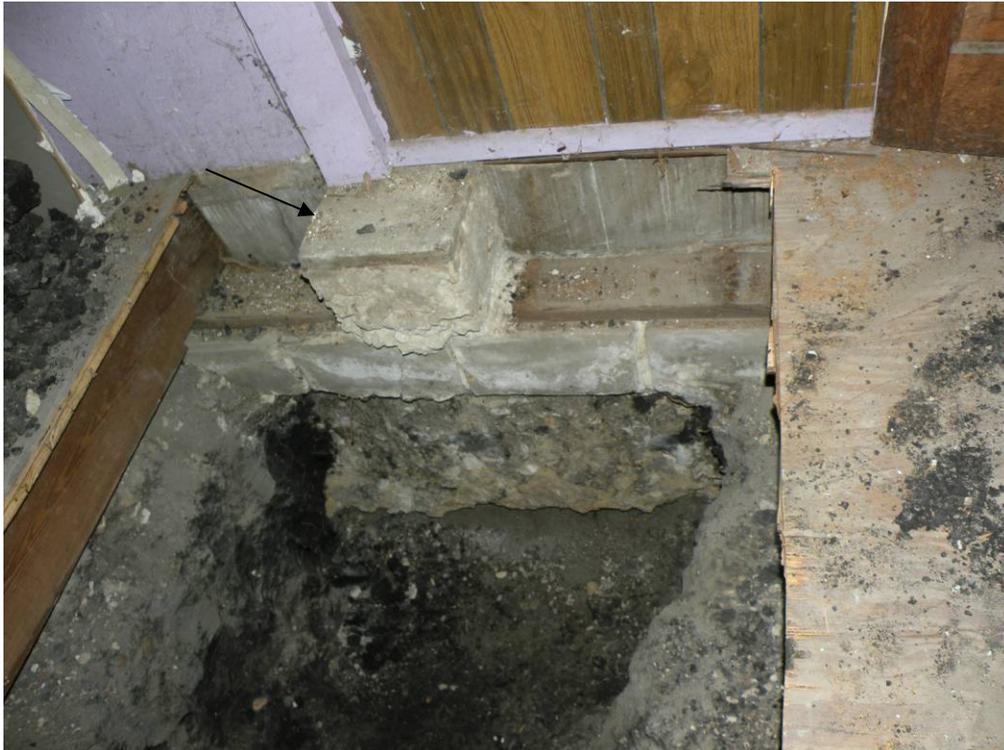
PHOTOGRAPH 24 – GENERAL VIEW OF TP-3 WITH CONCRETE PEDESTAL FOOTING LOCATED ABOVE A SINGLE CMU BLOCK COURSE THAT IS SUPPORTED ON A CONCRETE GRADE BEAM. THE PEDESTAL SUPPORTS A 4-INCH X 6-INCH WOOD POST.

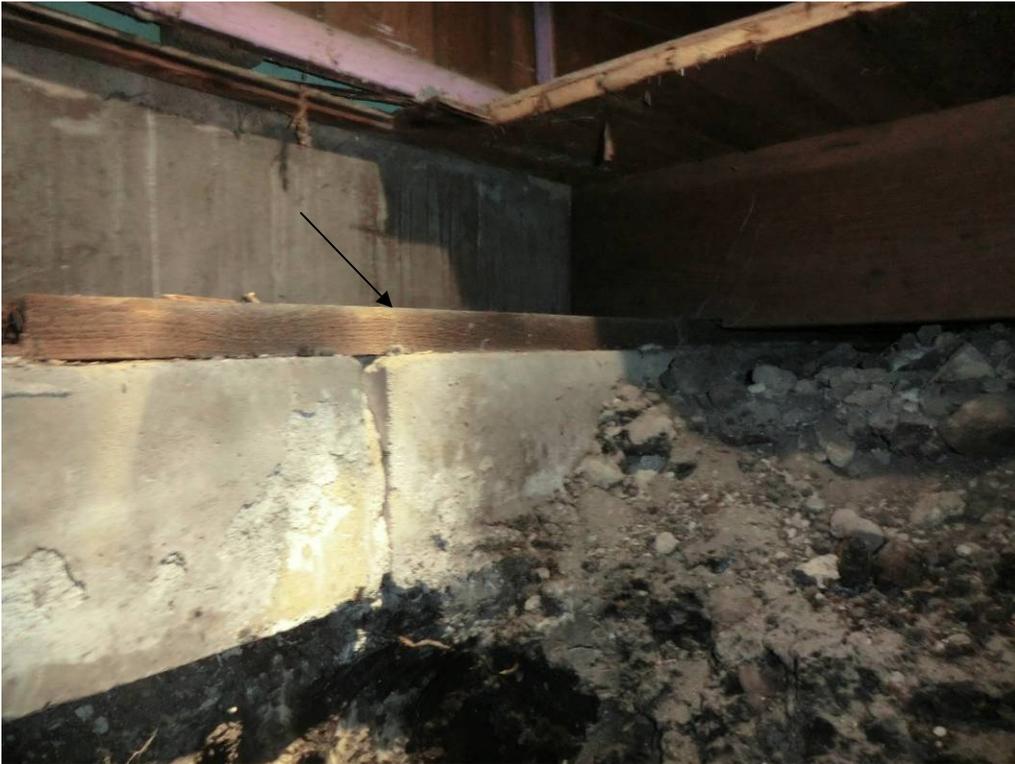
PHOTOGRAPH 25 – GENERAL VIEW OF FLOOR JOISTS SUPPORTED ON 2-INCH X 6-INCH WOOD SLEEPER LAID ACROSS TOP OF CMU BLOCK COURSE AT WEST GRADE BEAM.

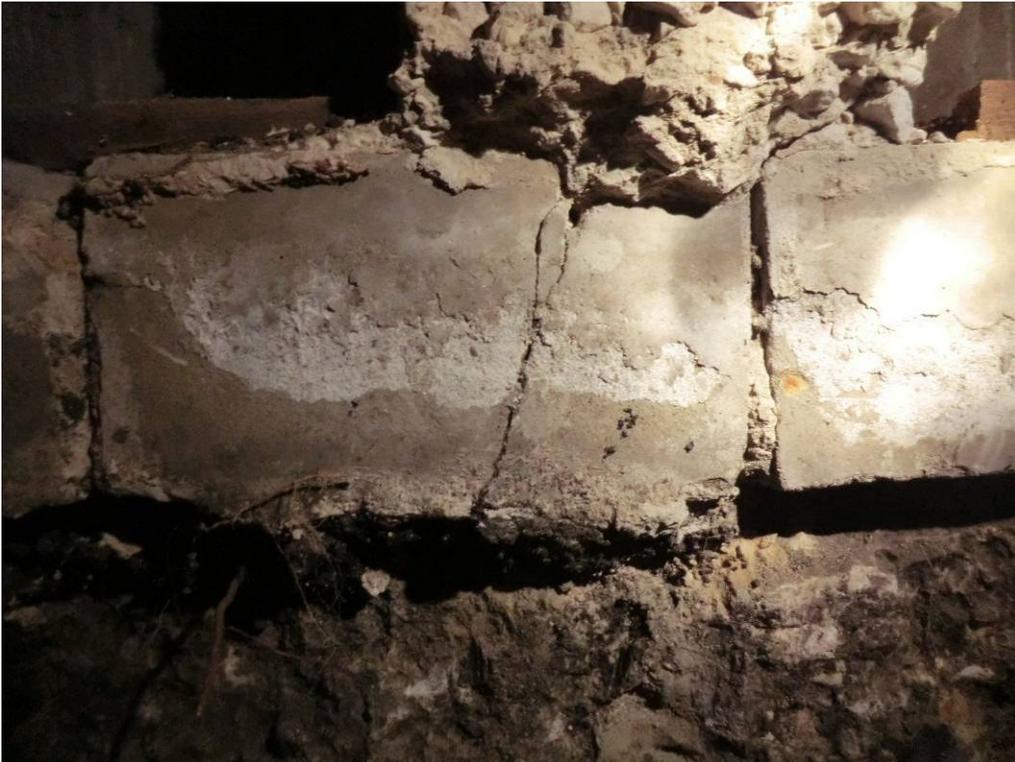
- The CMU block units are cracked and have signs of efflorescence as shown in Photograph 26.
- The wood floor is suspended on 2-inch x 10-inch cedar joists that are spaced approximately 16-inches on-center and extend from east-to-west with wood cross bracing as shown in Photograph 27. The cross bracing is spaced approximately 10 ft apart. The floor joists in this location were found to be in good condition.
- The floor joists are supported on 2-inch x 6-inch wood sleepers that are supported on CMU block units that have been buried in the ground in a north-to-south orientation as shown in Photograph 28. The sleeper shown in Photograph 28 has a longitudinal crack.
- One of the wood sleepers that supports a floor joists was observed deflecting down toward the north as shown in Photograph 29. This appears to be a result of differential movement.

- The exterior grade beams were generally found to be in good condition with no significant indications of deterioration where they were exposed.
- The west side CMU block wall has experienced significant cracking and separations. Given the 4-inch x 6-inch wood post supports and tie rods used to provide lateral stability to these walls, we suspect that they may not be reinforced. These walls should be analyzed by Alpha Consulting Engineers to determine their adequacy.
- The wood sleepers, supported on the CMU blocks, beneath the wood subfloor are exhibiting some signs of differential movement.
- Differential movements will likely continue over the life of the structure.

PHOTOGRAPH 26 – CLOSE-UP VIEW OF CRACKED CMU BLOCK SHOWN IN PHOTOGRAPH 24, LOCATED BELOW THE CONCRETE PEDESTAL.

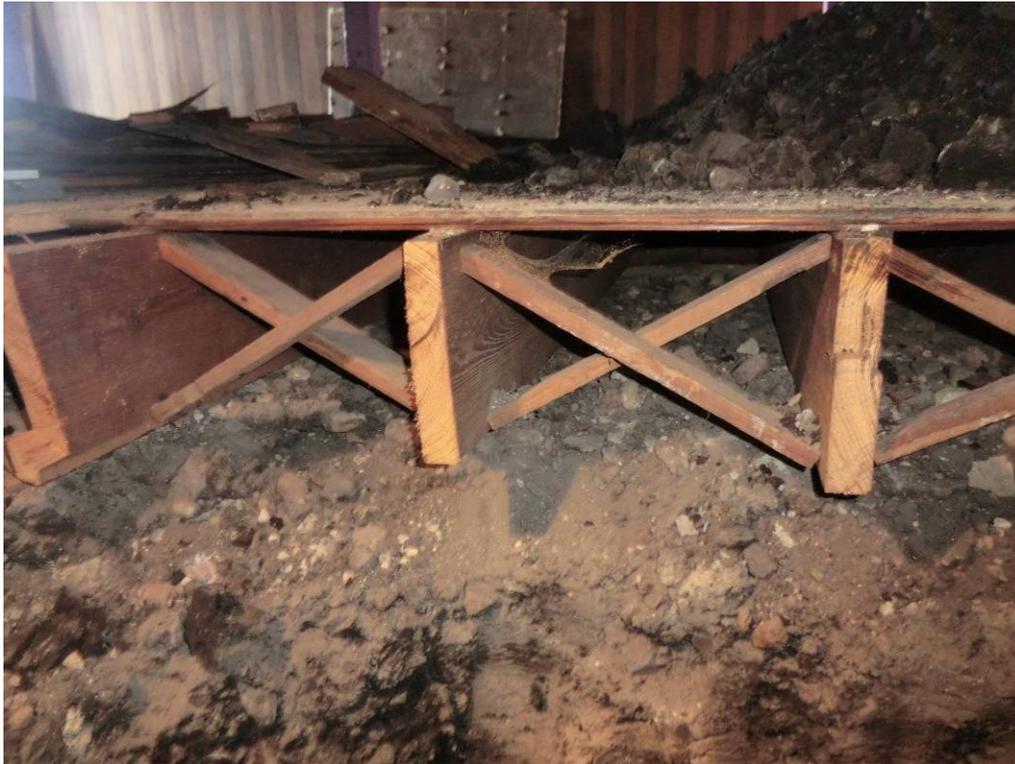
PHOTOGRAPH 27 – GENERAL VIEW OF WOOD SUBFLOOR WITH 2-INCH X 10-INCH FLOOR JOISTS WITH CROSS BRACING. NOTE, THE FLOOR JOISTS ARE RESTING ON 2-INCH X 6-INCH WOOD SLEEPERS LAID ACROSS CMU BLOCKS THAT ARE BURIED IN THE GROUND.
