**RE: Forensic Study of Existing Foundation Components
Sterling Building
1432-1434 E. Commerce Street
San Antonio, Texas**

**THE STERLING BUILDING
1432 TO 1434 E. COMMERCE STREET
SAN ANTONIO, TEXAS**

PROJECT NO. ASR14-003-00

March 10, 2014

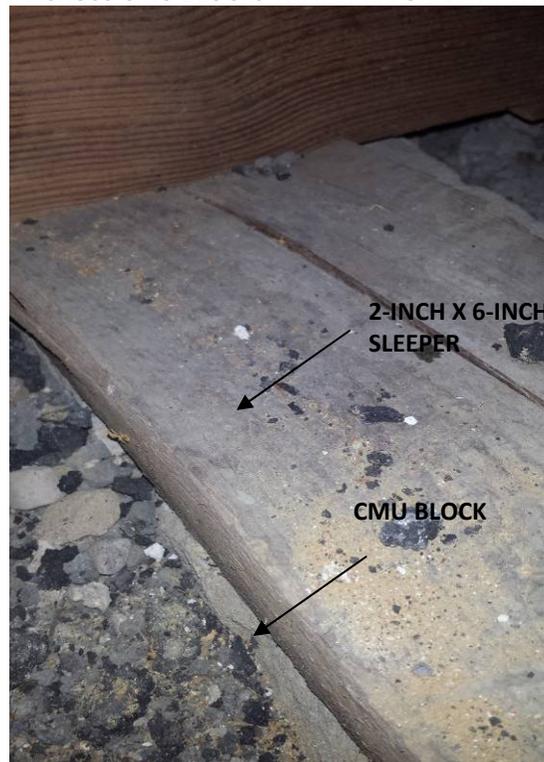
PHOTOGRAPH 28 – CLOSE-UP VIEW OF 2-INCH X 6-INCH WOOD SLEEPER LAID ACROSS CMU BLOCK SUPPORTING THE FLOOR JOISTS THAT SPAN BETWEEN THE EAST AND WEST WALLS OF SUITE 1434. NOTE, THERE IS A 1/8-INCH WIDE CRACK IN THE WOOD SLEEPER.

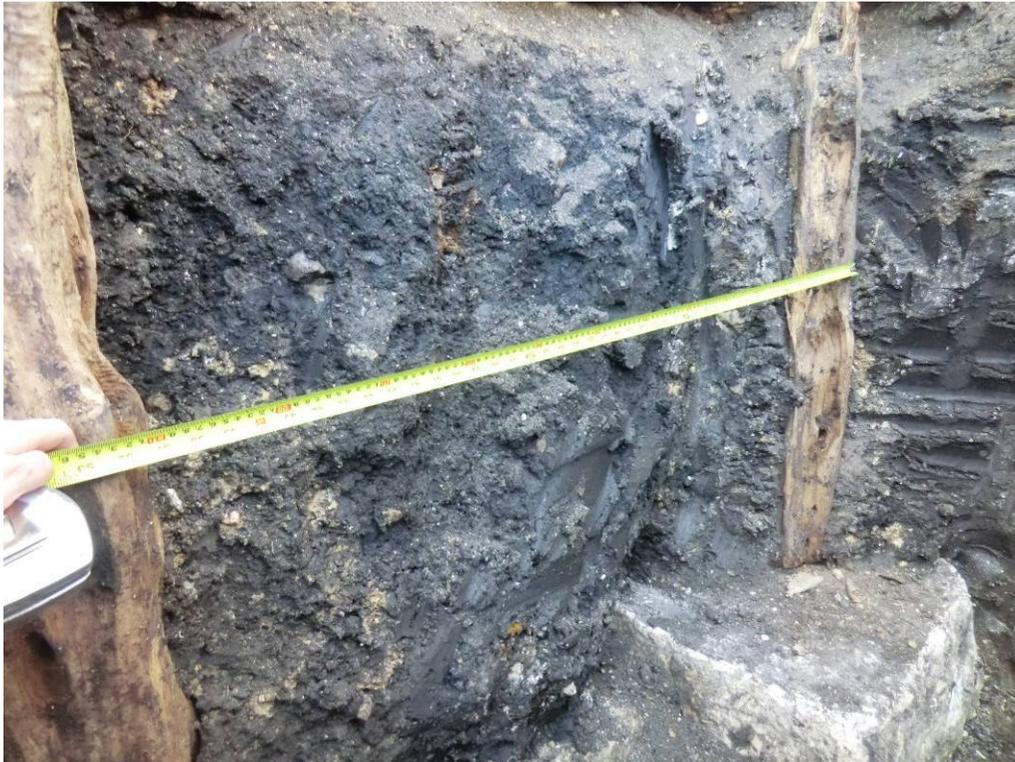
PHOTOGRAPH 30 – GENERAL VIEW OF CEDAR POSTS AND CONCRETE FOOTING IN TP-4. POSTS ARE SPACED APPROXIMATELY 4-FT APART.

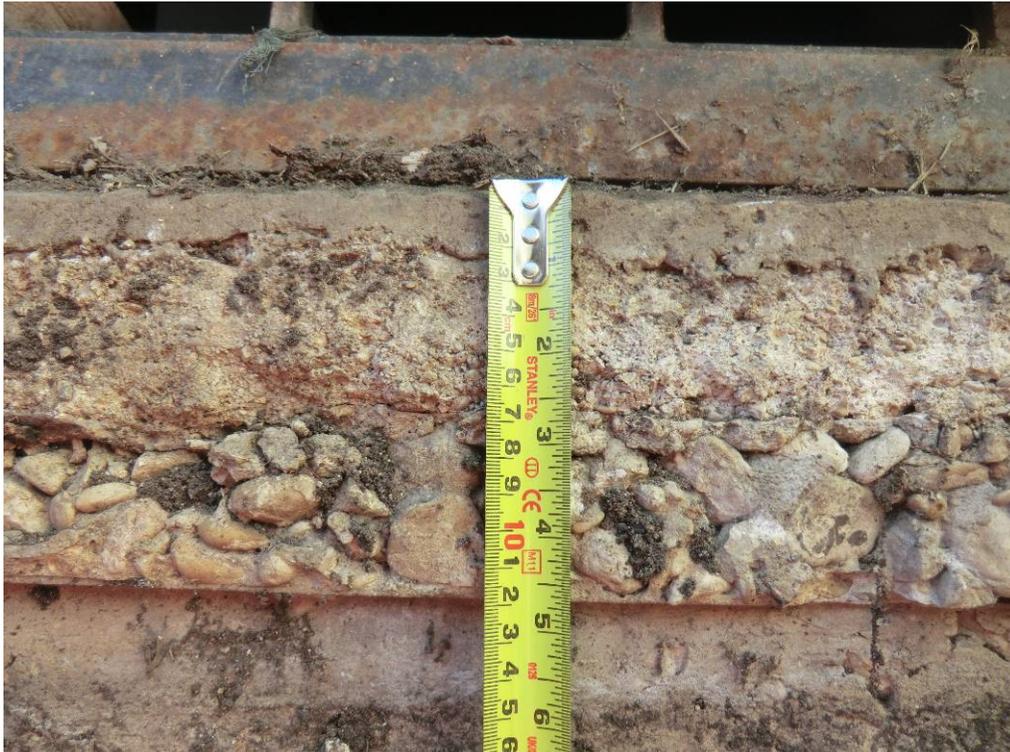
PHOTOGRAPH 31 – CLOSE-UP VIEW OF CONCRETE SLAB THICKNESS AT TP-4.

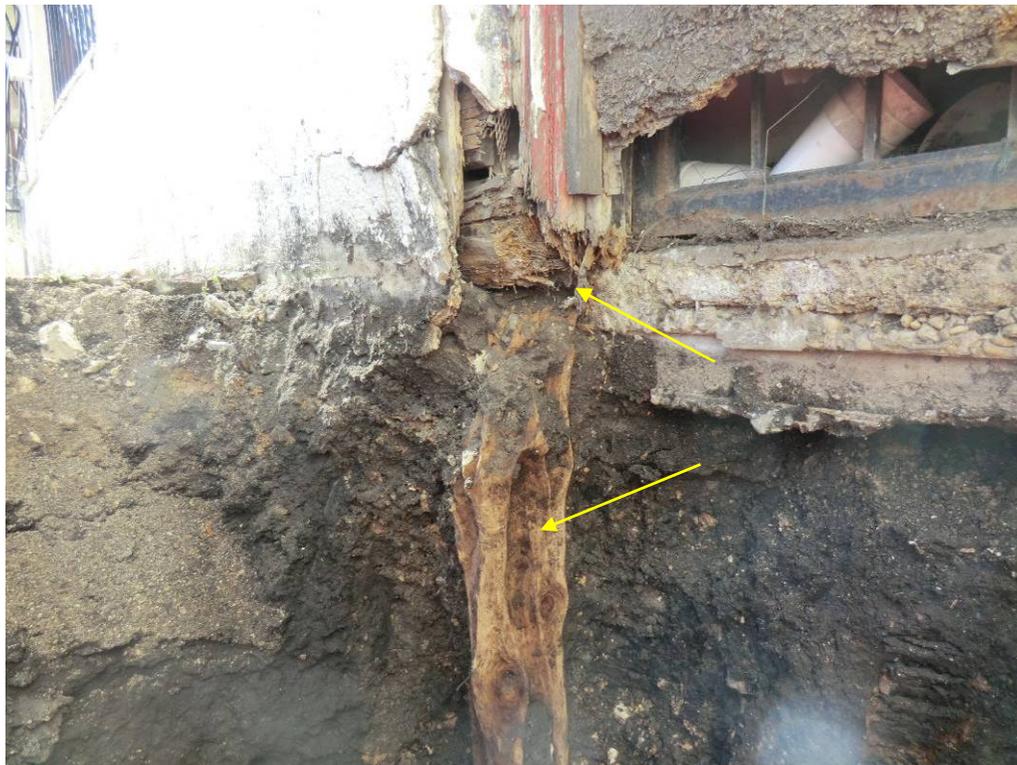
- The cedar posts originally supported the exterior, wood-framed wall as shown in Photograph 32; however, decay and rot of both the posts and the wood sill has resulted in the members no longer being attached to one another as shown in Photographs 32 and 33.

PHOTOGRAPH 32 – GENERAL VIEW OF TOP OF CEDAR POST AT SOUTHWEST CORNER OF TP-4. NOTE, A GAP HAS FORMED BETWEEN THE TOP OF THE POST AND THE WALL FRAMING. VOIDS ENCOUNTERED IN POST WHERE DECAY HAS OCCURRED.

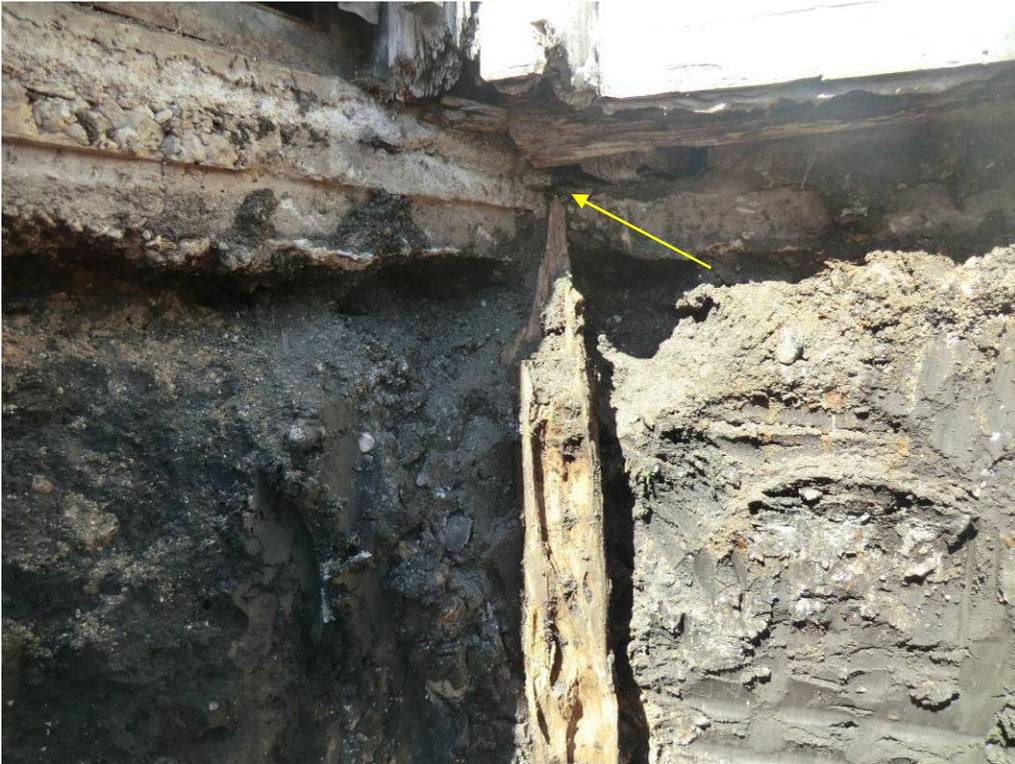
PHOTOGRAPH 33 - GENERAL VIEW OF TOP OF THE CEDAR POST AT THE NORTHWEST CORNER OF TP-4. NOTE, THE TOP OF THE POST HAS DECAYED AND IS NO LONGER IN CONTACT WITH THE WALL FRAMING.

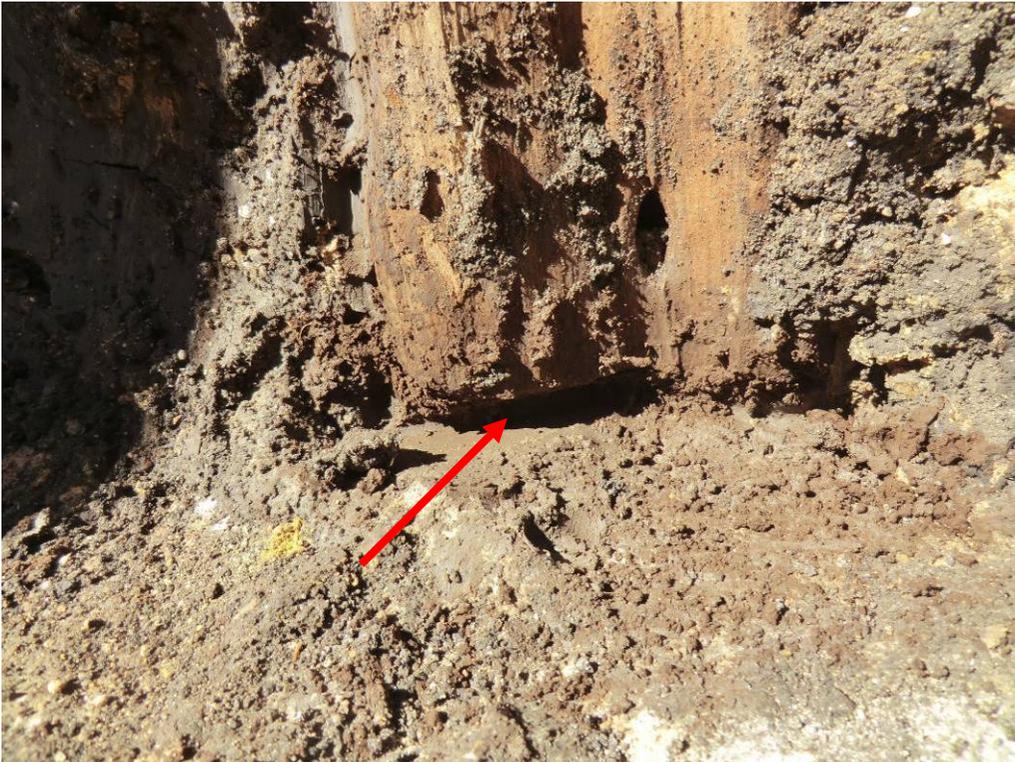
- A gap was observed at the base of the cedar post located at the northwest corner of the test pit and the top of the concrete block footing as shown in Photograph 34.

PHOTOGRAPH 34 - CLOSE-UP VIEW OF THE BOTTOM OF THE CEDAR POST AT THE NORTHWEST CORNER OF TP-4. NOTE, A GAP HAS FORMED BETWEEN THE BOTTOM OF THE CEDAR POST AND THE TOP OF THE CONCRETE FOOTING.
