Due Diligence Study
of
Frost Bank Tower and Parking Garage
100 W. Houston St.
San Antonio, TX 78205

For the
City of San Antonio

April 24, 2015

Alderson & Associates, Inc.
MEP Consulting Engineers | TBPE Firm No. F1008
7700 Torino, Suite 101
San Antonio, TX 78229
P: (210) 614-1110

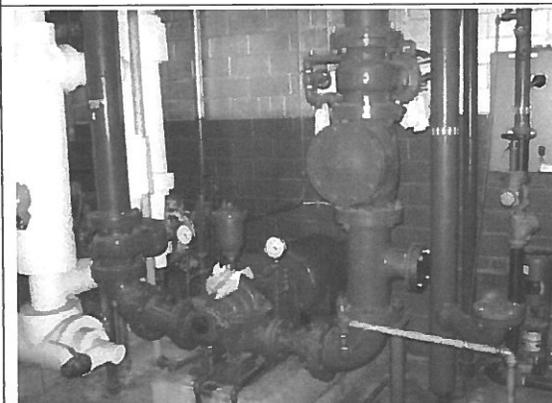
<p>Photo 1.1.05: Fire Pump (center) and Fire Jockey Pump (right)</p>	<p>Photo 1.1.06: Pre-action System Assembly Serving UPS Room and Main Printing Room</p>

The fire pump will require replacement due to the pump not providing sufficient pressure at the penthouse level. Refer to Fire Code Analysis in Appendix 2.1.

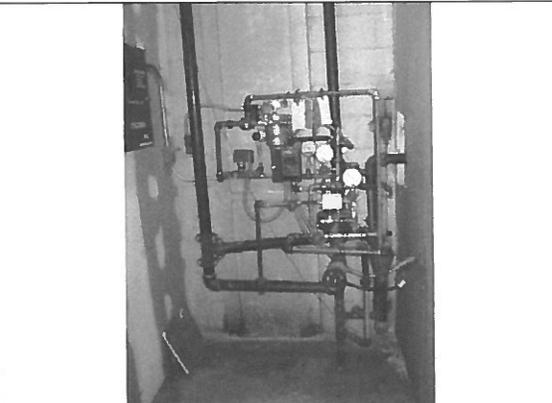
The existing pre-action system that serves the UPS Room and Printer Room on the 1st level of the parking garage is in good condition. The pre-action controller was installed in 1998 and is not anticipated to need replacement within the next 10 years.

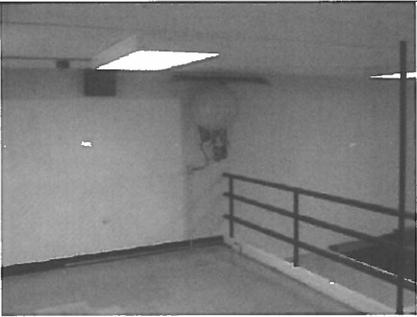
The fire extinguishing systems located in the vaults are original equipment to the building that was constructed with the parking garage structure in 1964. The system is in good condition and has been well maintained. While it is not anticipated that the system need replacement, maintenance must be continued to keep the system in operation. If the vault spaces are utilized for a different function and a system is not required, it is highly recommended that the system be removed.

<p>Photo 1.1.07: Typical Halon Extinguishing Agent System</p>

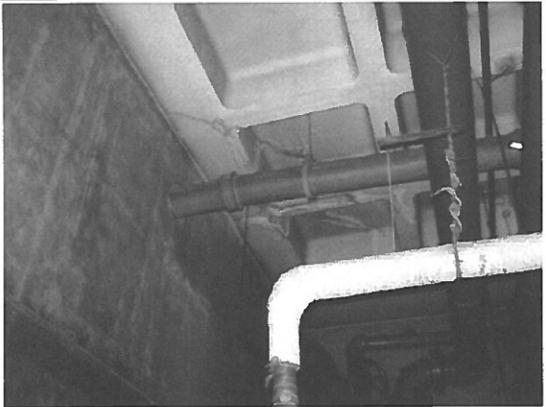
The majority of the sanitary and vent piping system is original to the building. As each floor is undergoing renovation, the sanitary and vent piping on the floor has been replaced. The cast iron sanitary piping that comprises the majority of the building's sanitary system appears to be in good condition as no leaks or obvious signs of damage are evident. The sanitary system, however, is 42 years old and with a typical cast iron sanitary system having a service life of approximately 50 to 70 years, it would be expected that although system replacement would not be required within the next 10 years, portions of the system will require maintenance.

<p>Photo 1.2.07: Cast Iron Sanitary Sewer Exiting Building (Grey Pipe)</p>	<p>Photo 1.2.08: Basement Sewage Ejection System</p>

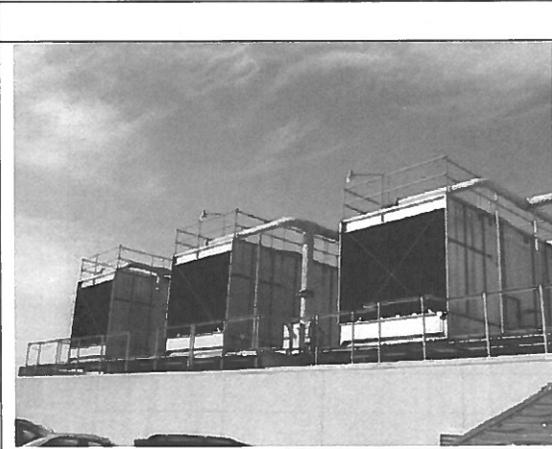
The cooling towers are approximately 20 years old. Ongoing maintenance, such as cleaning and fill replacement will be required. The cooling towers are currently operating on an equalized, common basin system without an automatic means to isolate a tower or provide cooling tower optimization sequences. There is an opportunity to improve the efficiency of the cooling system by modifying the cooling tower/condenser water system to enable tower optimization control sequences to be implemented.

<p>Photo 1.3.03: Cooling Towers Located on Roof of Parking Garage</p>	<p>Photo 1.3.04: Interior of Cooling Tower</p>

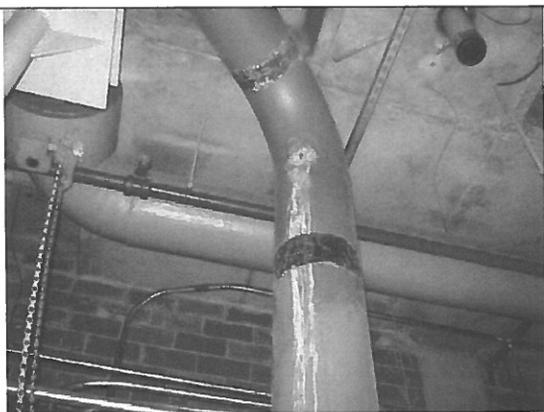
The chilled water and condenser water piping systems are original to the building. These steel piping systems have been in operation for 42 years and while they do appear to be in generally good condition, leaks have developed in several locations. This has required maintenance and replacement of several portions of the piping system.

Photo 1.3.11: Condenser Water Piping System Leak at Elbow

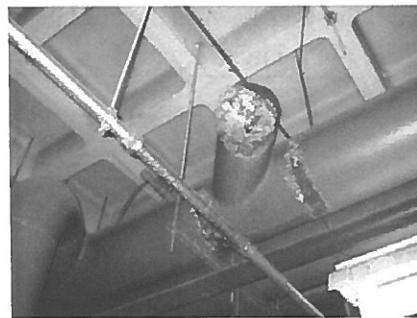
Photo 1.3.12: Condenser Water Piping System Leak at Capped Line

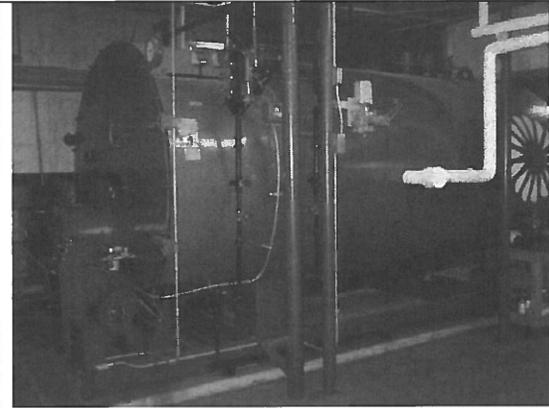
The steam boilers are original to the building. The boilers have been retrofitted and maintained. The burners in both boilers are currently being replaced. Steam boilers, by nature, require significant maintenance in order to keep them in good operational condition. They will require significant maintenance resources and chemical treatment to keep them operational. When the boiler reaches its end of life where it is not economical to repair, it should be replaced with a hot water boiler.

Photo 1.4.01: B-1 - 300 hp Steam Boiler

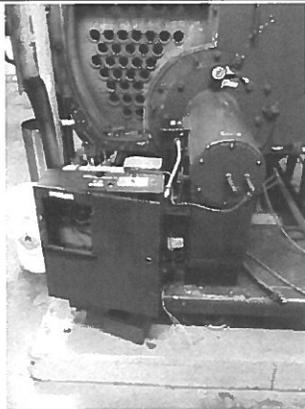
Photo 1.4.03: Burner Replacement on 100 hp Steam Boiler

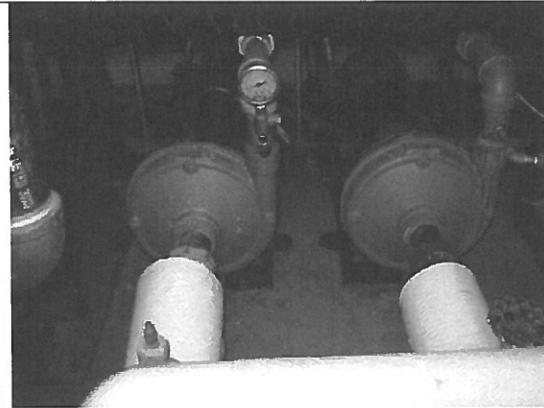
The condensate receiver and condensate return pumps are in good operational condition and are not expected to require replacement in the next ten years.

Photo 1.4.06: Steam Condensate Return Pumps

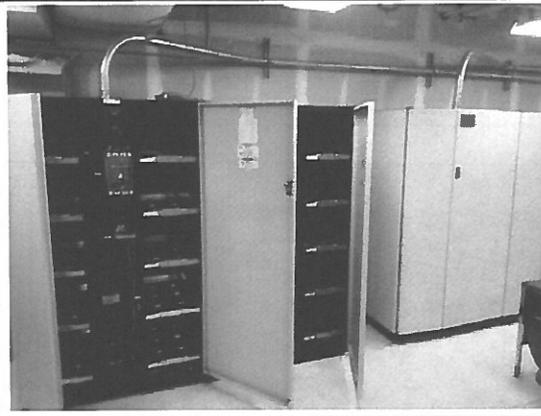
Photo 1.9.10: Decommissioned UPS units
