RE: Frost National Parking Garage
San Antonio, Texas 78220

At the request of Mr. Dean Alderson, P.E. and with your approval, R-S-C-R, Inc. is pleased to provide you with the following structural report for the above referenced property. The purpose of this report is to provide a professional opinion as to the general condition of the property referenced above. This office conducted a site visits on June 15 and June 18, 2015. During this site visits; observations were performed on the Parking Garage and office building. Observations were generally performed on each level of the parking garage, including the cooling tower and the basement. Observations of the office building were performed where accessible areas existed; the eighteenth floor and mechanical level. Photographs were taken during the site visit. We also reviewed existing drawings provide by Frost National Bank. Since the occupancy and use of the building and parking garage will not change, a structural analysis and additional testing is not required for this report.

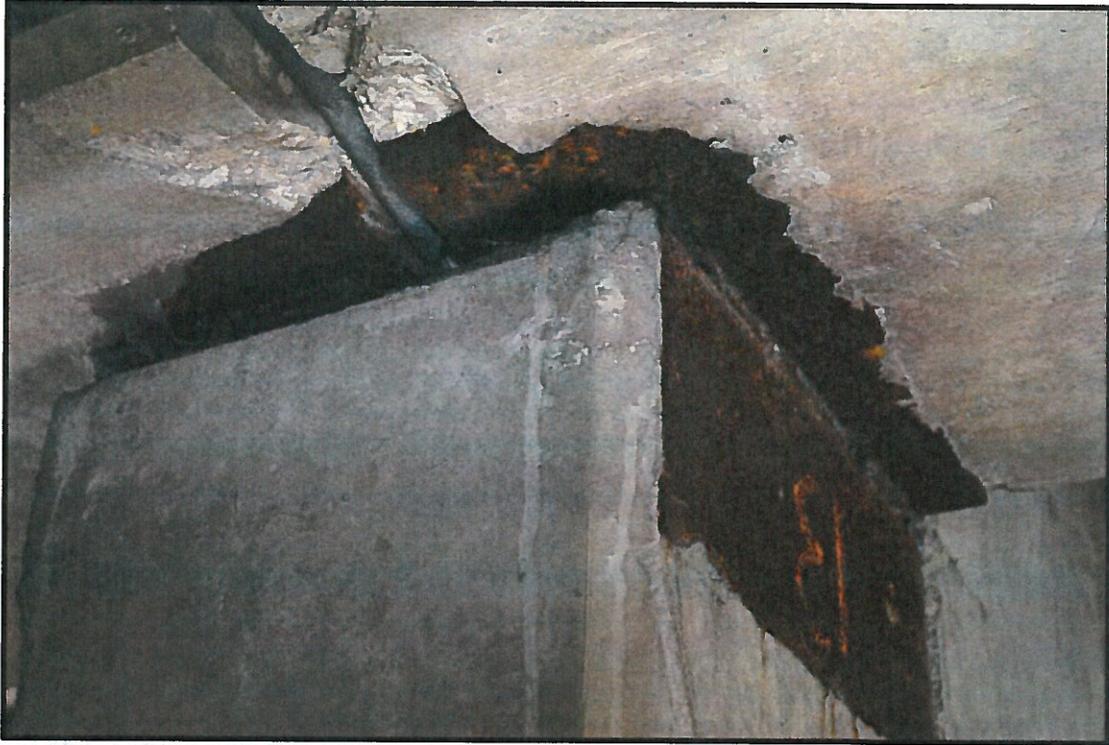
- Photographs 1 and 2 were taken on the third level. They show oxidation occurring on the embed plates cast in the pre-cast elements and angles attaching them to the columns. This was found throughout this portion of the parking garage, on all levels. We recommend removal of oxidation from the plates and angles, and paint applied.

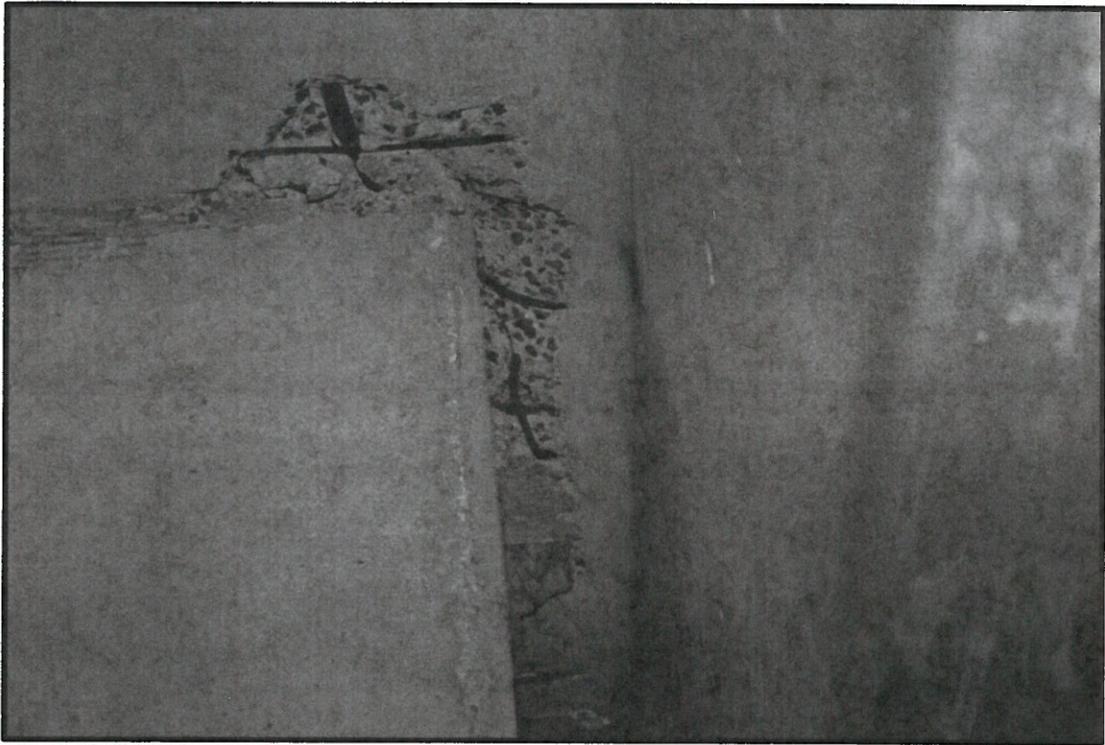
- Photograph 3 was taken on the third level. It shows a connection between two precast beams. This is the only level observed where the bolts are not painted. We recommend the bolts be painted.

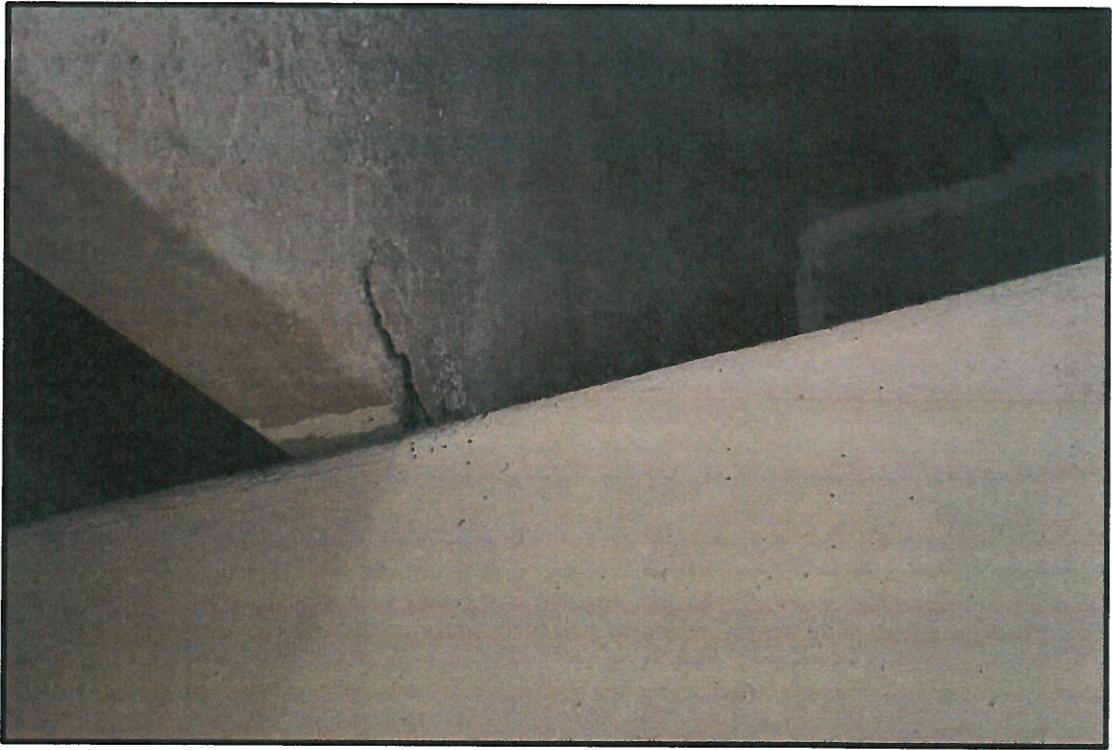
- Photograph 4 was taken at an interior column. This is a common occurrence on levels 3 through 7. This photograph shows exposed wire mesh. We recommend these areas be patched with a cementitious grout.

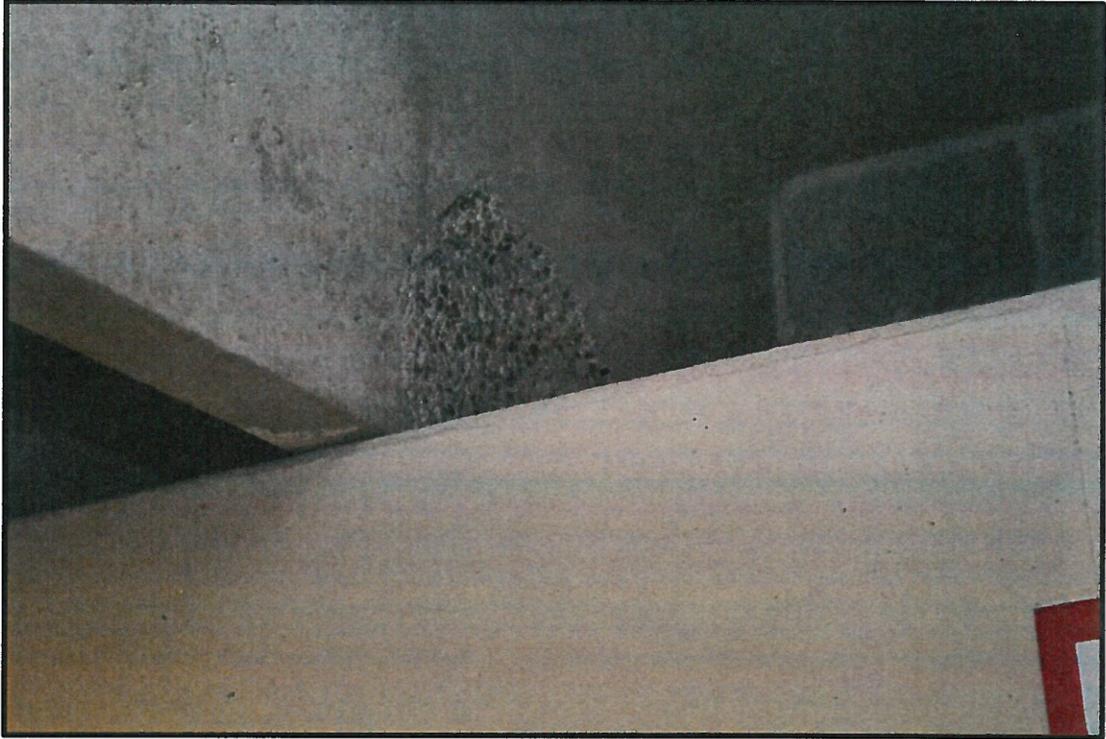
- Photographs 5 and 6 were taken on the fourth level. They indicate minor damage to a pre-cast double tee. We recommend these areas be repaired or patched with a cementitious grout.

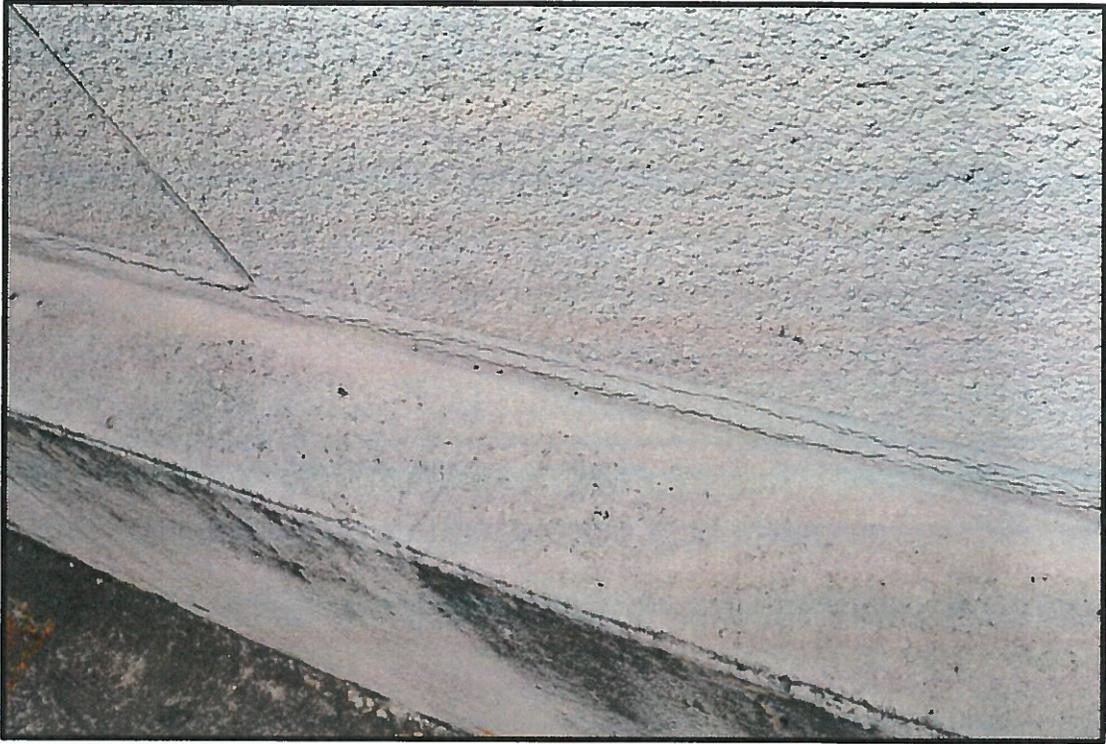
- Photographs 7 and 8 were taken on the roof. They show areas where the sealant or caulk is failing. We recommend this sealant be removed and replaced.

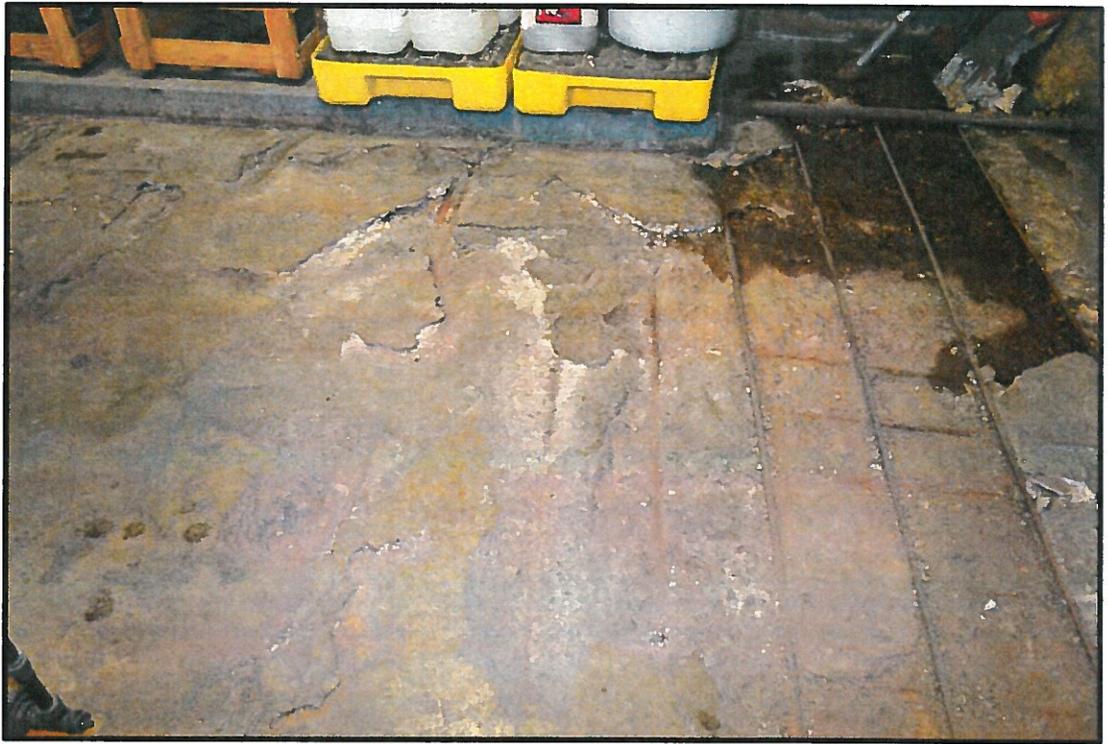
- Photographs 9 through 15 were taken in the basement. They show damage done to the slab and exposed reinforcing steel. We recommend repair of the slab and replacement of reinforcing steel, if required.

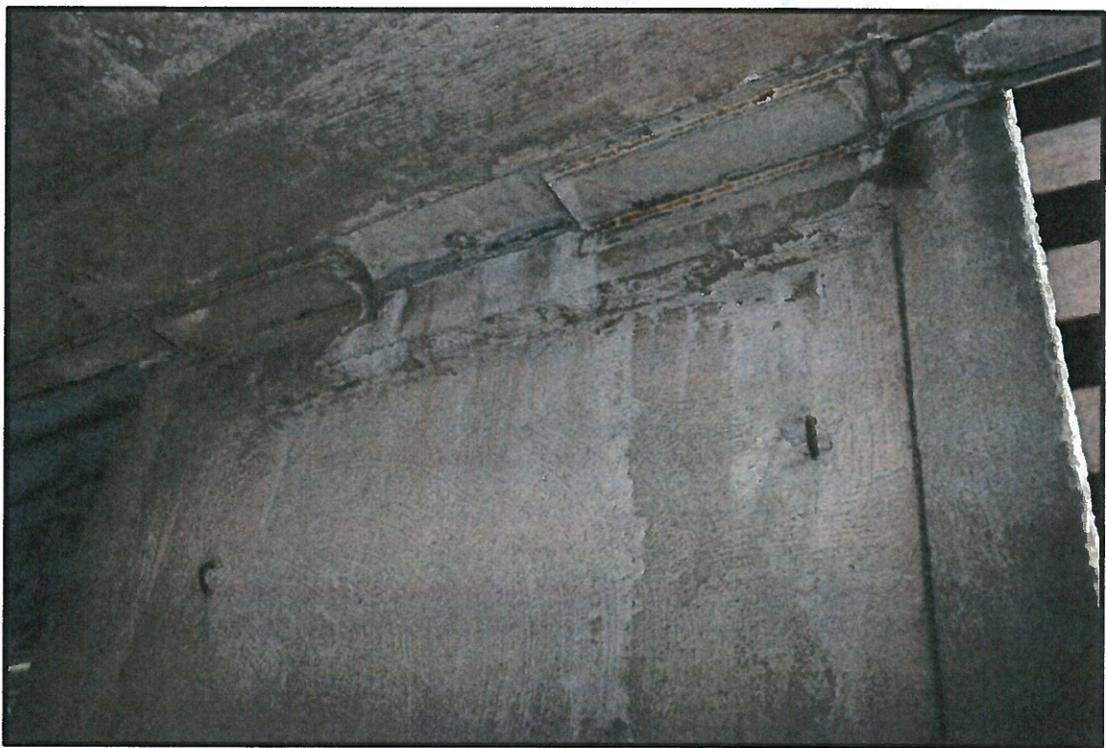
- Photograph 16 shows a typical connection between the pre-cast concrete panels and the supporting structure. This type of connection occurs on each level. It shows painted plate and angles. In some areas, evidence of minor oxidation has occurred. We recommend the oxidation be removed and the connection be repainted.

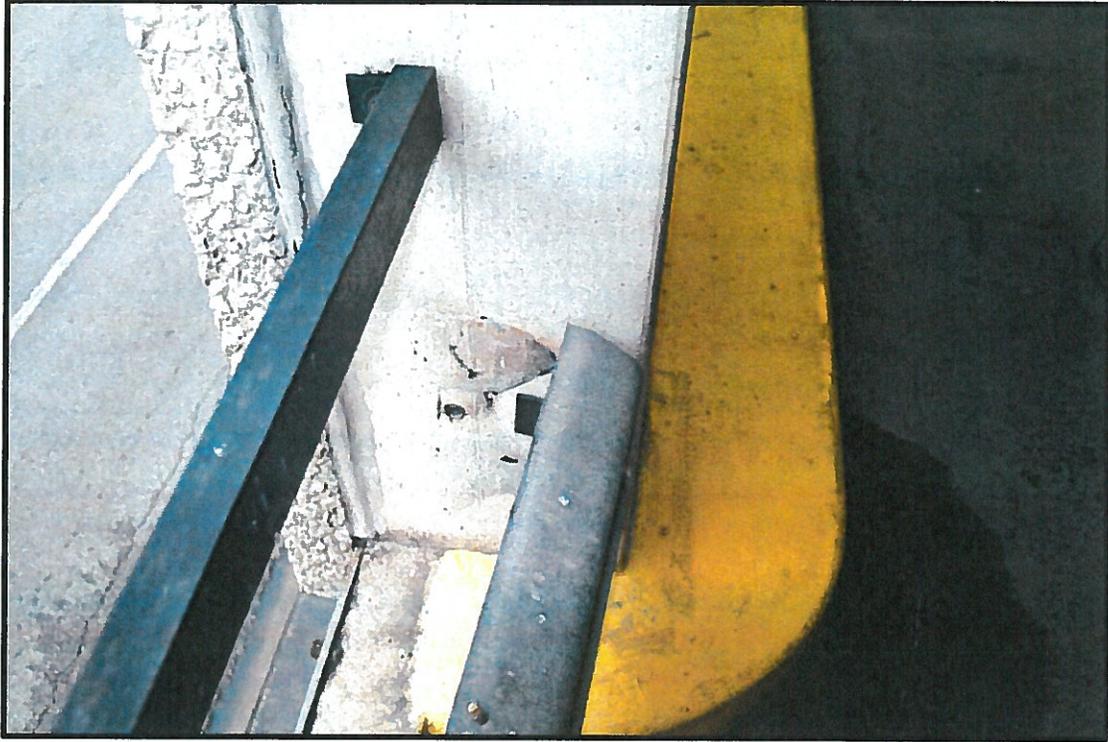
- Photographs 17 and 18 were taken on the third level. It shows minor damage to the guard rail. We recommend the guard rail be replaced.
- Photographs 19 and 20 were taken on the third and fourth levels, respectively. They show exposed plates and weld with minor oxidation occurring. We recommend the plates be cleaned and repainted.

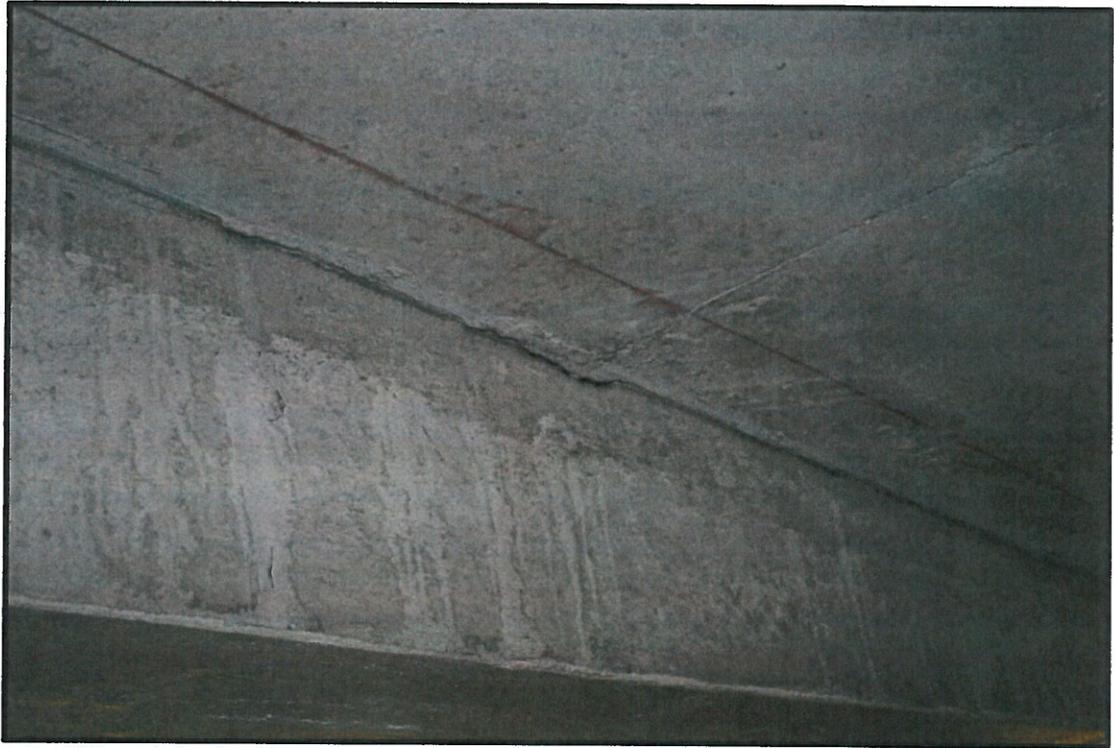
- Photograph 21 was taken at the sixth level. It shows a crack in the side of a beam. No noticeable deflection or transverse cracks were observed. We recommend the crack be injected with epoxy.

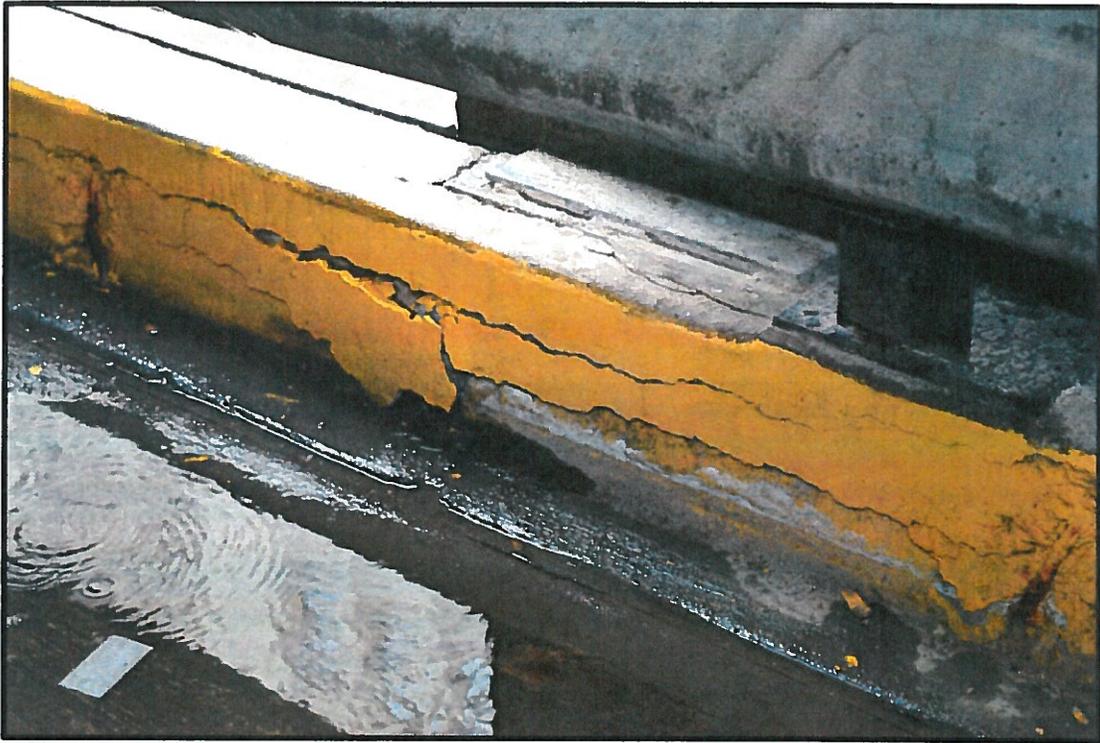
- Photographs 22 through 29 were taken at various levels in the parking garage. These photographs show concrete spalling probably due to ASR. ASR (Alkali Silica Reaction) is a common occurrence. We recommend these types of conditions be repaired

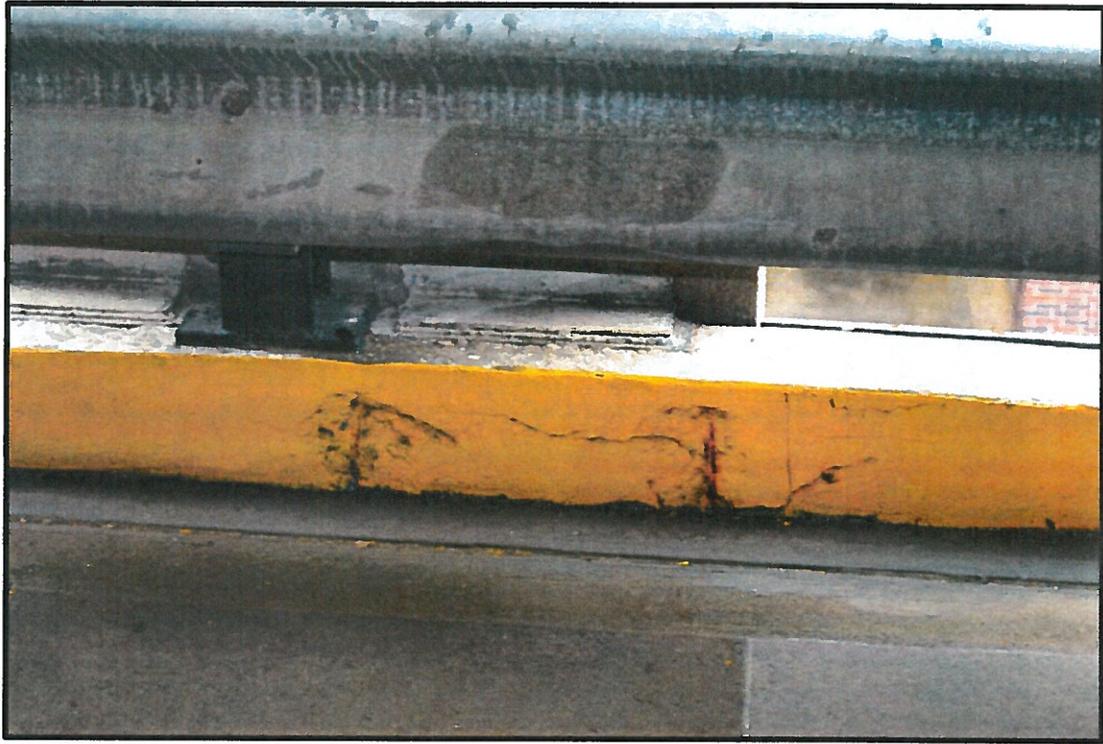
- Photograph 30 and 31 were taken at the 5th level. They show exposed reinforcing steel and spalled concrete. We recommend these be repaired.
- Photographs 32 and 33 were taken on the 6th parking deck. They show exposed reinforcing steel and spalled concrete. We recommend these areas be repaired.

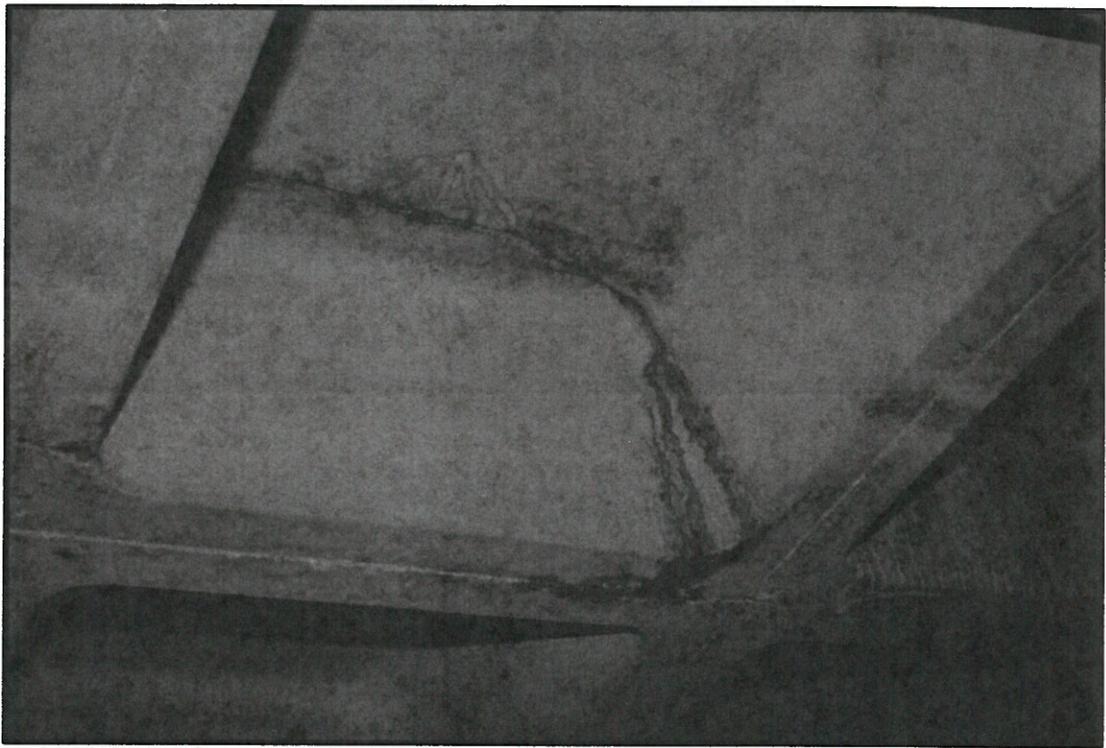
- Photograph 34 was taken on the 7th level of the parking garage. It shows the deterioration of finishes, applied to the concrete frame, which is normally installed on the interior of buildings.

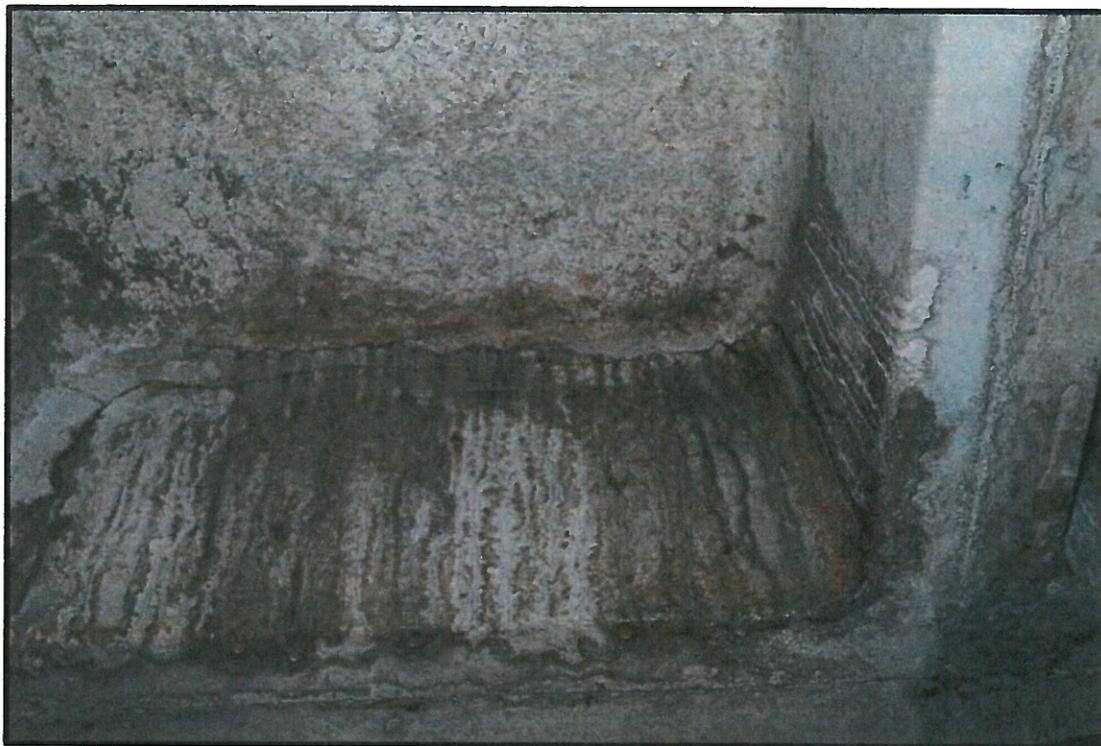
- Photographs 35 through 37 were taken of the bottom of the 8th level. They intake oxidation stains emitting through shrinkage cracks in the concrete system. We recommend these be repaired.

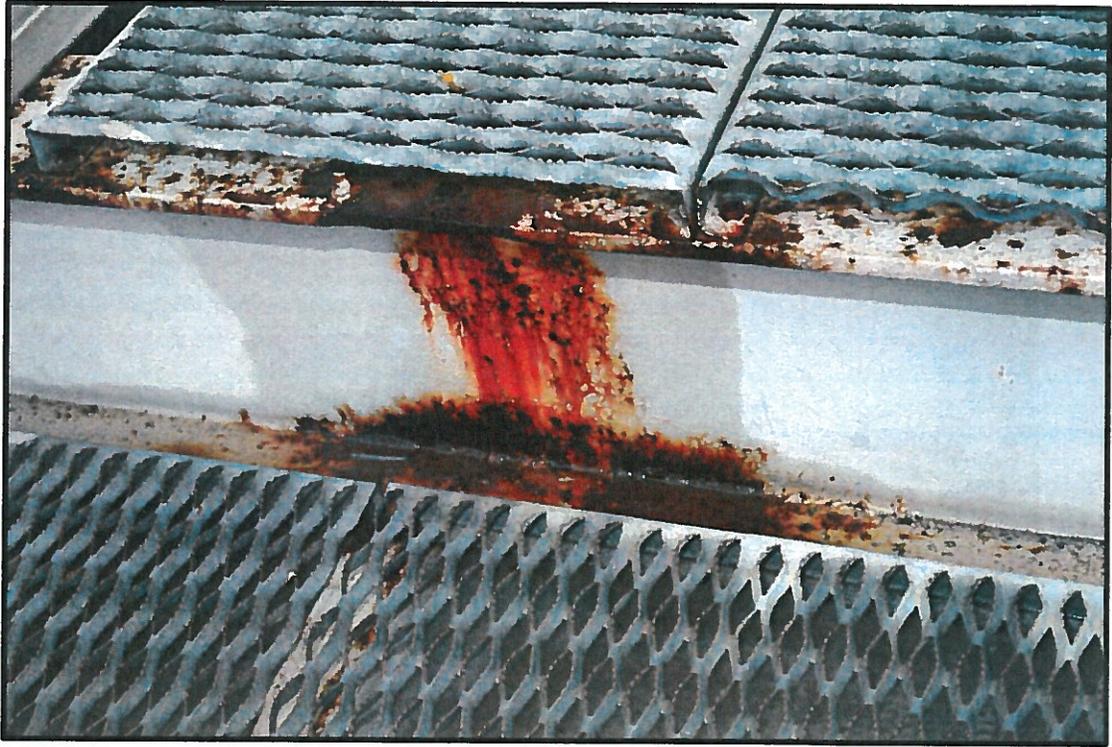
- Photographs 38 through 41 were taken of the cooling tower structure on top of the parking garage. They show oxidation occurring on the steel members. We recommend these areas be cleaned and repainted.
