**LA VILLITA RFP – EXHIBIT 11**  
**CATEGORY C – RETAIL SHOPS**  
**BUILDING INFORMATION**

**BUILDING 3**

**Hessler House, c. 1870**

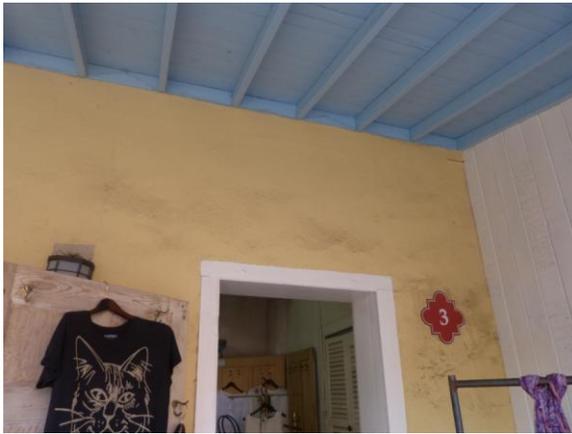
Building 3-Wood ceiling/Masonry

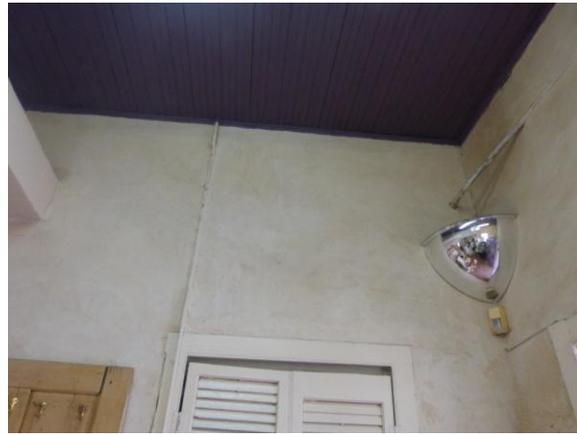
Building 3-Wall pipe/Ceiling

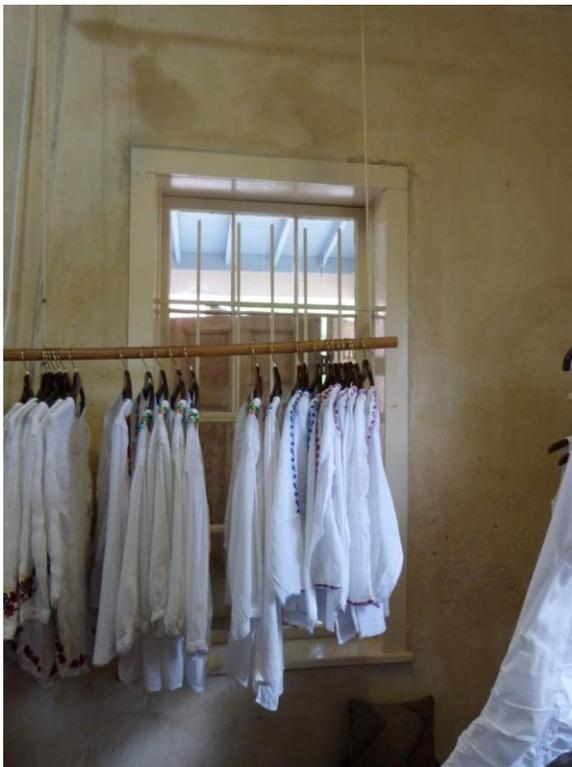
Building 3-Ceiling-hung display

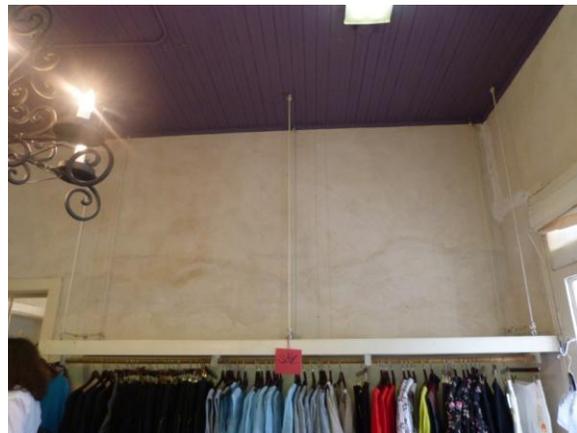
**Walls.** Walls have been replastered with what appears to be an appropriate lime-based plaster. Moisture is causing some flaking in at least two spots. General appearance is good.

Building 3-Wall moisture and staining

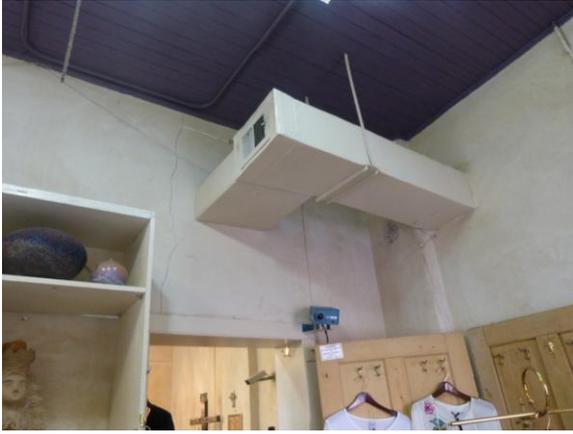
**Air-conditioning and heating.** Tenant perceives cooling capacity of 1980s chilled water cooling/electric heating fan-coil to be inadequate and reports many recent problems. System does not bring in outside air. External appearance of fiberglass ductwork appears to be in good condition.

Building 3-Cooling unit

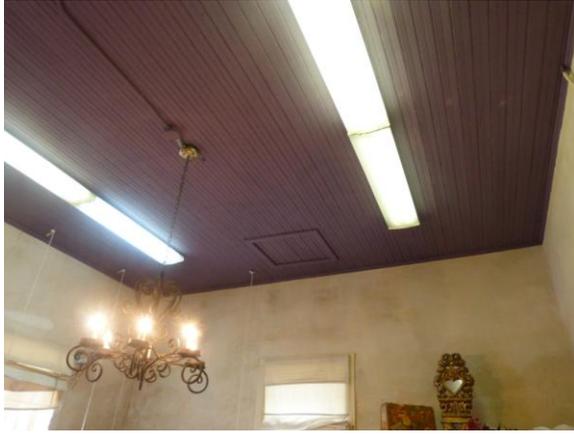
**Ceilings.** Painted beaded boards. Some peeling of paint indicating possible roof leak, condensation problem, or heat-related issue.

Building 3-Wood ceiling

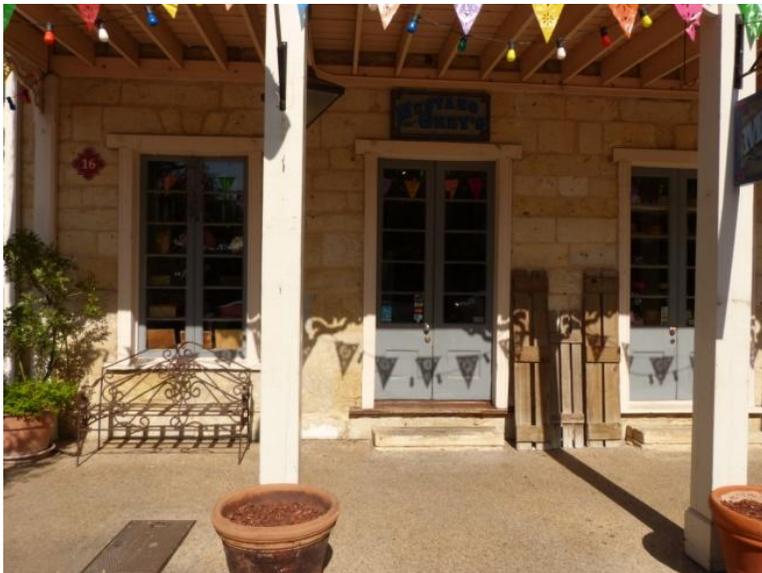
**Windows and doors.** Wooden window frames and sash need to be rehabilitated and some need to be replicated. Rear doors and windows are in poor condition and need to be replicated. Ten windows and door in process of restoration:

mortar is being repointed.
