**STERLING PROPERTY  
(1434 E. COMMERCE AND 323 IDAHO)**

**Phase I Environmental Site Assessment**

**Pape-Dawson Engineers, Inc.**

**February 2013**

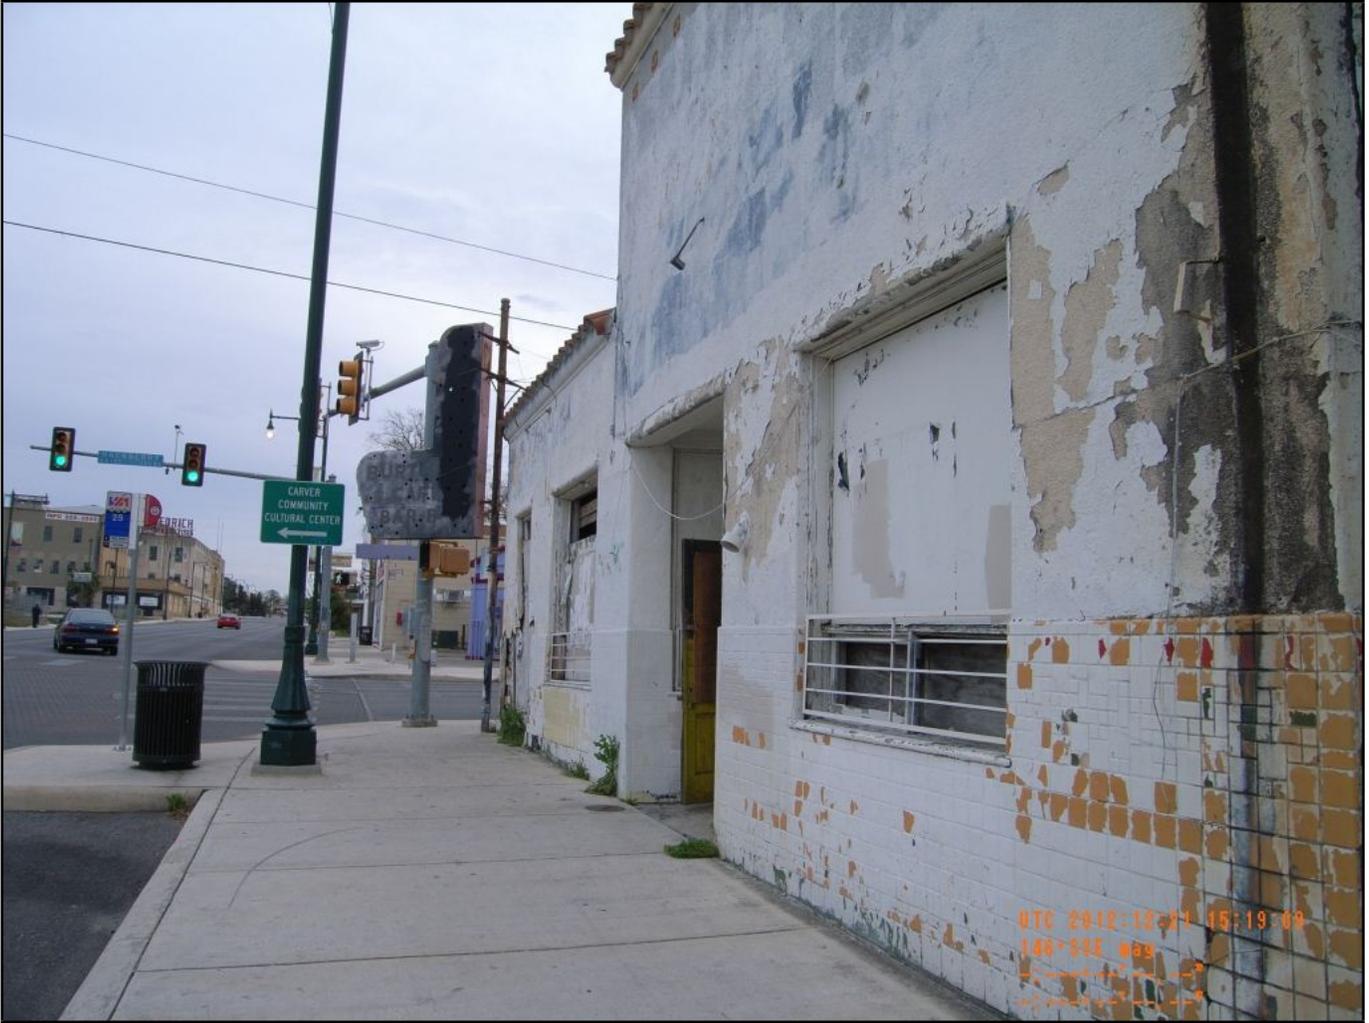
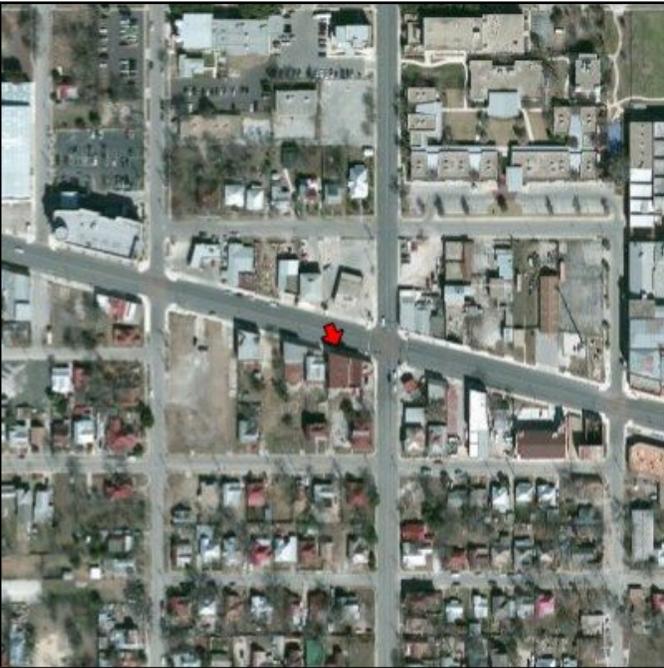
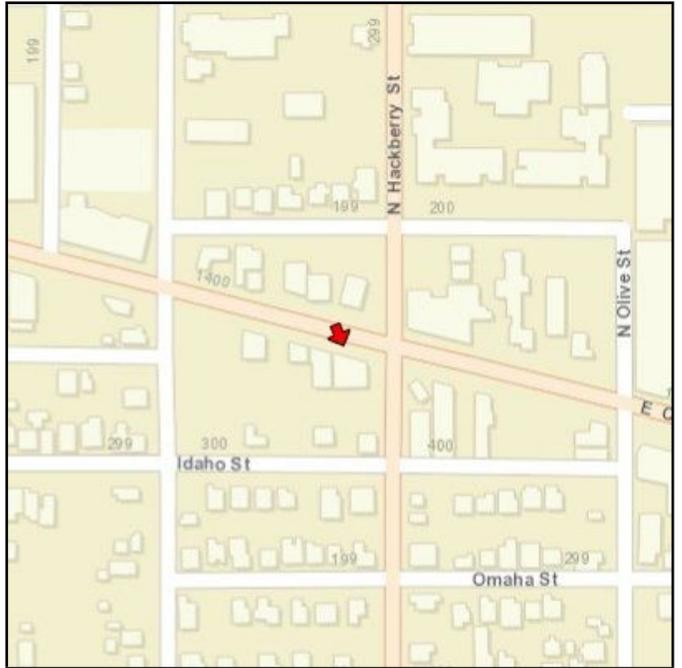
**Photograph 1**

Photo view is facing south-southeast towards the commercial structure located on the subject site.

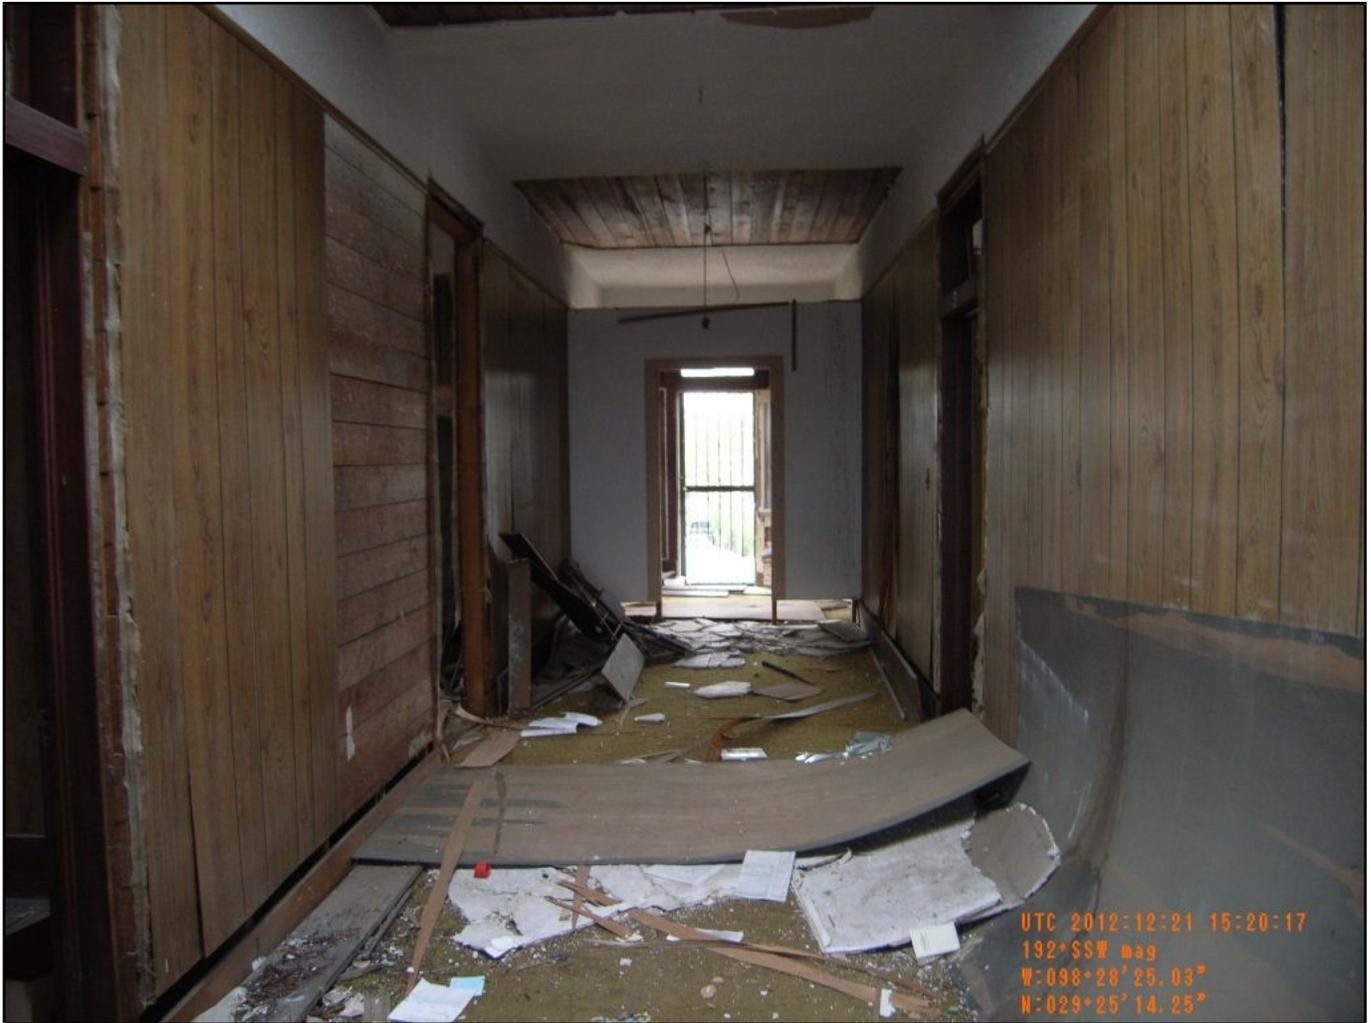
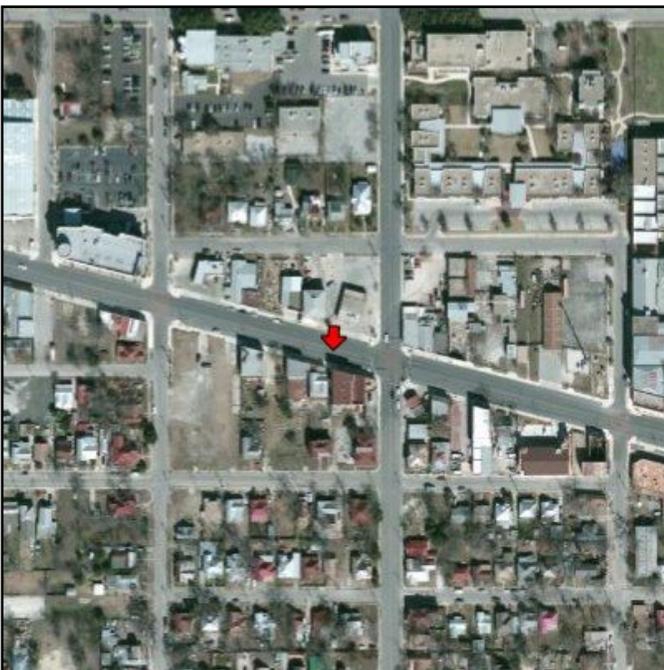
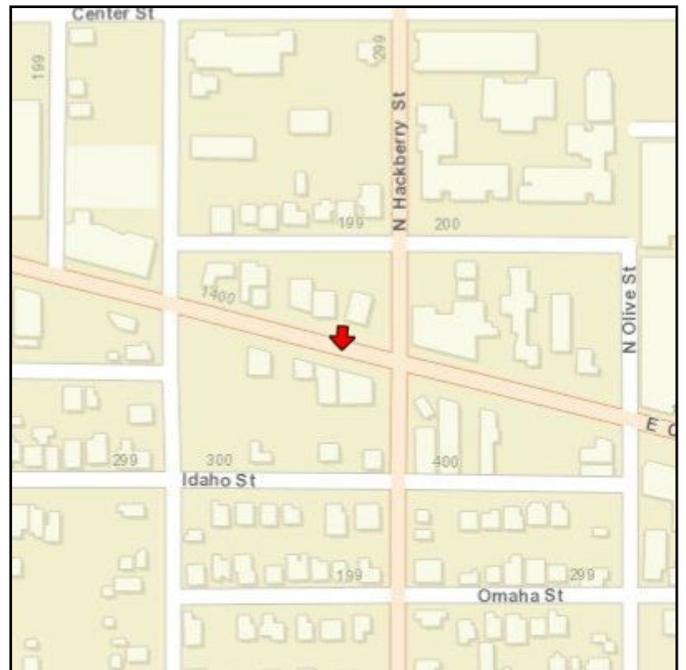
## Photograph 2

The subject site was developed with a vacant commercial building and two (2) residential dwellings at the time of the site visit. Construction and demolition debris and trash debris were scattered throughout the commercial building. The debris included a lawn mower, furniture, card board boxes, sheet rock, plastic bags, and other debris. No hazardous materials were observed within the commercial structure.

Photo view illustrates the interior of the commercial structure.

Although the construction and demolition debris and trash debris are not considered a recognized environmental condition as defined by ASTM 1527-05, the debris should be removed from the subject site and recycled or disposed at an appropriate landfill facility.

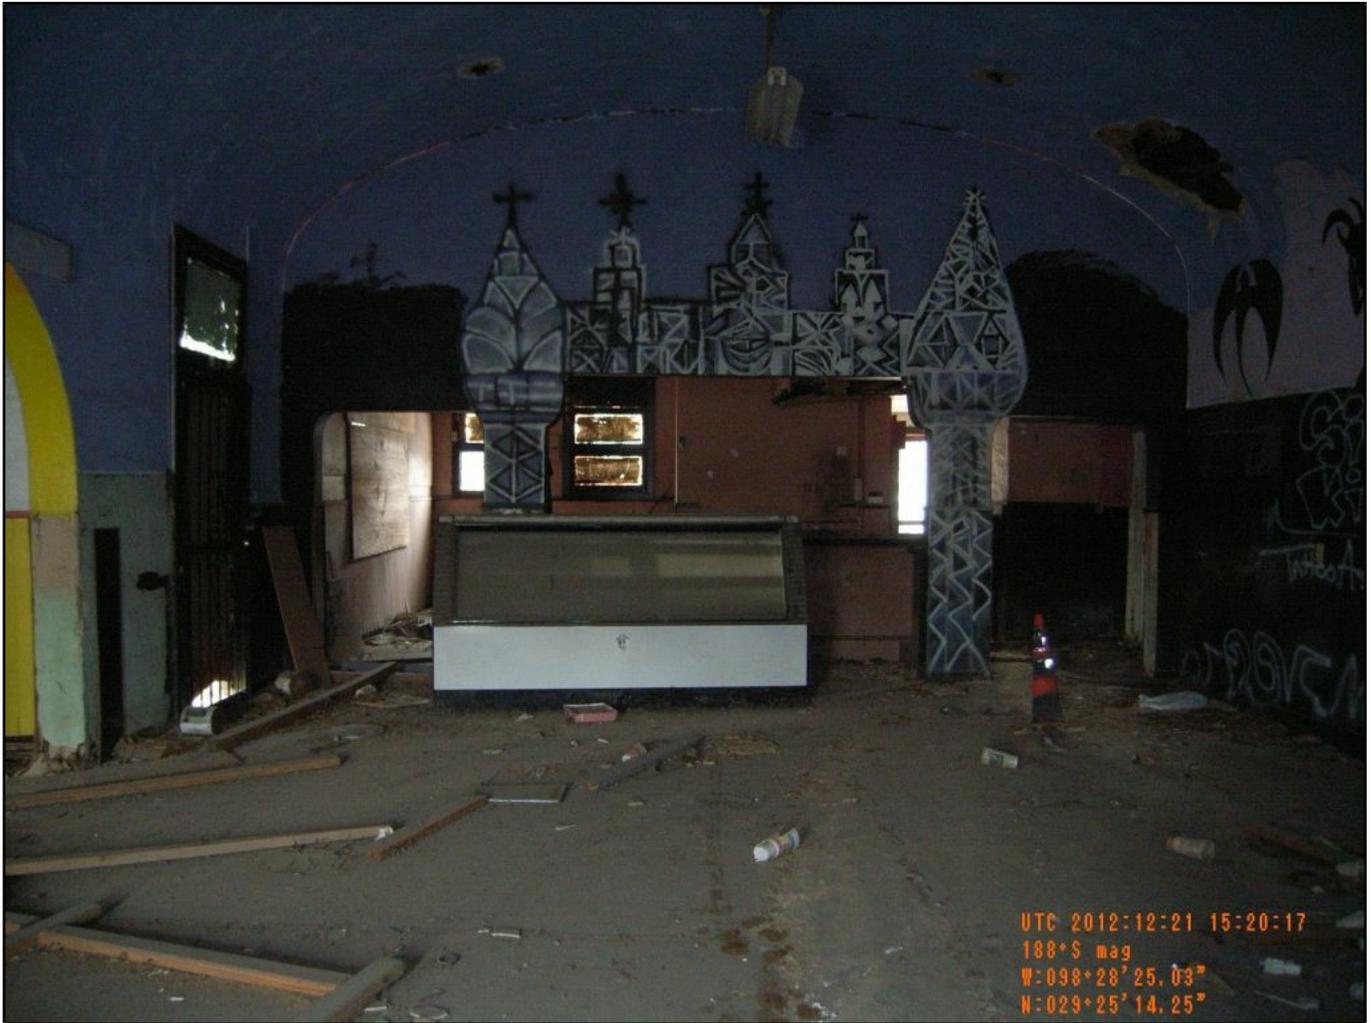
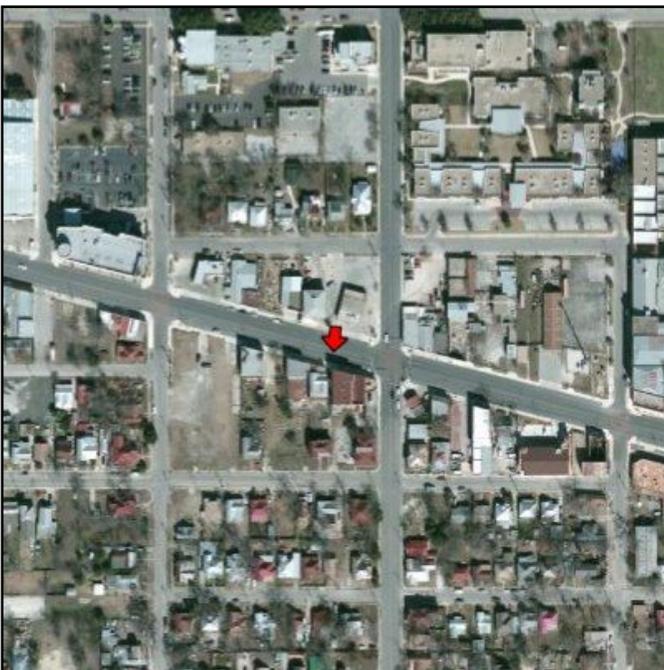
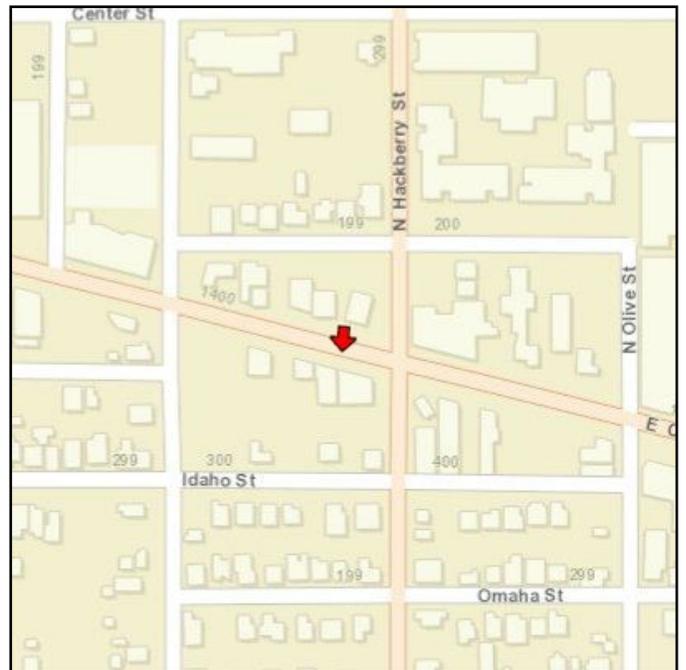
### Photograph 3

Photo view illustrates the interior of the commercial structure.

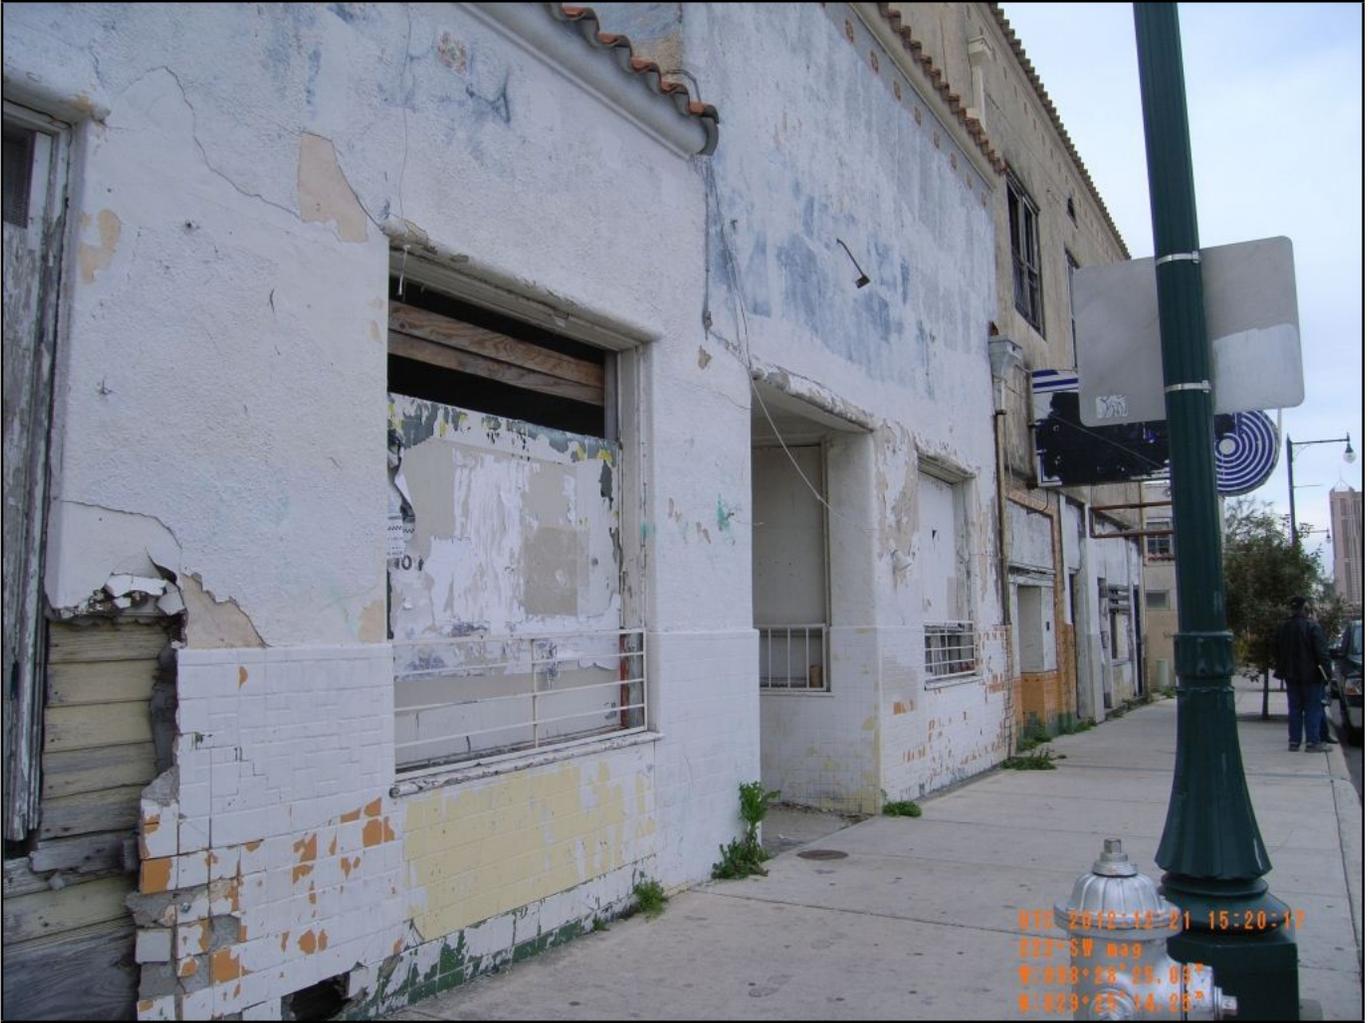
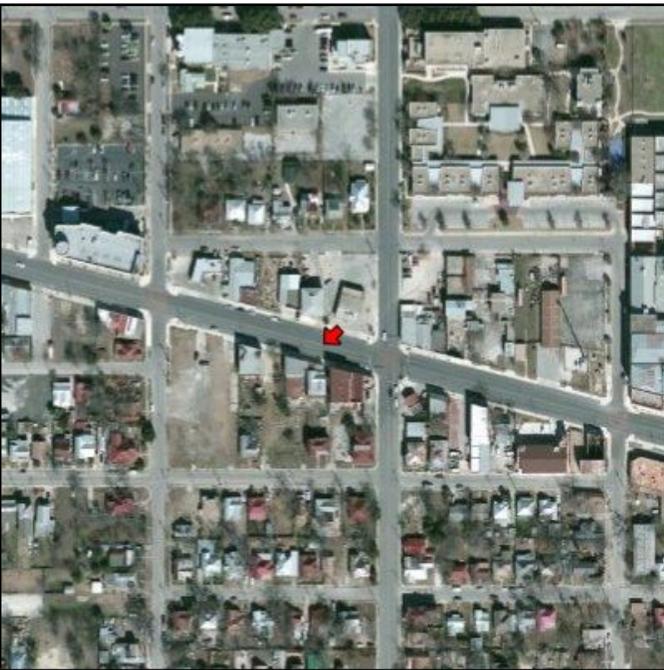
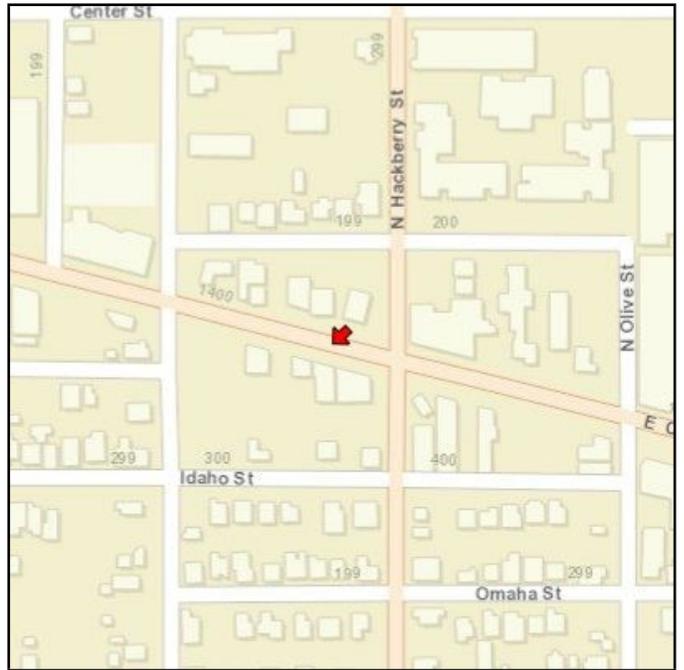
**Photograph 4**

Photo view illustrates the exterior of the commercial structure along East Commerce Street.

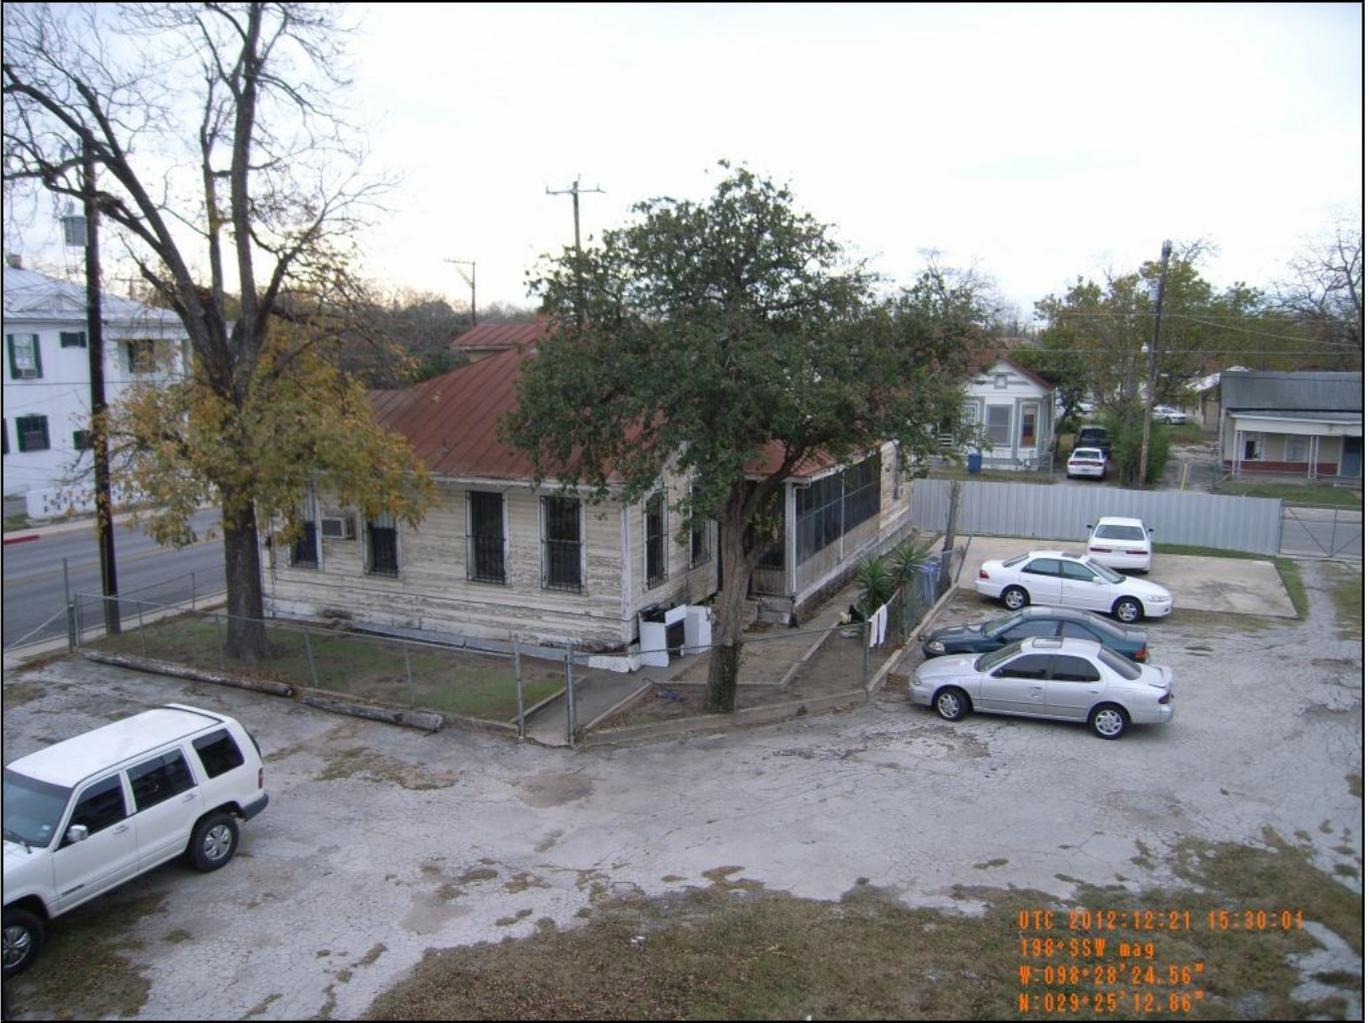
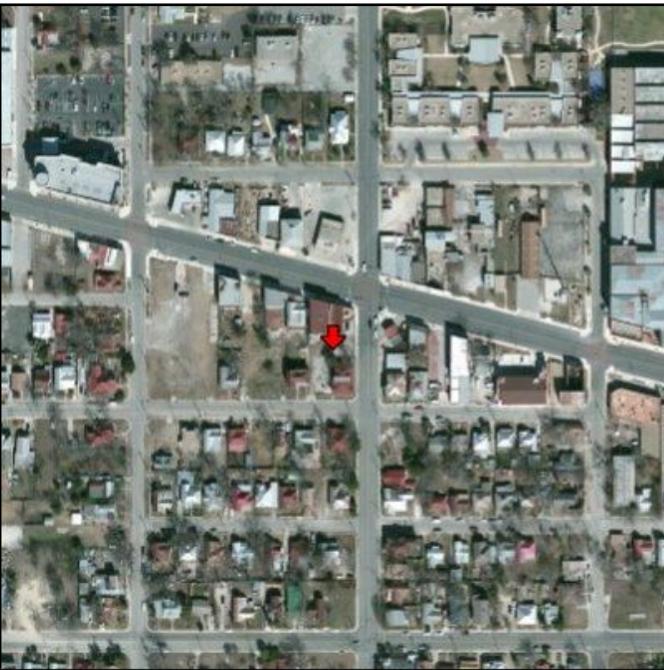
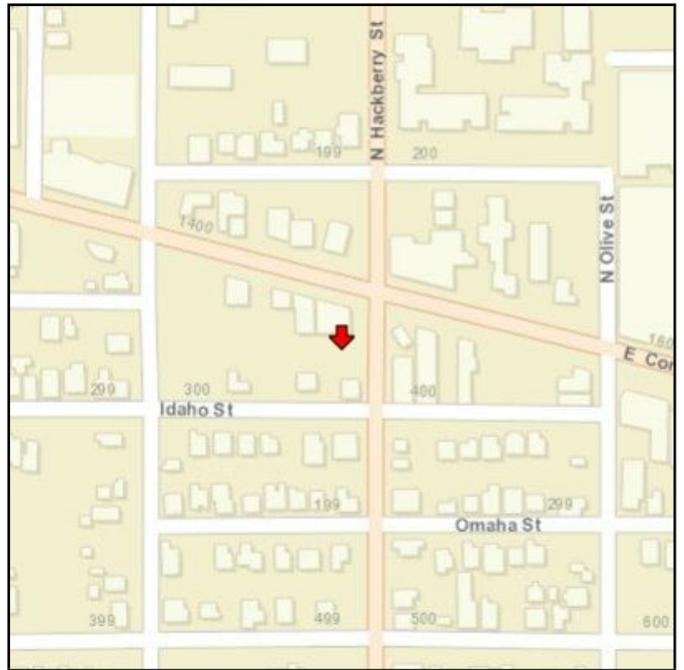
**Photograph 5**

Photo view is facing south across the subject site towards a residence located on site.

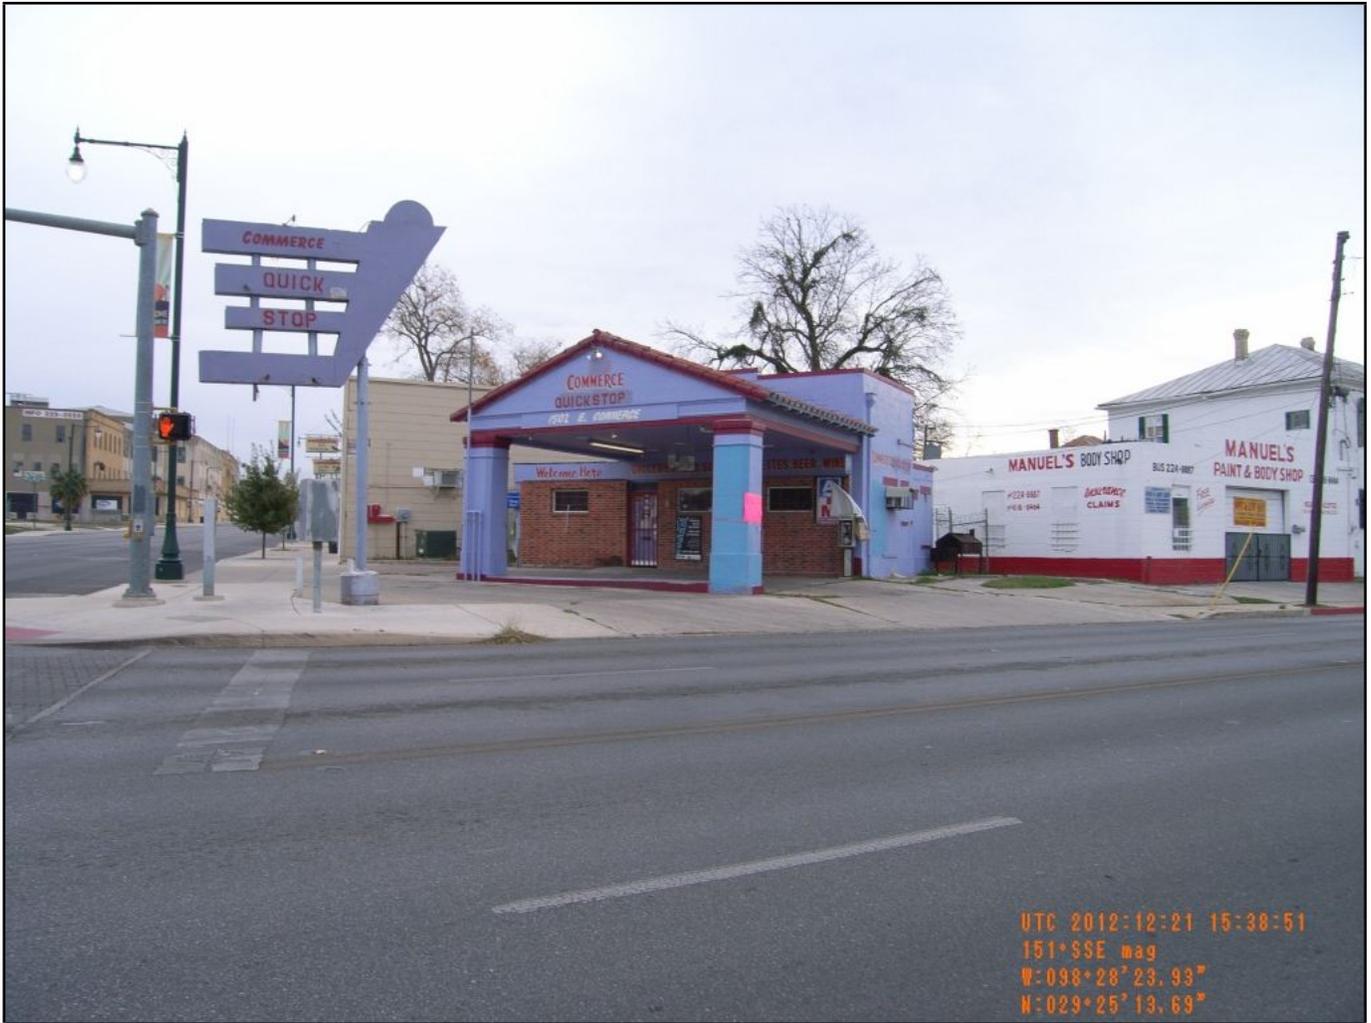
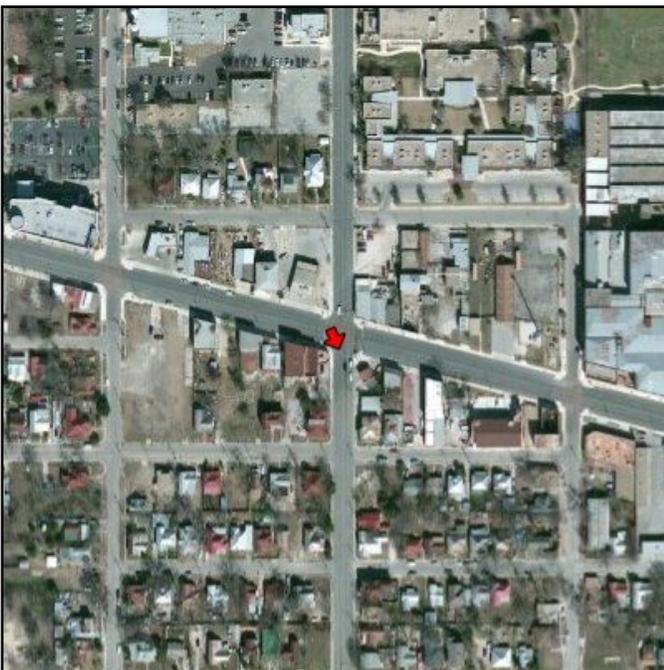
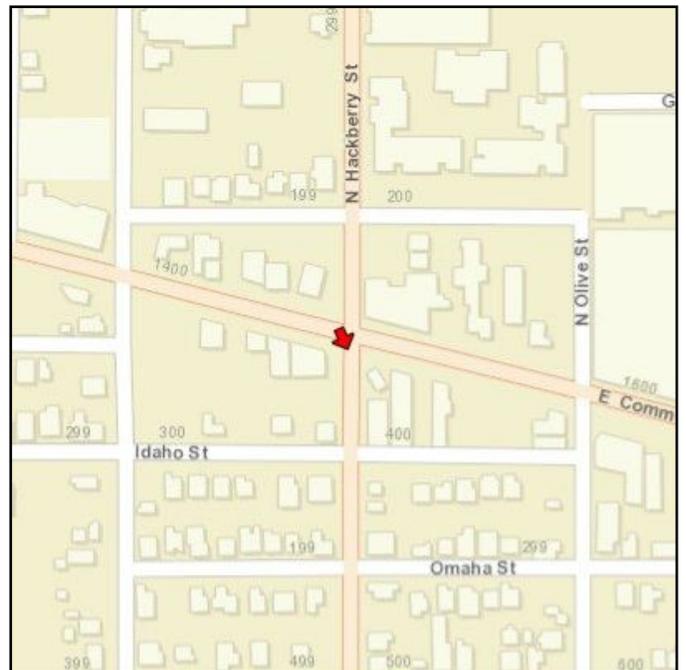
**Photograph 6**

East Side Paint & Body Shop was listed at 106 South Hackberry Street in the 1951, 1957, 1962, 1967, and 1973 city directories (Exhibits 3 and 4; Section 3.5; Appendix 5, Photograph 6; Appendix 6). Manuel's Paint and Body Shop was listed at 106 South Hackberry Street in the 1978 through 2002 city directories, and identified east of the subject site during the site visit. An auto repair shop and welding facility was identified at 106 South Hackberry Street in the 1951, 1952, and 1971 *Sanborn* Maps. Due to the close upgrade location of this facility, Manuel's Paint & Body Shop is considered a REC for the subject site.

Photo view illustrates the Commerce Quick Stop and Manuel Paint & Body Shop facility.

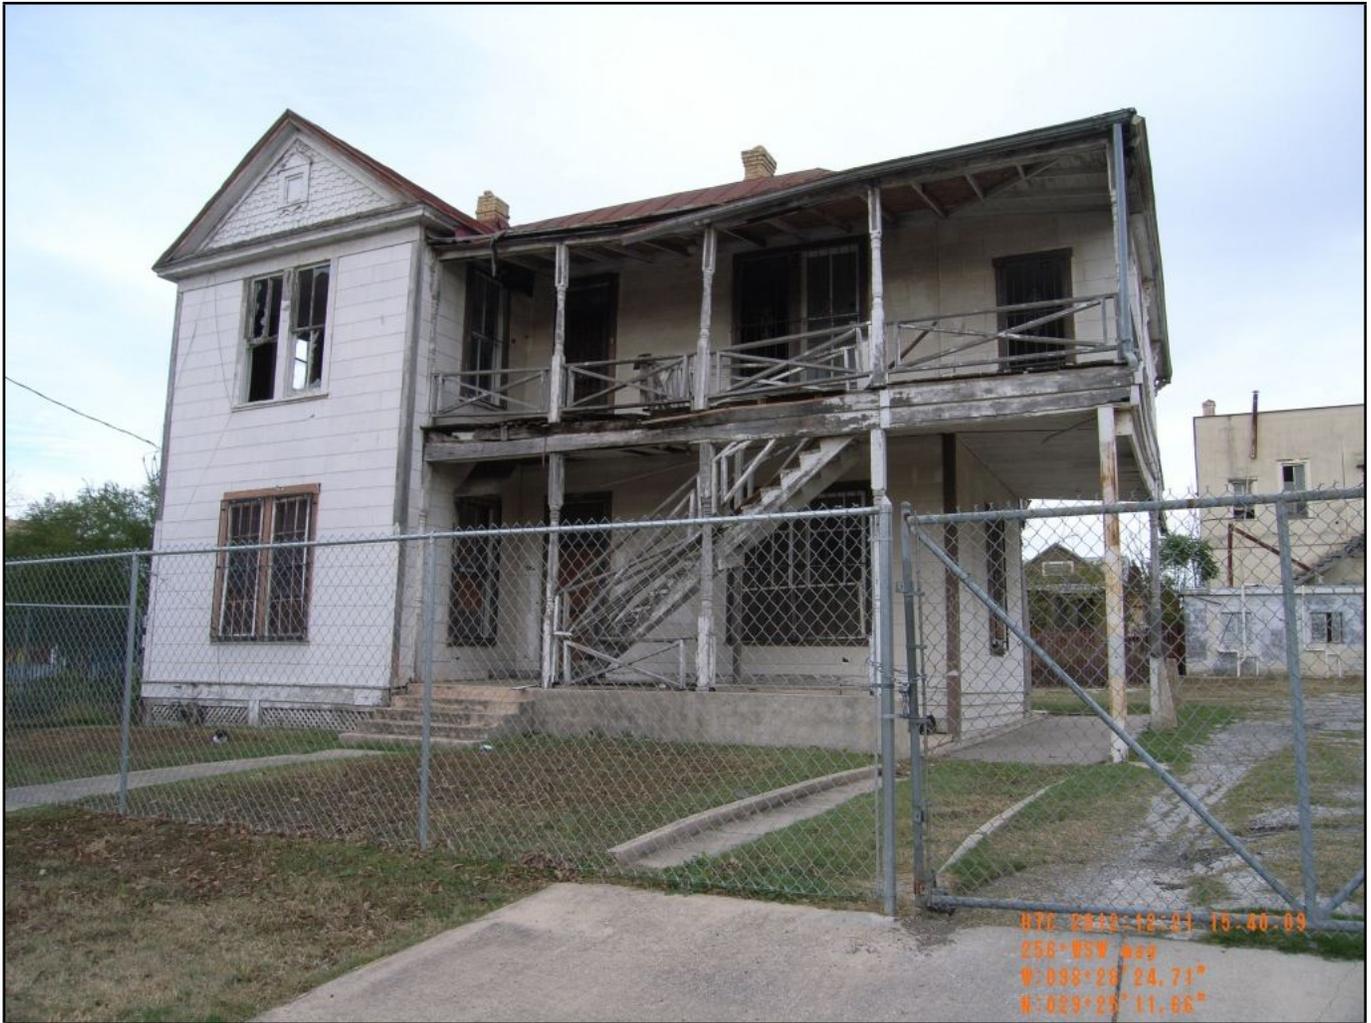
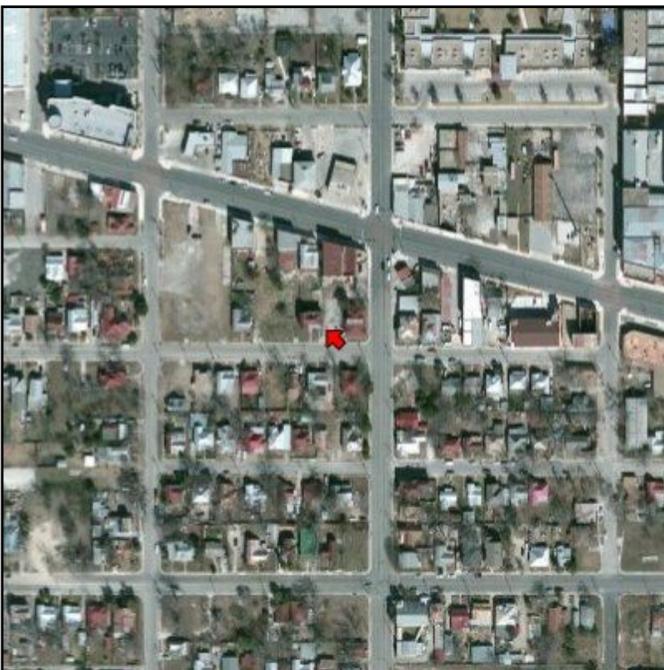
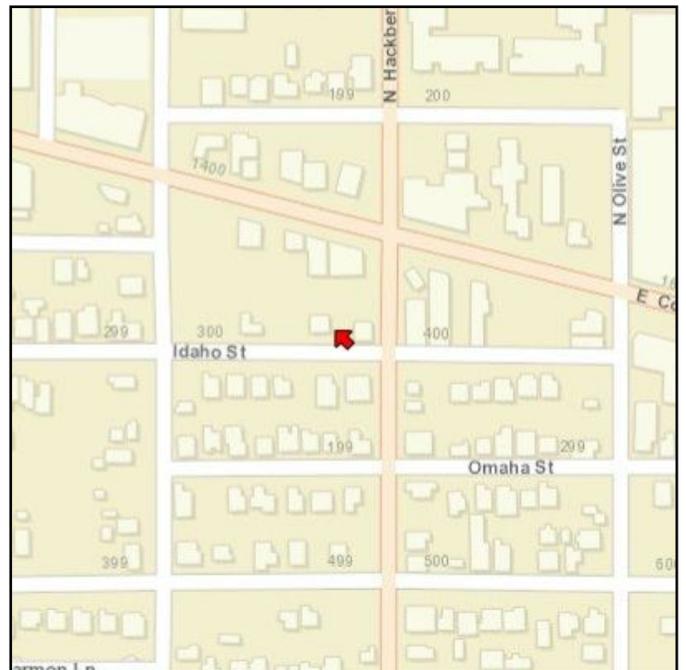
**Photograph 7**

Photo view illustrates a residential structure located on the subject site.
