## **STRUCTURAL ASSESSMENT**

**Project:** 1432-1434 East Commerce St. **Job. No:** 122200  
**Location:** San Antonio, TX  
**Date:** Dec. 10, 2012 **Weather:** Sunny,  
Windy, 60 deg  
**Performed by:** Jeff Houghton and Frank Lamas,  
Alpha Consulting Engineers, Inc.

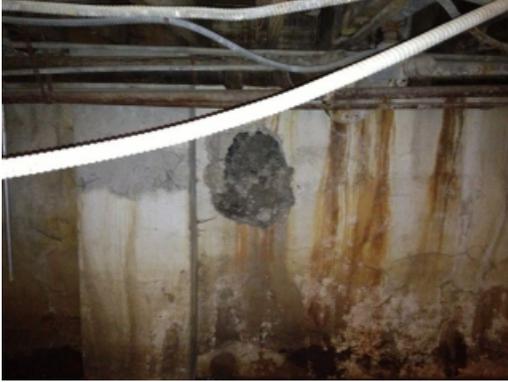
Fig. 3

The basement wall opposite the stair has a hole approximately 18 inches in diameter located near the top of the wall (See Fig. 3). The wall appears to be cast-in-place concrete but no reinforcing is visible in the wall. Due to the nature

of the wall retaining the subgrade under the building floor, this condition should be investigated further when full access to the basement is available.

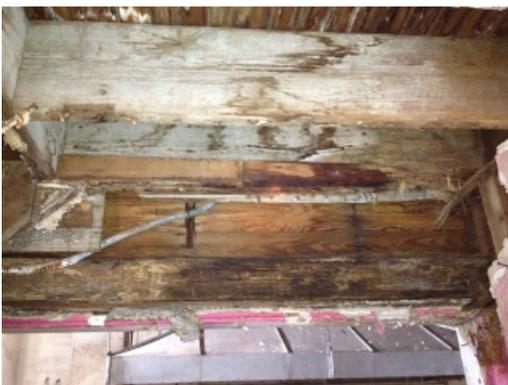
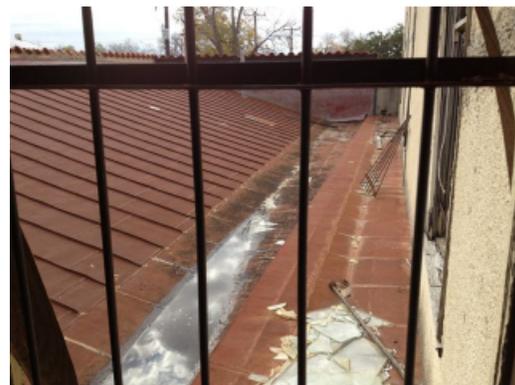
An interior lintel located near the south end of the common wall is severely deteriorated and appears to have possible termite damage. The deterioration appears to be due to leaking of ponding of water at the roof level above (See Figs. 4 and 5). The lintel is a load bearing component and is in need of replacement.

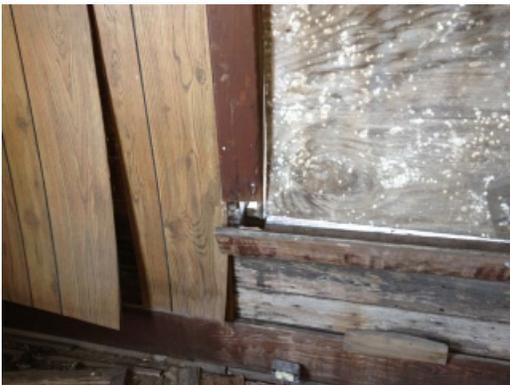
Fig. 6

Floorboards located on the second floor at the northwest corner are in need of replacement due to deterioration from water. The source of the water is from the damaged window conditions in both north and west walls at the corner (See Fig. 6). The support beams at this location appear to be structurally sound, however, the floor beams should be further reviewed for deterioration after the damaged boards are removed.

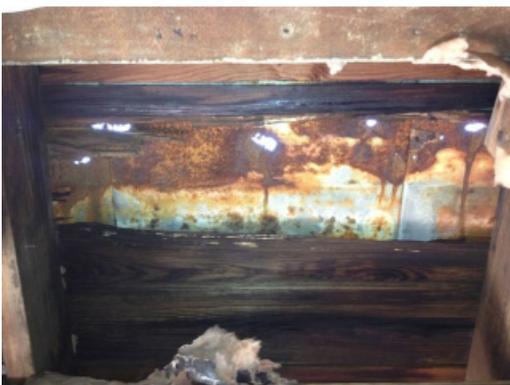
Fig. 7

Deterioration has occurred in the metal roofing at the eastern low metal roof area. The wood sheathing and wood support beams at this location are also deteriorated from the roof leak and are in need of replacement or reinforcement. (See Fig. 7).

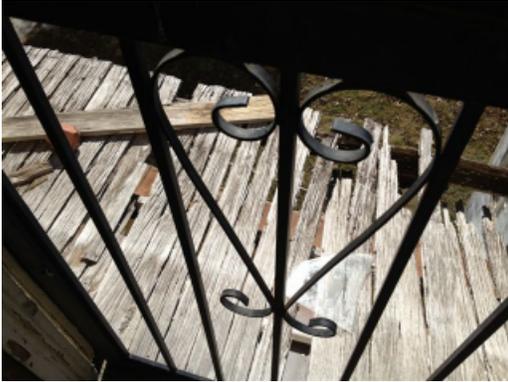
Fig 8.

The wooden canopy on the south wall of the building is completely deteriorated and needs to be completely removed and replaced if canopy is required. (See Fig. 8).

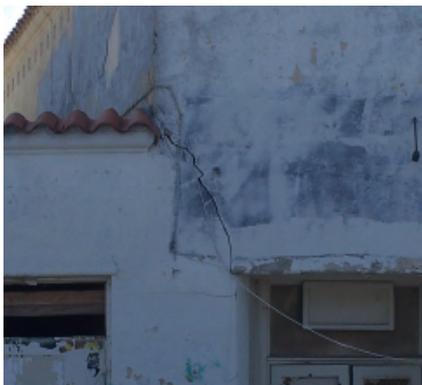
Fig. 9

There is severe distress in the exterior finished wall cladding at the north east end of the building. It appears that this location has been subject to vertical foundation movement and a large crack is located at the north wall (See Fig. 9). The cladding at this location is ceramic tile over stucco. There are no contraction joints along any walls to relieve any stress from movement and stucco being a rigid, low strength material, will tend to yield under relatively small movements. On the other hand, the wood framing components are more forgiving and can withstand greater movement without distress. The interior plaster walls at this location do not show signs of distress which also suggest to us that the structural framing is not damaged. The base of the walls at this location is also showing signs of bowing outward suggesting an upward pressure (See Fig.10). Such pressure likely came from vertical movement of the adjacent sidewalk responding to the subgrade taking in moisture.

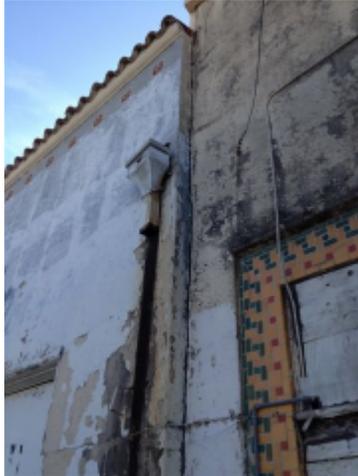
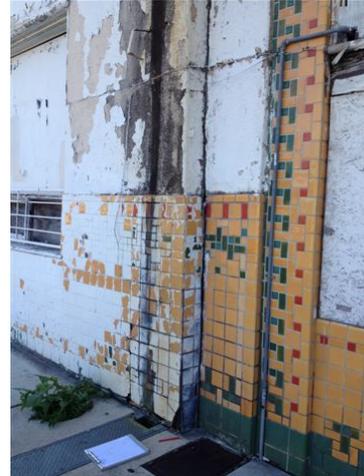
A missing downspout on the north wall is also causing water from the roof scupper to cascade down the vertical wall surface, causing damage to the tile surface and substrate (See Figs. 11 and 12).

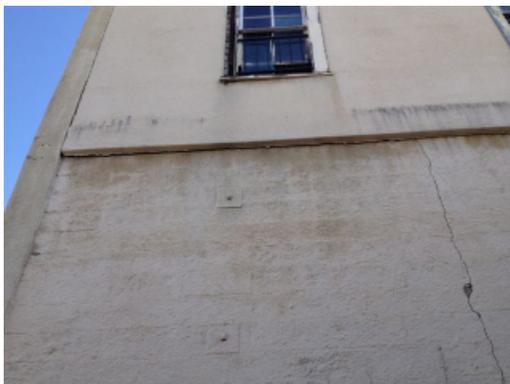
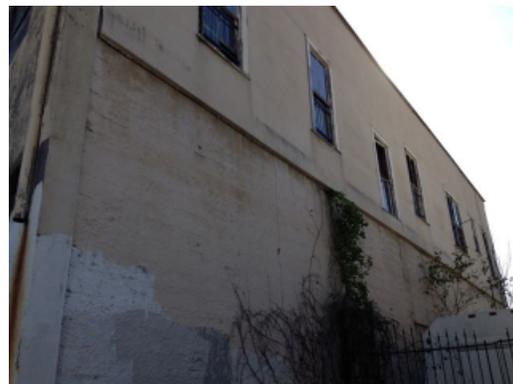
Vertical cracks are located in the exterior wall finish at further locations along the north, east and south walls. (See Figs. 13 and 14). These cracks appear to be mainly from shrinkage cracking of the rigid stucco material. It is recommended that the entire exterior wall finish be replaced with adequate control joints built into the wall.

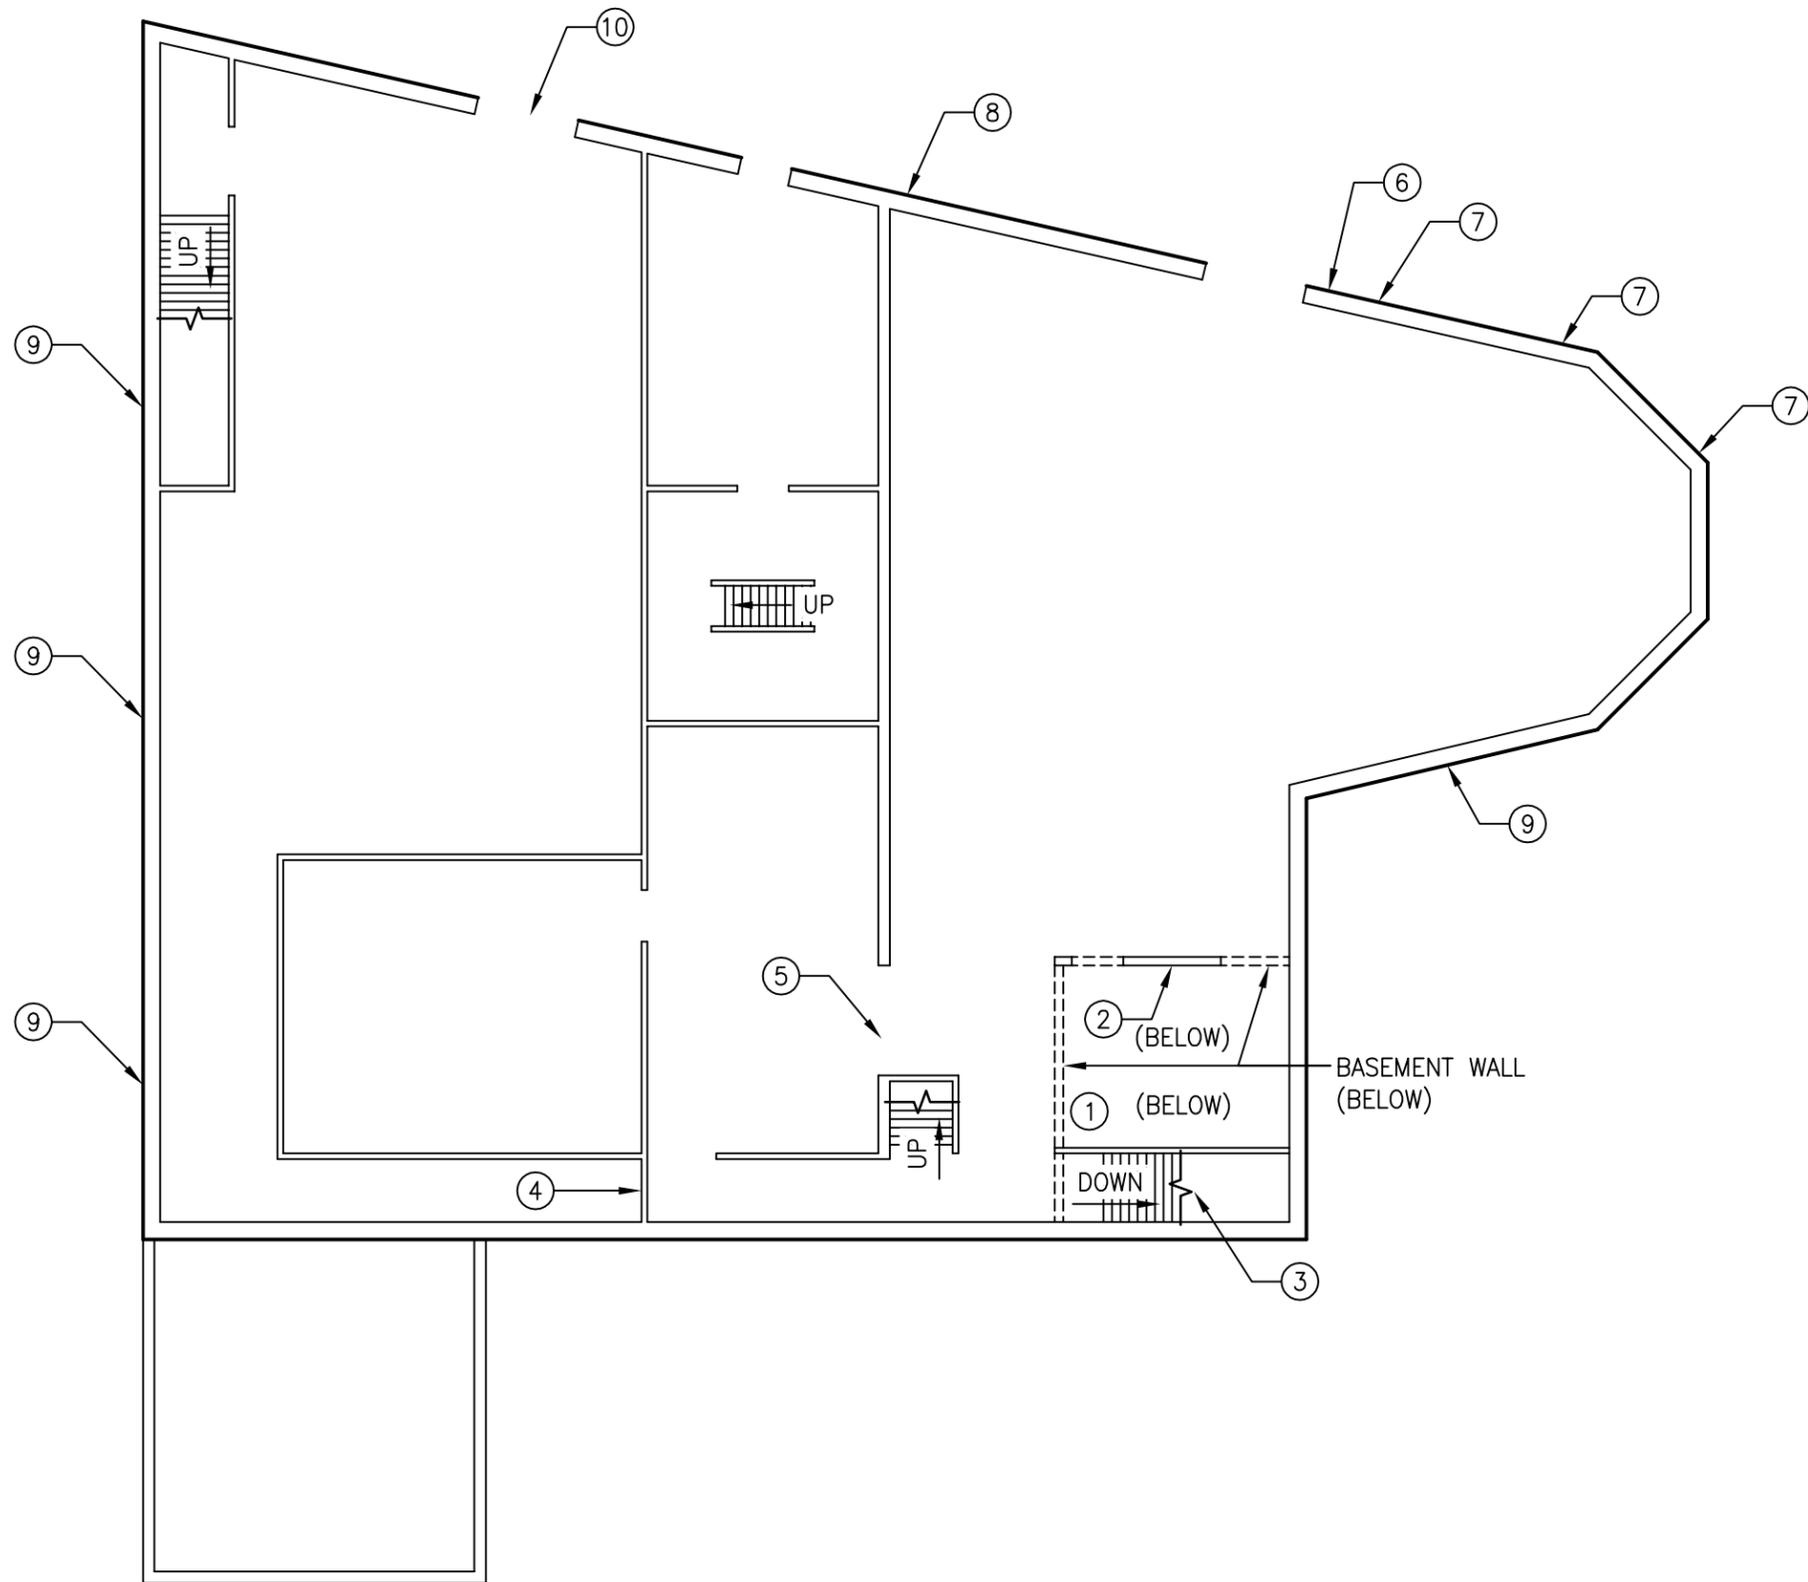
**1 FIRST FLOOR PLAN**  
SCALE : 3/32" = 1'-0"

- WATER IN BASEMENT. (LEVEL VARIES)
- LARGE HOLE IN BASEMENT WALL.
- BOTTOM STAIR TREADS COMPLETELY GONE DUE TO DETERIORATION.
- FLOOR BOARDS AND SUPPORT BEAMS COMPLETELY GONE DUE TO DETERIORATION.
- SEVERE DETERIORATION ON DOOR LINTEL.
- SEVERE DIAGONAL CRACK IN EXTERIOR WALL FINISH.
- EXTERIOR FINISH ON WALLS BOWING OUTWARDS.
- MISSING DOWNSPOUT AT ROOF SCUPPER.
- VERTICAL CRACKS IN EXTERIOR WALL FINISH.
- DETERIORATED FLOOR BOARDS AND SUPPORT BEAMS AT DOOR SILL.

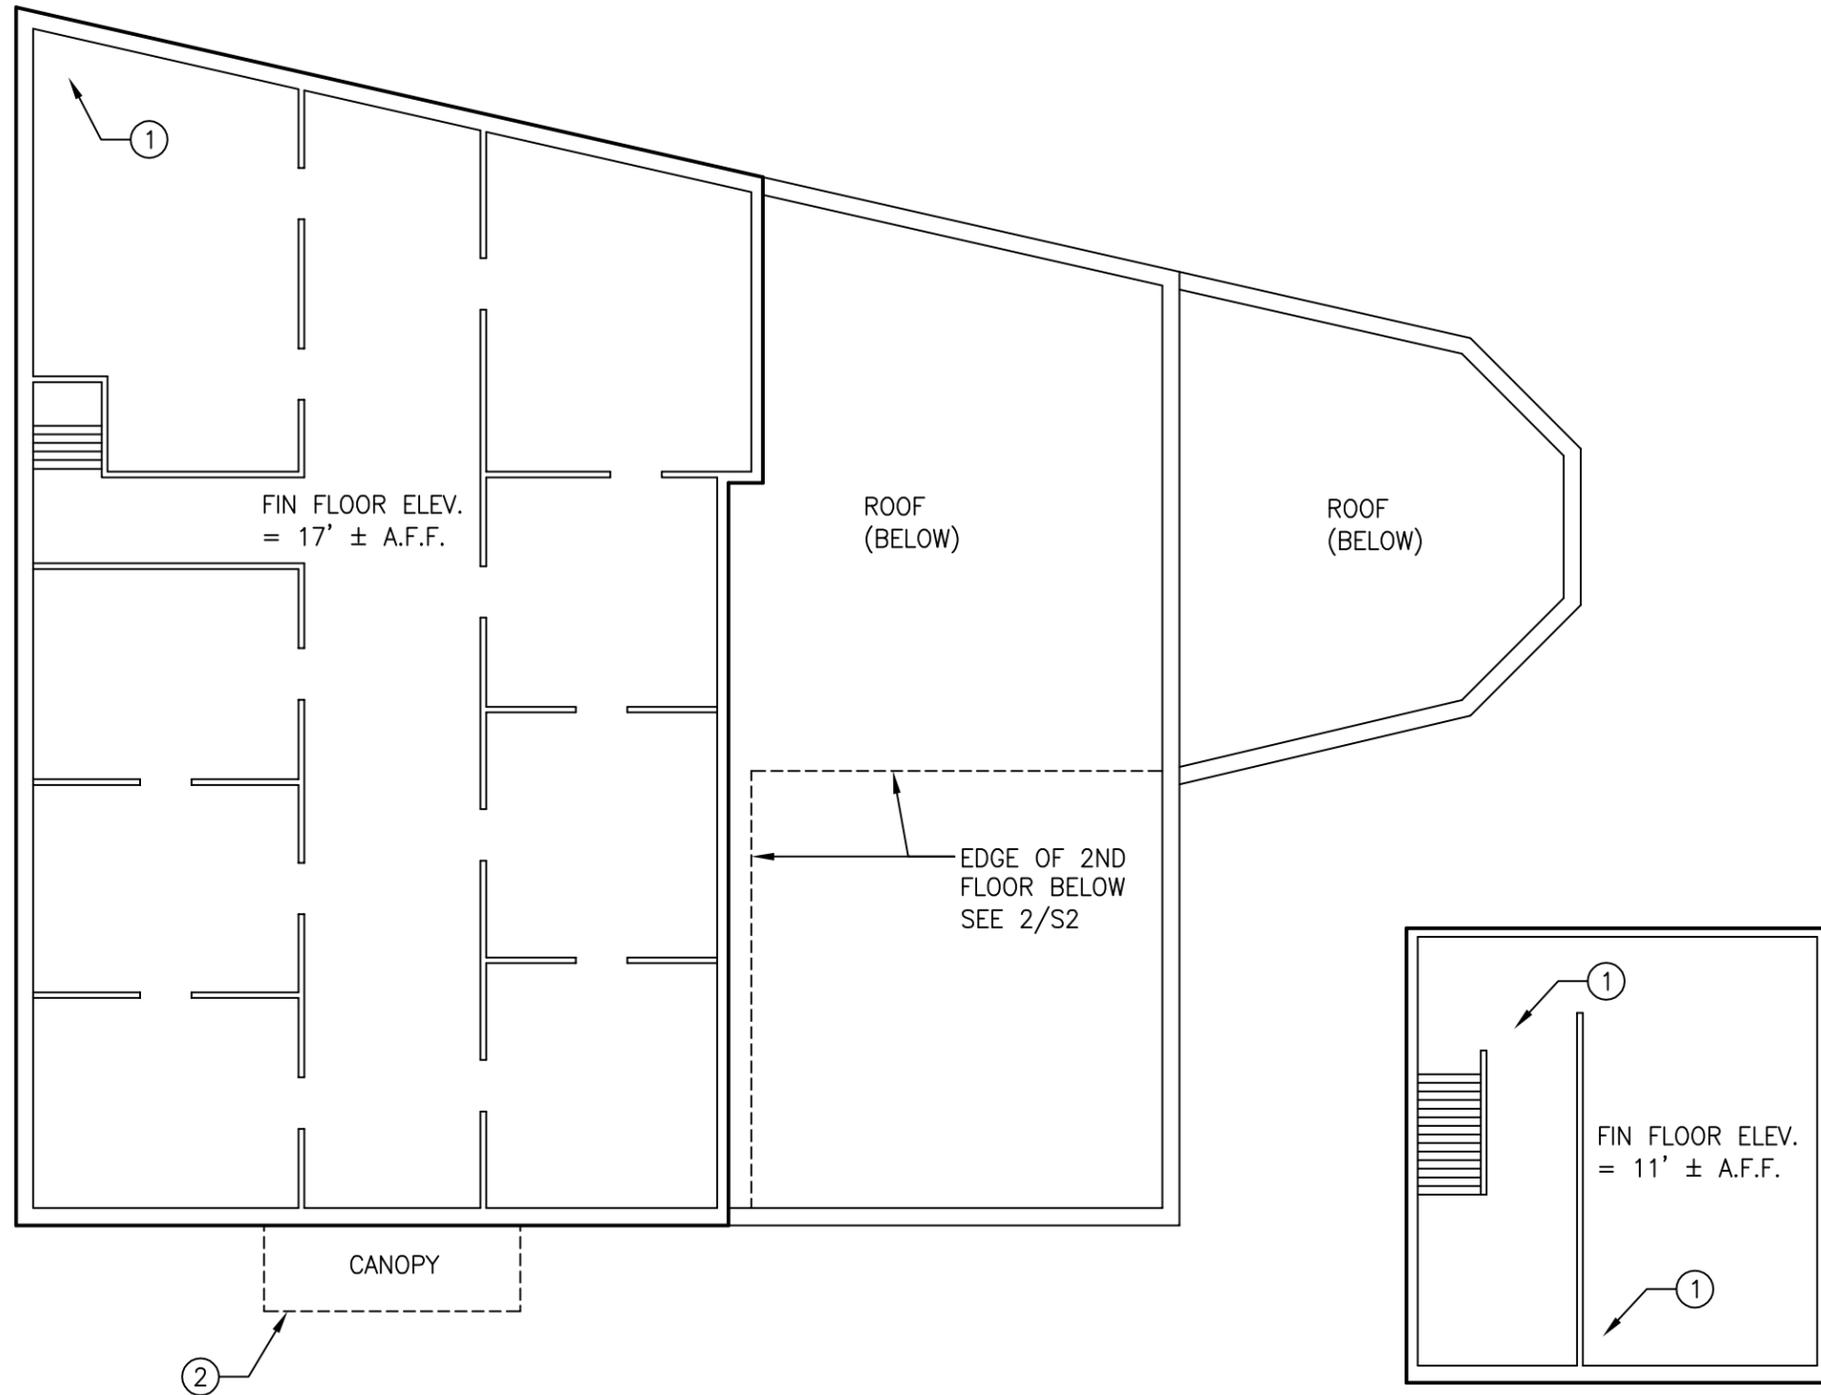
**2 SECOND FLOOR PLAN**  
SCALE : 3/32" = 1'-0"

- FLOOR BOARD DETERIORATION
- WOOD CANOPY COMPLETELY DETERIORATED.

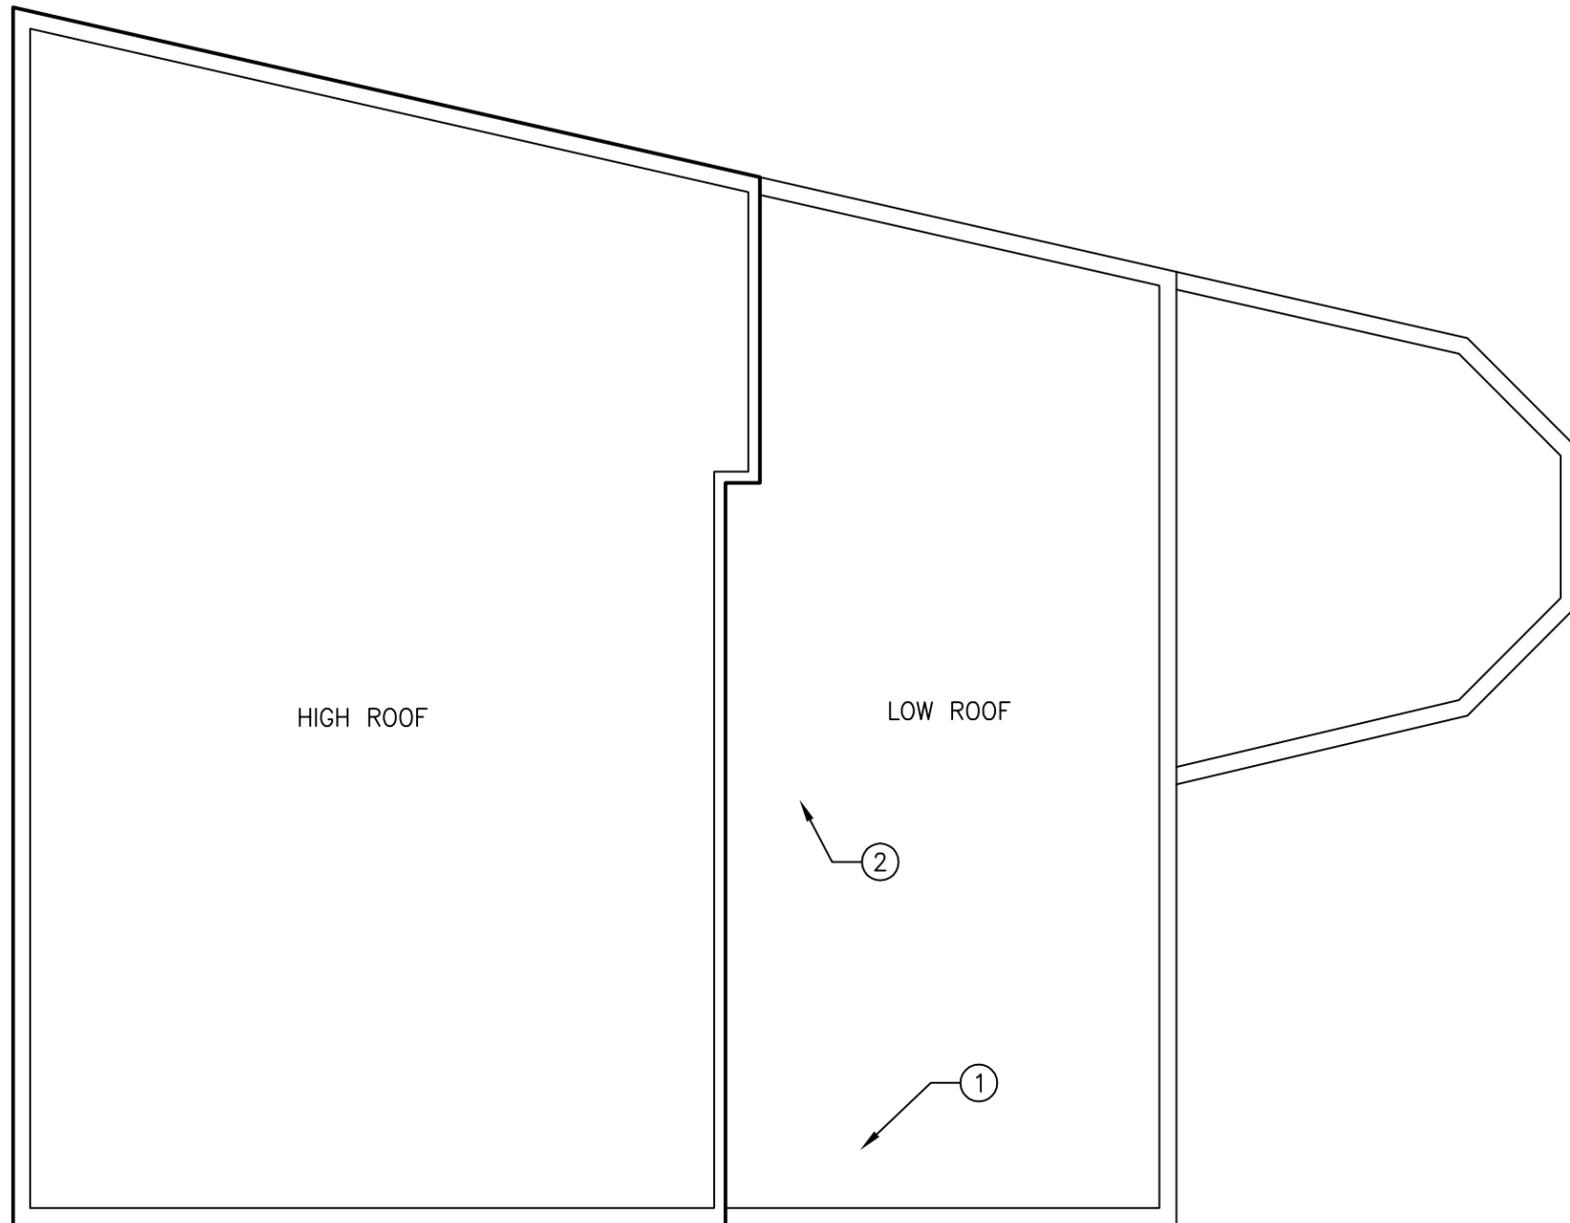
**1 ROOF PLAN**

- METAL ROOFING AND SUPPORT BEAM DETERIORATION
- PONDING WATER.
