LA VILLITA RFP – EXHIBIT 10
CATEGORY B – GALLERIES
BUILDING INFORMATION

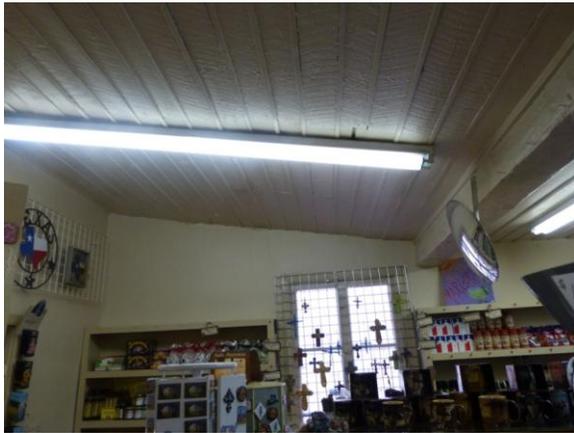
Building 2-Ceiling

Ceilings. Painted wooden beams with plaster in between, in good condition. Rear ceilings are of painted rough cedar boards. All in good condition.

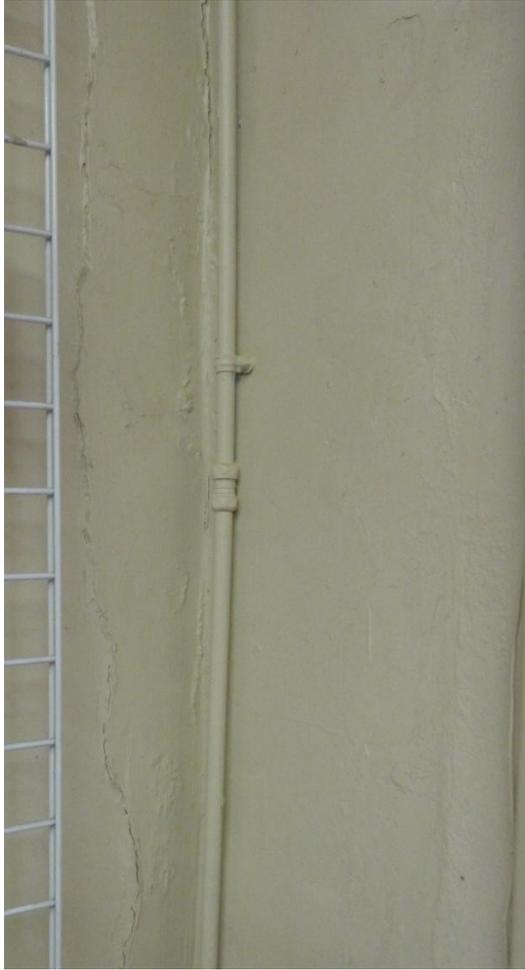
Building 2-Patched masonry

Walls. East wall has experienced movement. Remaining masonry walls appear to be structurally sound. Plaster finish has lost adhesion in some areas. East wall should be completely replastered. Porch has been repaired.

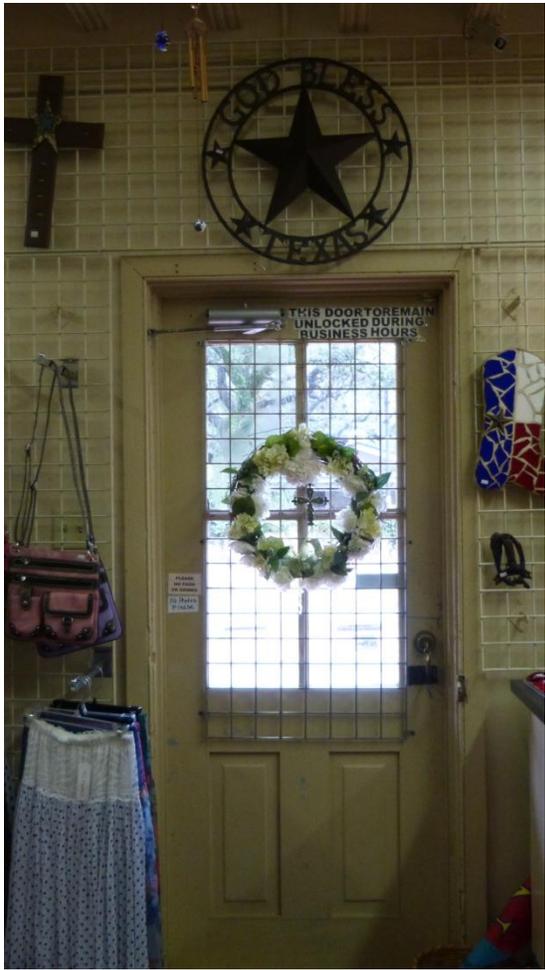
Building 2-Front door

Windows and doors. Doors are in fair condition but need caulking. Windows and shutters have been replaced.

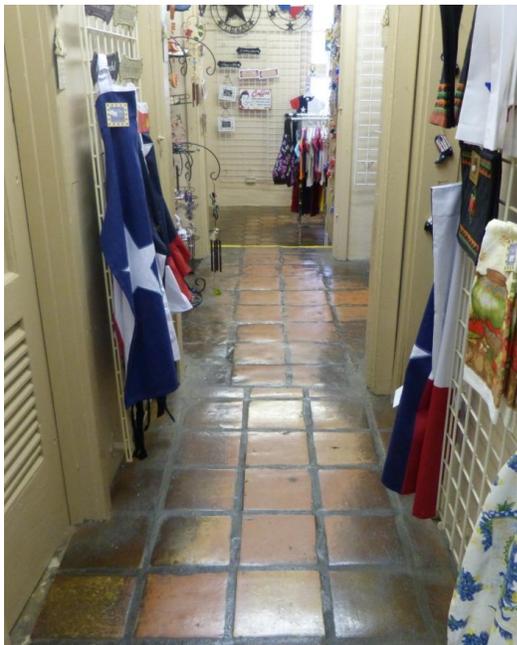
Building 2-Flooring

Floors. Various types of clay tile, probably WPA-era work. Appropriate patina of age, but may eventually need stripping and resealing.

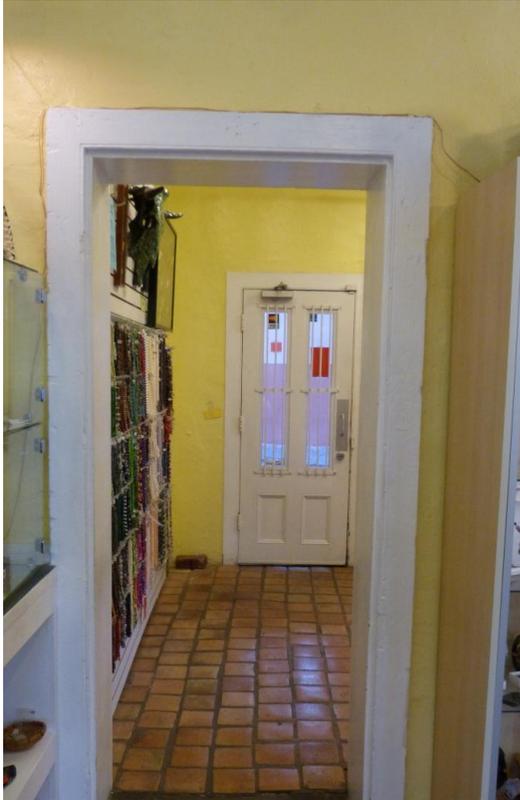
Building 7-Flooring

Floors. Clay tile in serviceable condition. Floors in rear office are of glazed hand-painted tiles from the WPA period. Floor should be covered to protect this interesting feature.

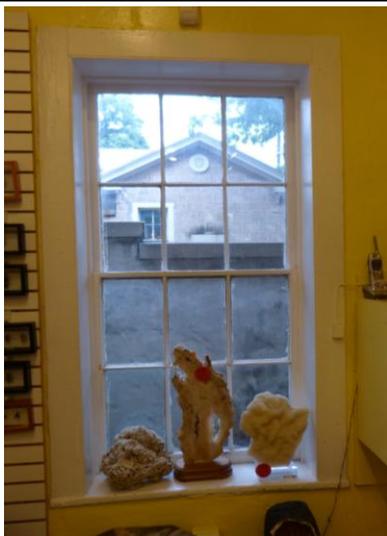
Building 7-Window

Windows and doors. Windows need repairs and new cap flashings. Masonry and window on north side are being repaired.

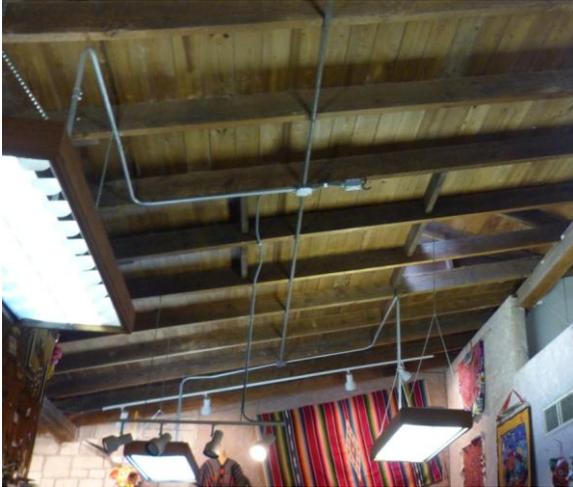
Building 8—Ceiling

Ceilings. Exposed beams and underside of roof decking. Beams have been replaced.

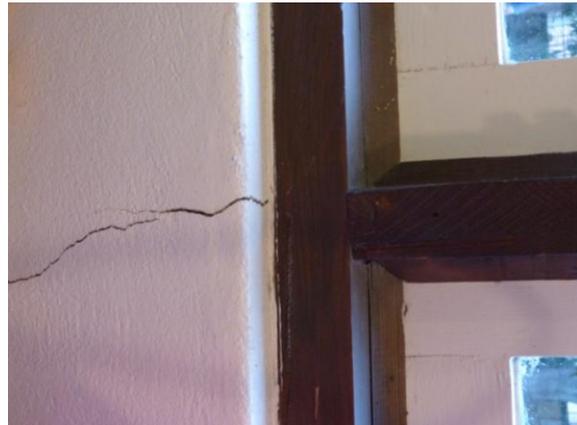
Building 8—Crack near window

Walls. Painted plaster in fair condition with deterioration at north wall and elsewhere.

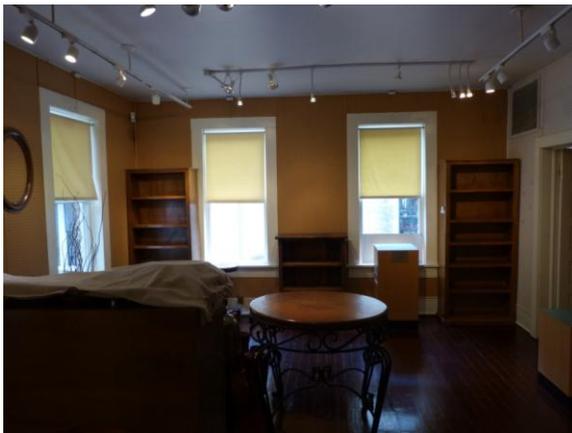
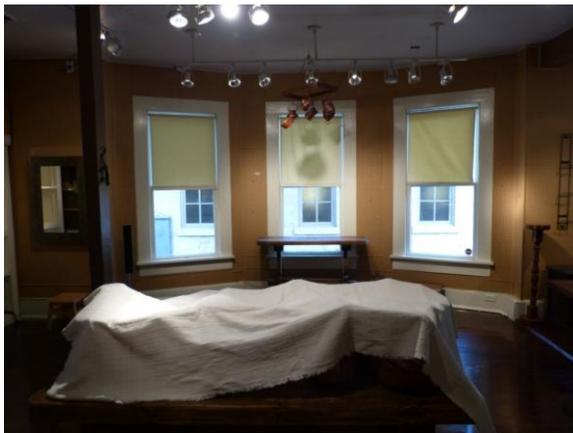
Building 11-Second-floor windows

Windows and doors. Wooden window frames and sash need to be reworked to repair sash weights and provide proper locking mechanisms. Doors in acceptable condition. Basement windows have been replaced.

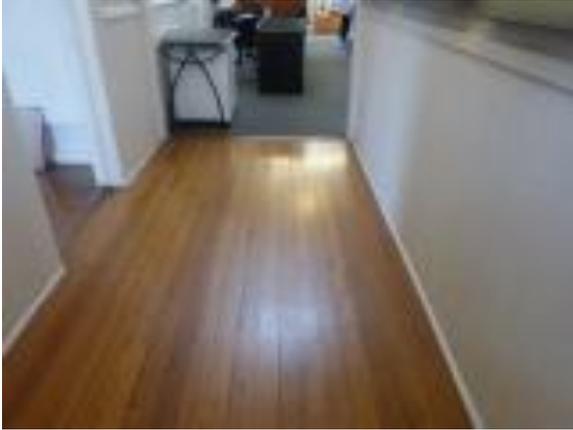
Building 22—Hall Flooring

Floors. Wooden floors in satisfactory condition may need refinishing. Partially covered by carpet.
