# CONCEPTUAL EVALUATION AND REPORT WEST COMMERCE STREET BRIDGE OVER UPRR

**CITY OF SAN ANTONIO  
TRANSPORTATION & CAPITAL IMPROVEMENTS**

*April 24, 2015*

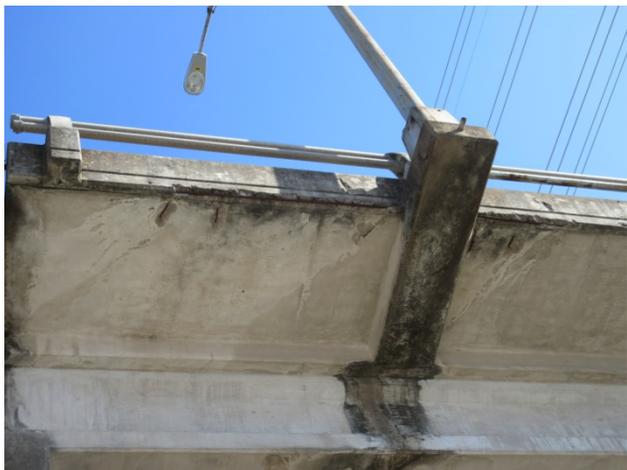
Figure 7 - Spalling at Edge of Overhang

There are multiple locations where the bridge overhang has been spalled and reinforcing steel is exposed. Recommend these areas be sand blasted to remove rust and laitance and then repaired with suitable non-sag repair mortar.

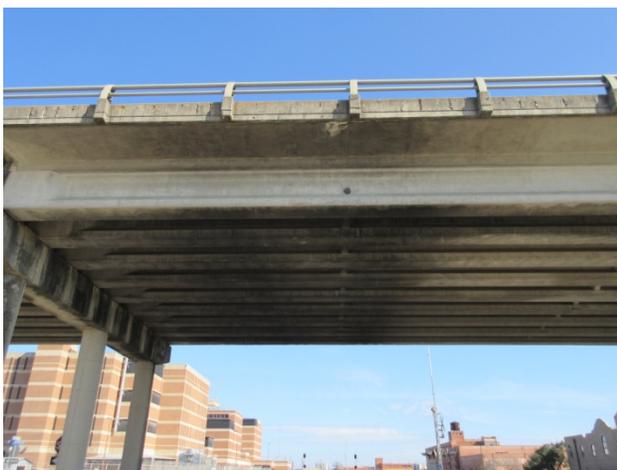
Figure 8 - Spalling on Soffit of Overhang

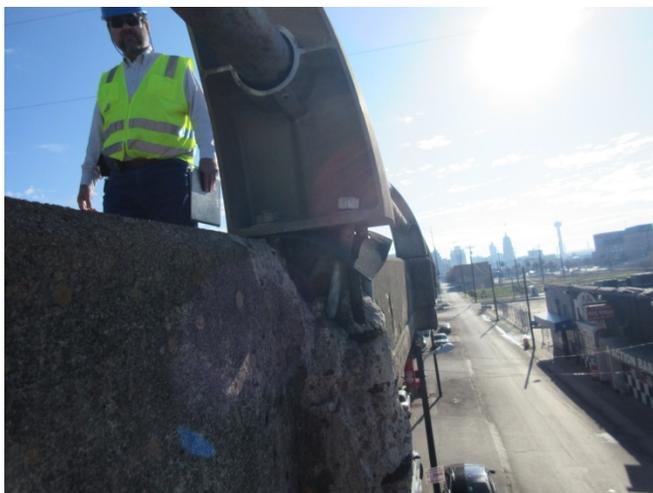
Figure 9 - Broken Concrete Rail Post

There are many places where the concrete bridge rail is spalled and rebar is visible. The pipe rail has also been repaired over time, and most of the repairs were not performed with galvanized steel. We recommend the spalled concrete areas be sand blasted to remove rust and laitance and then repaired with suitable non-sag repair mortar. The rusty rail posts and other elements should be sand blasted to remove rust and then re-painted with a silver paint designed for use on metal surfaces.

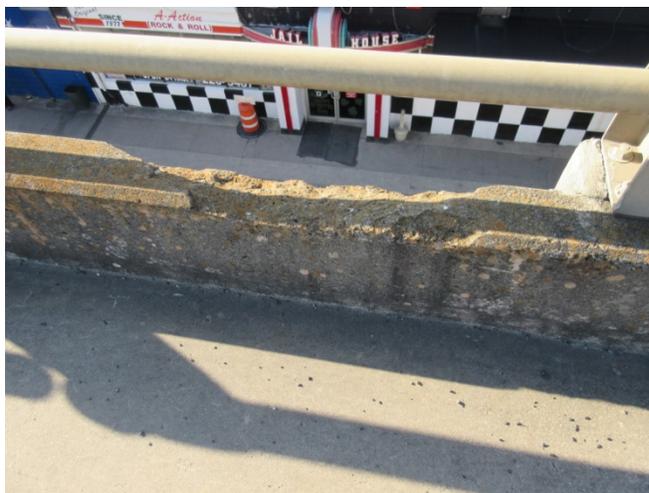
Figure 10 - Spalled Concrete Rail

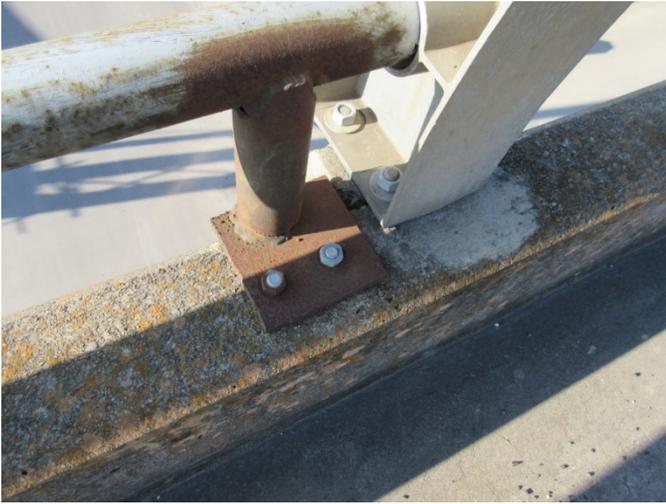
Figure 11 - Steel Rail Post Replaced

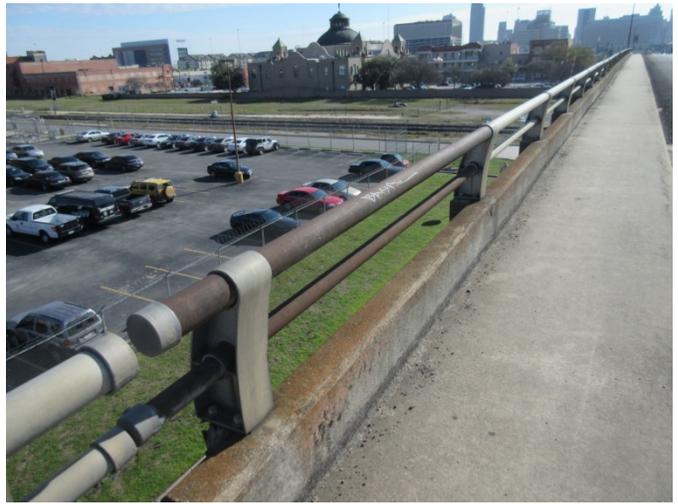
Figure 12 - Steel Rail Elements Rusty

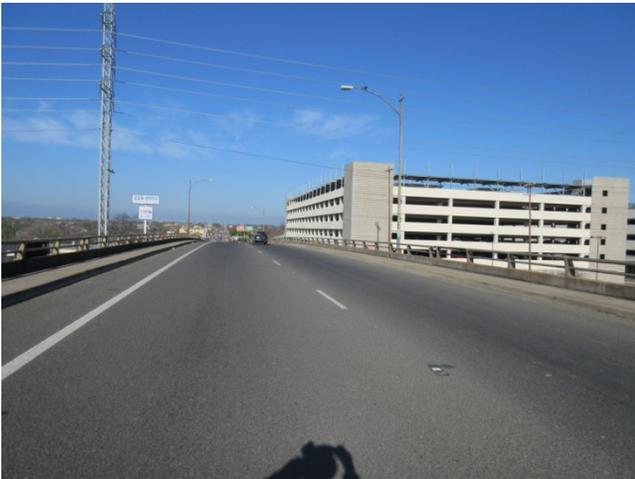
Owing to the bridge deck overlay, the actual surface of the concrete bridge slab could not be observed. However, overall the overlay surface appears to be in good shape. No repairs are recommended at this time.

Figure 13 - ACP Overlay Looking West

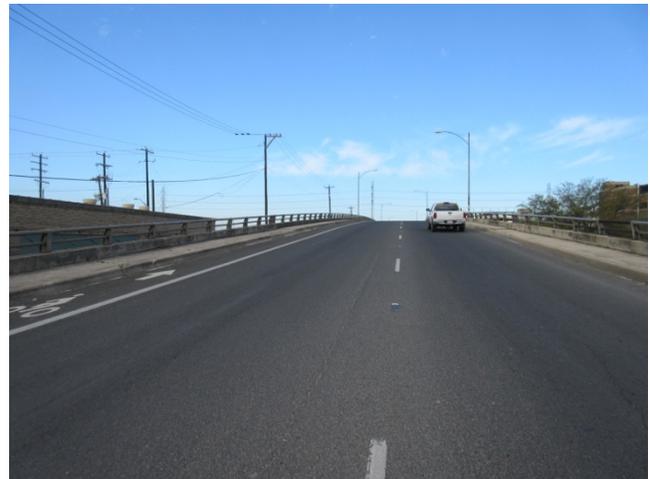
Figure 14 - ACP Overlay Looking East

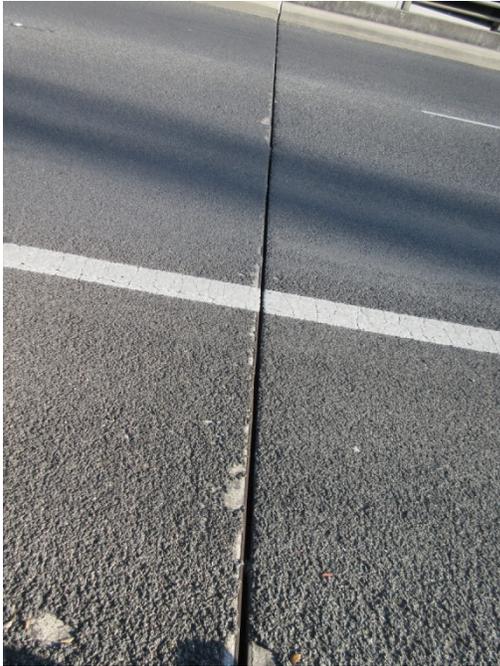
Figure 15 - Typical Slab Expansion Joint

Open expansion joints are generally clean but the construction joints exhibit piled overlay due to continued movement. All joints are open with no seals and because the bridge drains are clogged, most of the storm water drainage goes through these open joints. For expansion joints it is recommended that the armor plates be blast cleaned, a new backer rod be squeezed and inserted into the open joint and the joint be sealed by a non-sag silicone joint sealant. The same process can be utilized for any open joints in the sidewalk, whether expansion or not. For the construction joints, we recommend they be routed clean of debris and sealed with a non-sag silicone sealant.

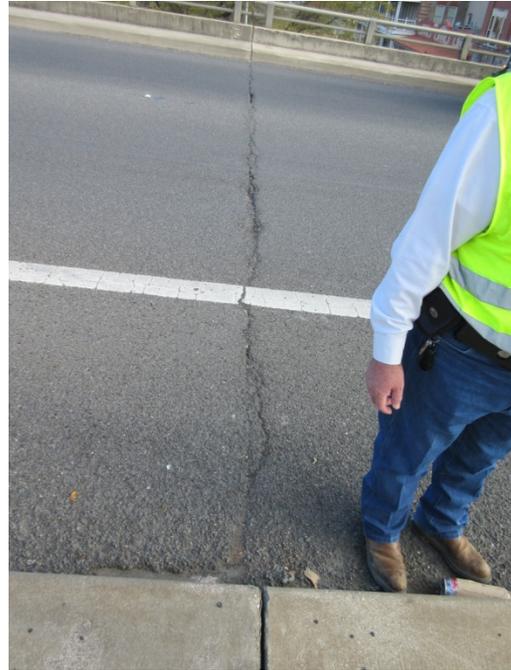
Figure 16 - Typical Slab Const. Joint

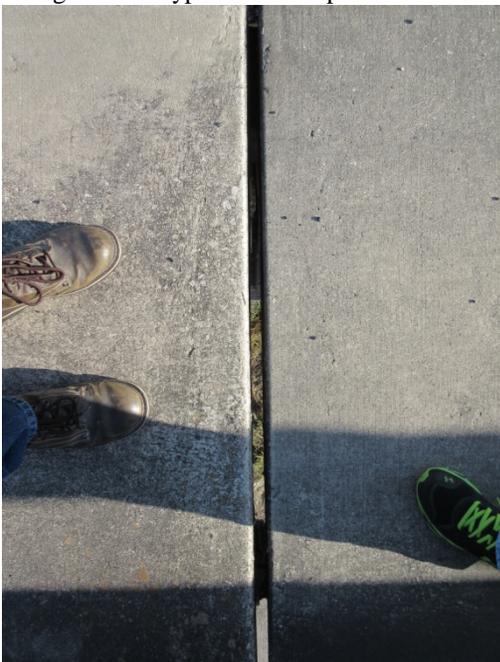
Figure 17 - Typical Sidewalk Exp. Joint

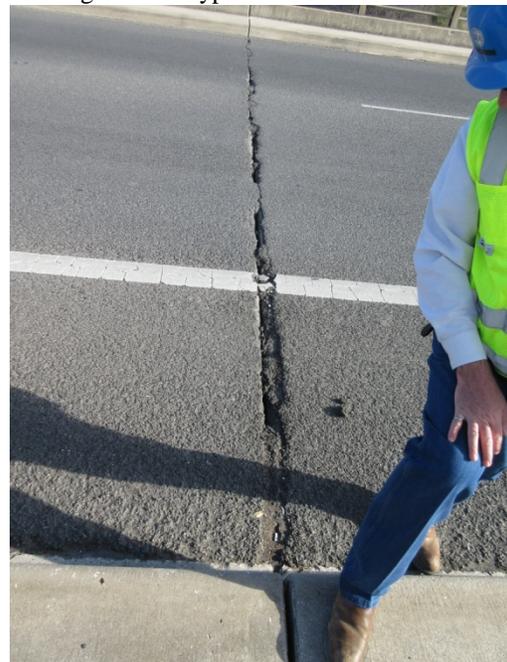
Figure 18 - Exp. Joint Full of ACP

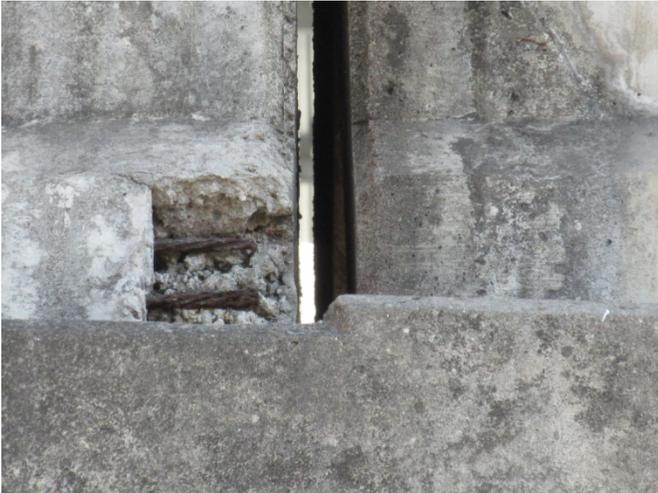
Figure 19 - Beam Bottom Flange Spalled

In general the bridge beams are in relatively good condition considering their age. There are multiple ends of beams that have spalled off over the years and reinforcing bars are exposed. For the beams with spalled ends, we recommended thorough blast cleaning of the spalled area and then patch the beam end with an TxDOT approved epoxy repair mortar.

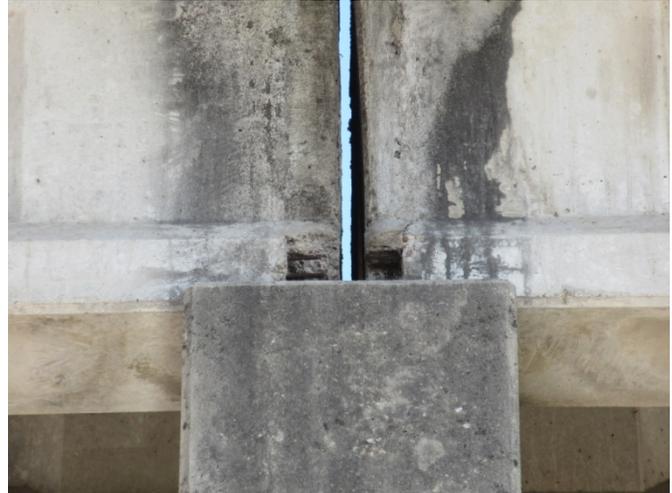
Figure 20 - Beams Bottom Flange Spall Both Beams

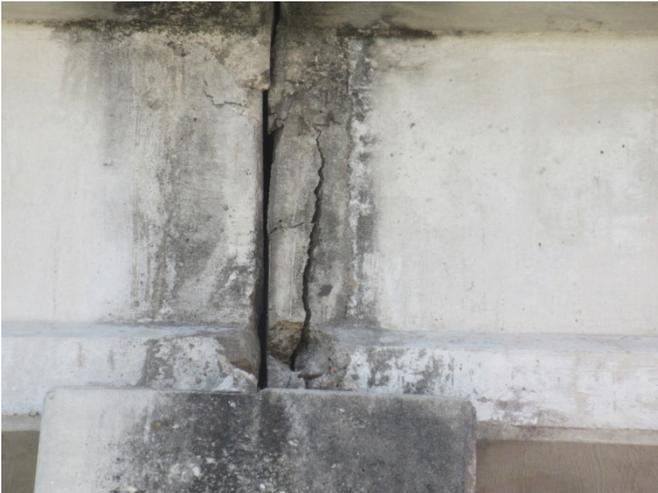
Figure 21 - Beam End Spalled

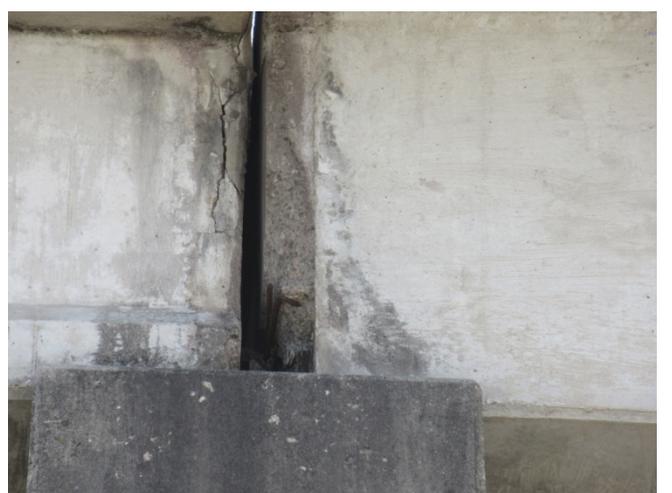
Figure 22 - Beam Ends Spalled Both Beams

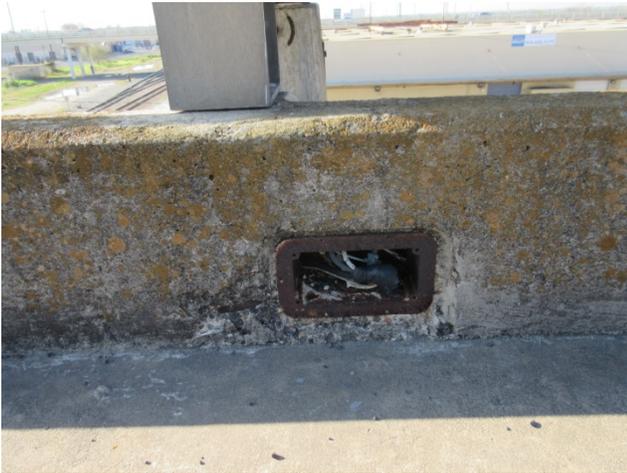
Figure 23 - Electrical Junction Box Cover Missing

The bridge lighting was not checked during evening hours so we can not speak to the actual operations of the bridge luminaires, however in general the light poles, mast arms, and luminaires appear to be in fair condition. There is at least one rail junction box that the cover has been removed from. We recommend replacement of the junction box cover to prevent water intrusion into the electrical conduits.

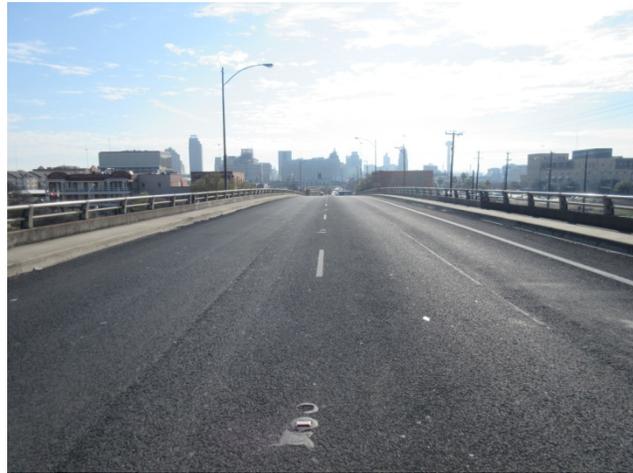
Figure 24 - Bridge Light Poles

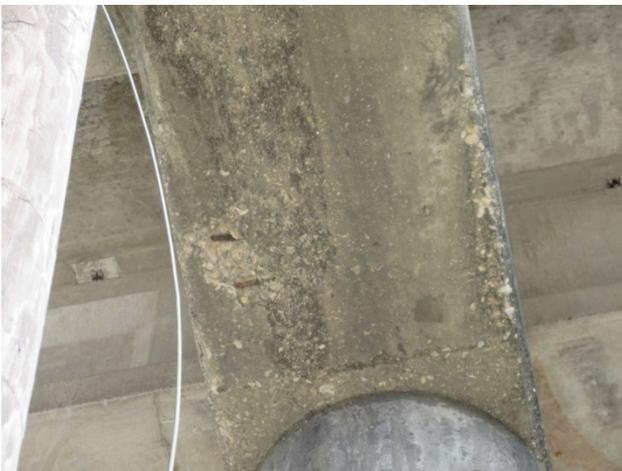
Figure 25 - Spalling on Soffit of Bent Cap

Several areas of the interior bent caps soffits were spalled. We recommend cleaning and repair with a non-sag repair mortar.

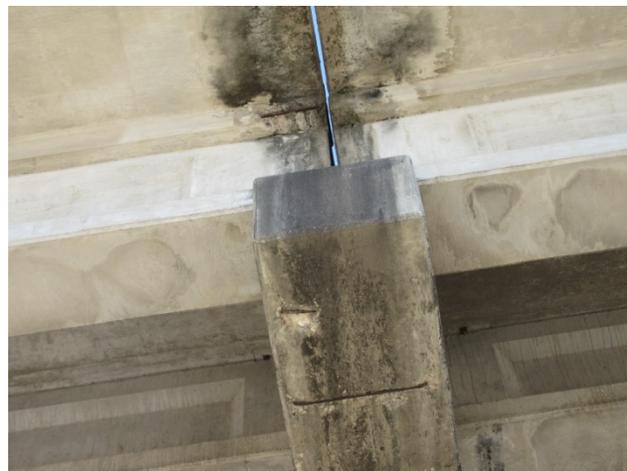
Figure 26 - Spalling & Exposed Rebar

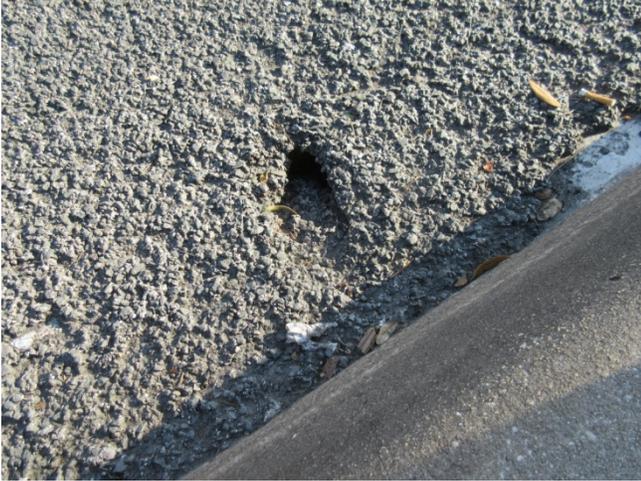
Figure 27 - Bridge Deck Drain Clogged with ACP

As previously mentioned the bridge drains appeared to be clogged and inoperable. We recommend these bridge drains be cleaned and that down-spouts be installed to channel the stormwater runoff to areas adjacent to existing storm drain inlets. If other changes are made to the bridge structure itself, other than routine maintenance the bridge approach sidewalks will need to be re-built for TAS compliance.

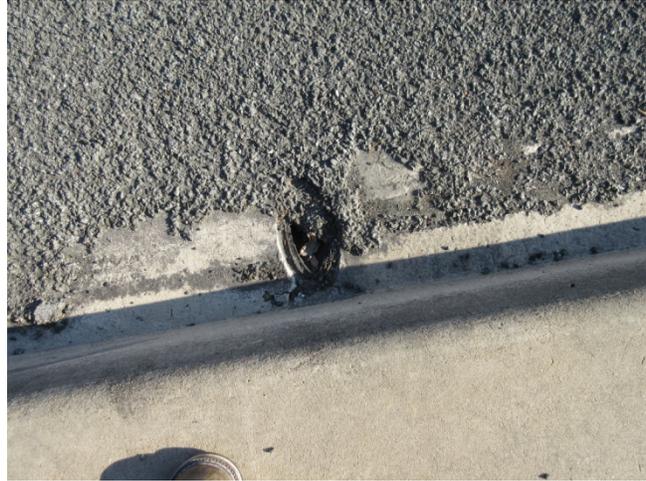
Figure 28 - Bridge Deck Drain Plugged with Trash & ACP

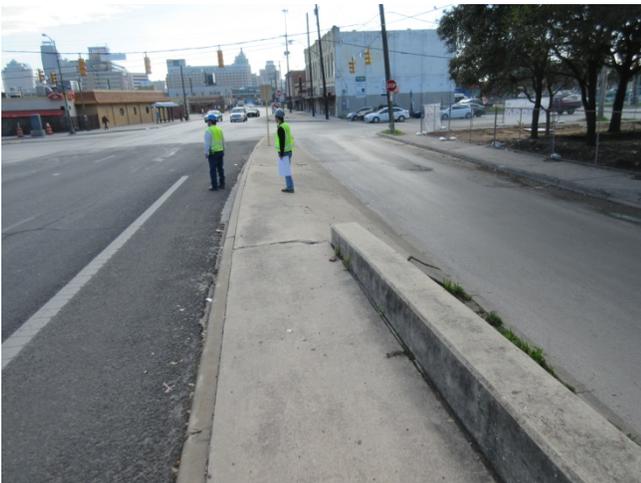
Figure 29 - North End Approach Sidewalk

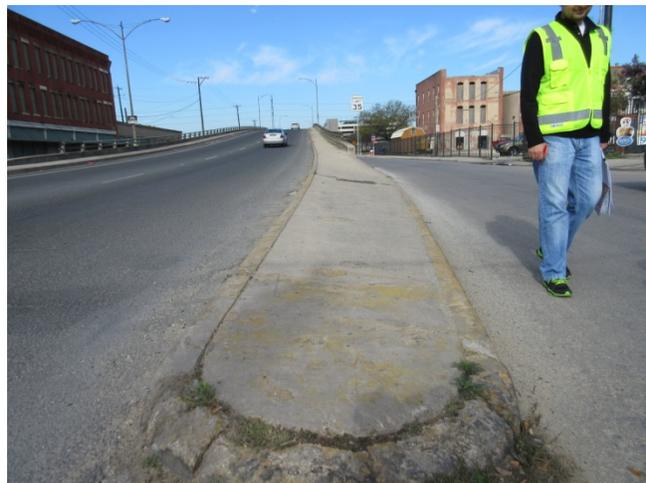
Figure 30 - North End Approach Sidewalk
