MISSION DRIVE IN MARQUEE

San Antonio, Texas

PAINT ANALYSIS REPORT COMPILED FOR BEATTY PALMER ARCHITECTS INC.

Compiled by Restoration Associates LLC
Mary C. Jary and Elisa Jary
February 2011

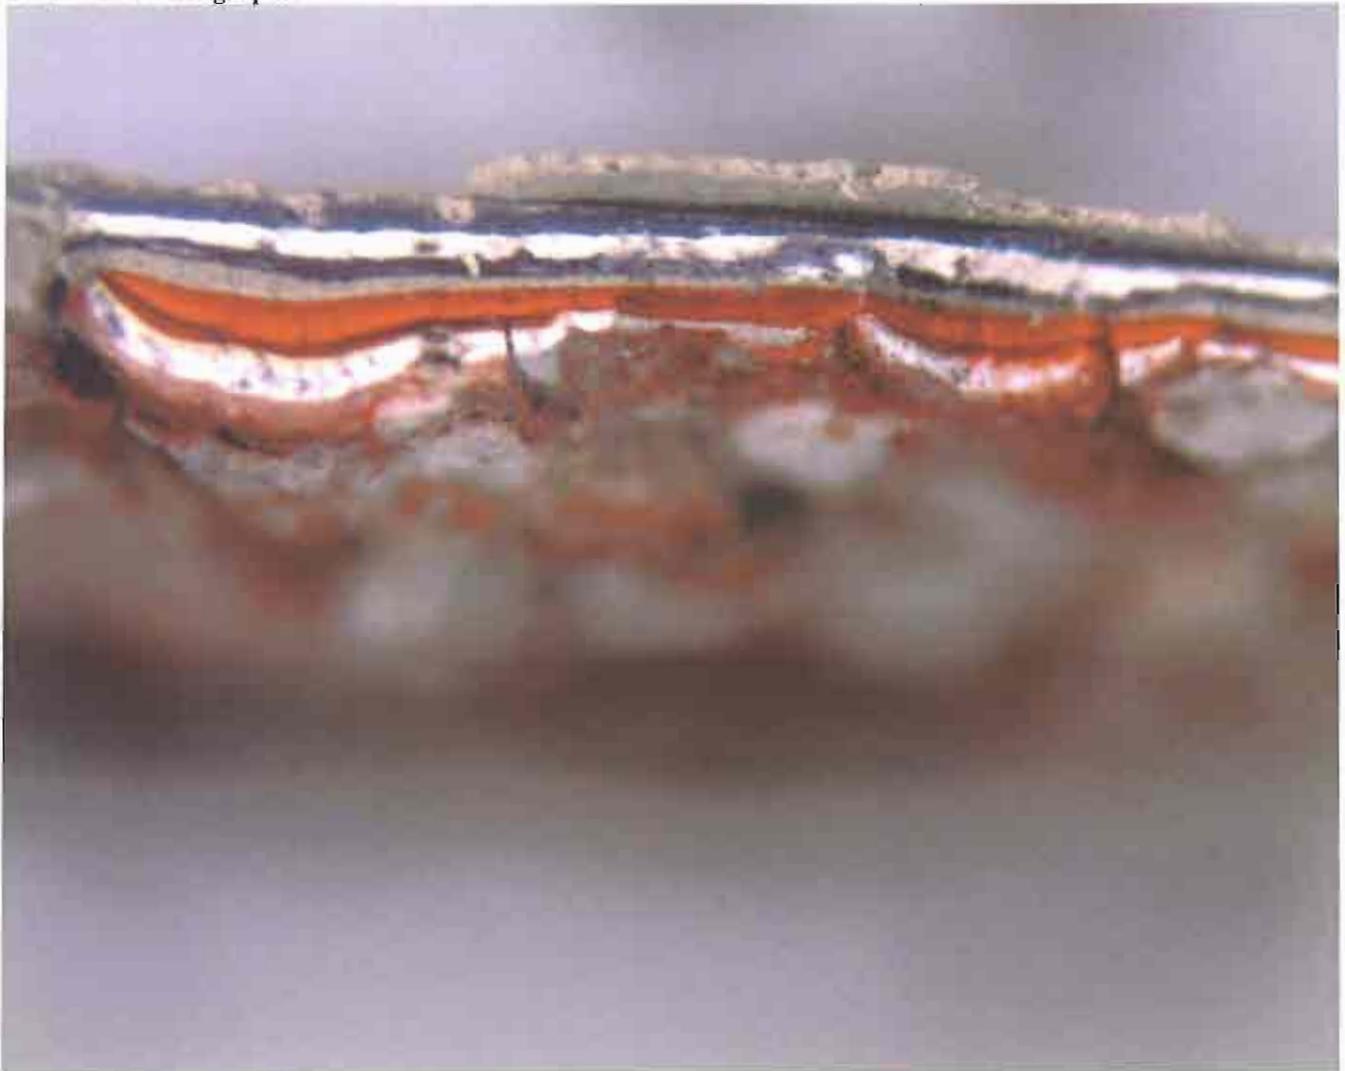
Element Code: Sample 1

Detail Photomicrographs:

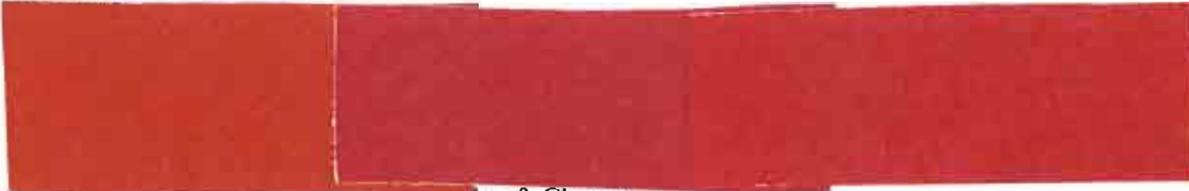
Element Code: Sample 2

Description: South wing wall niche

Paint Layer Chronology	Hue & Chroma Notation	Binder	Finish
1. orange red	7.5R 5/12-6/12	oil	
2. tan with aggregate			
3. off white skim coat with aggregate			
4. dark blue black			
5. off white skim coat with aggregate			
6. dark blue black			
7. cream existing			
8.			
9.			
10.			
11.			
12.			
13.			
14.			
15.

Observations: This sample showed various areas with the bright white occurring as the first layer and also on the same sample showing the orange red as the first layer. Different areas from the same sample showed differing layers of paint.

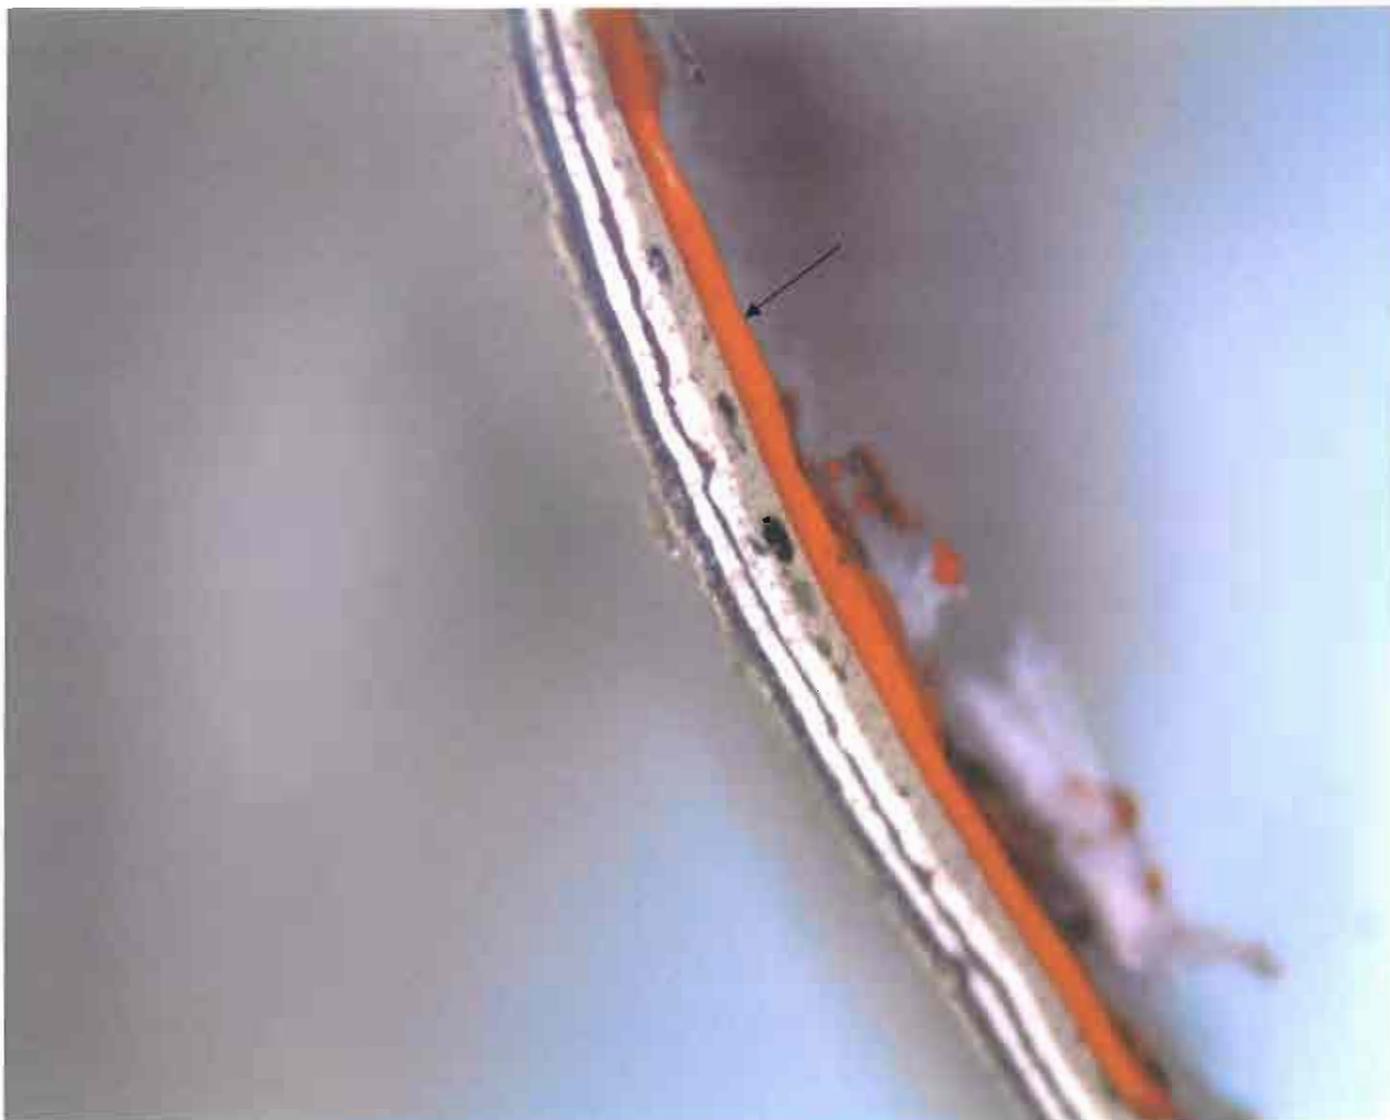
Element Code: Sample 2

Detail Photomicrographs:

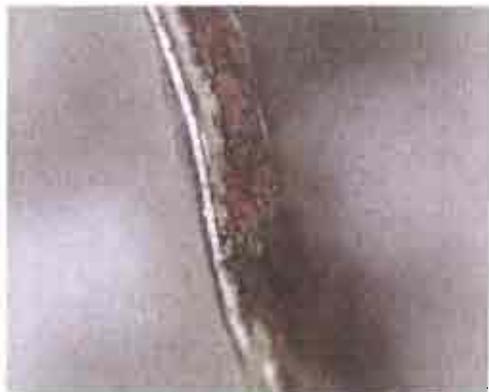
Element Code: Sample 3

Description: Marquee left of mural

Paint Layer Chronology	Hue & Chroma Notation	Binder	Finish
1. Coral	10R 7/6- 10R 8/4- 5YR 8/6		
2. tan with aggregate			
3. dark blue violet			
4. cream			
5. black			
6. off white existing			
7.			
8.			
9.			
10.			
11.			
12.			
13.			
14.			
15.

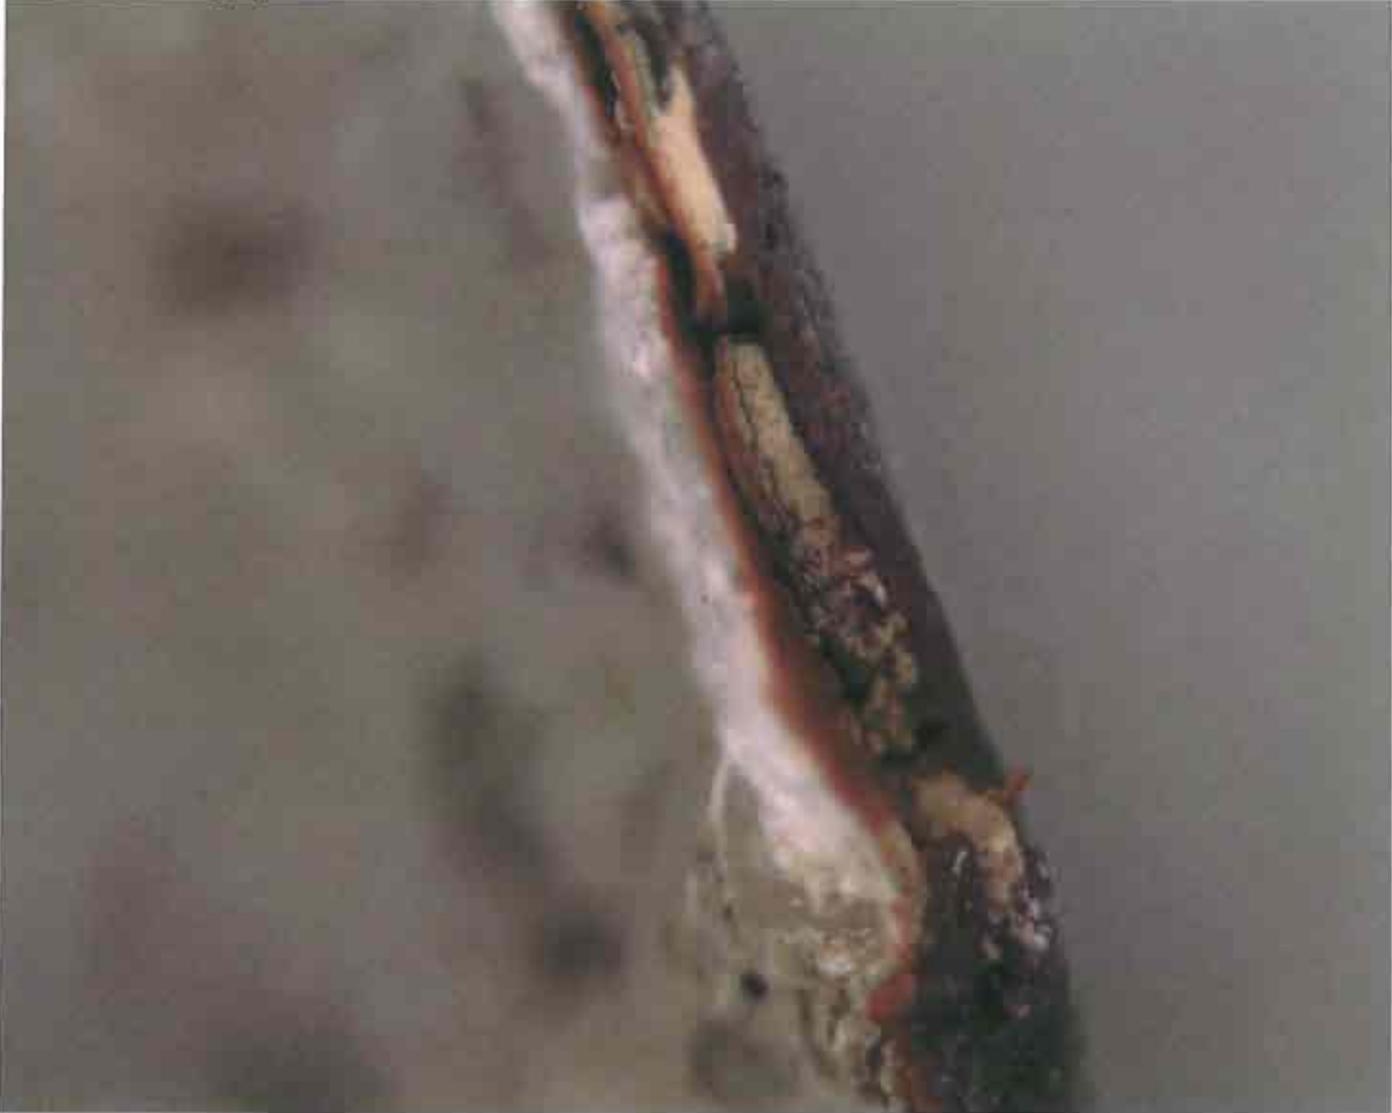
Element Code: Sample 3

Detail Photomicrographs:

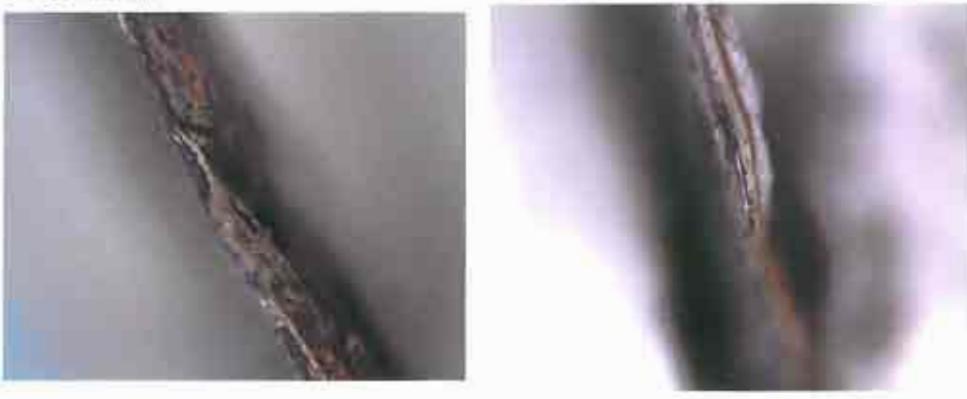
Element Code: Sample 4

Description: marquee left of mural

Paint Layer Chronology	Hue & Chroma Notation	Binder	Finish
1. red orange	7.5 R 5/12-6/12	oil	
2. tan with aggregate			
3. dark blue violet			
4. cream			
5. black			
6. off white existing			
7.			
8.			
9.			
10.			
11.			
12.			
13.			
14.			
15.

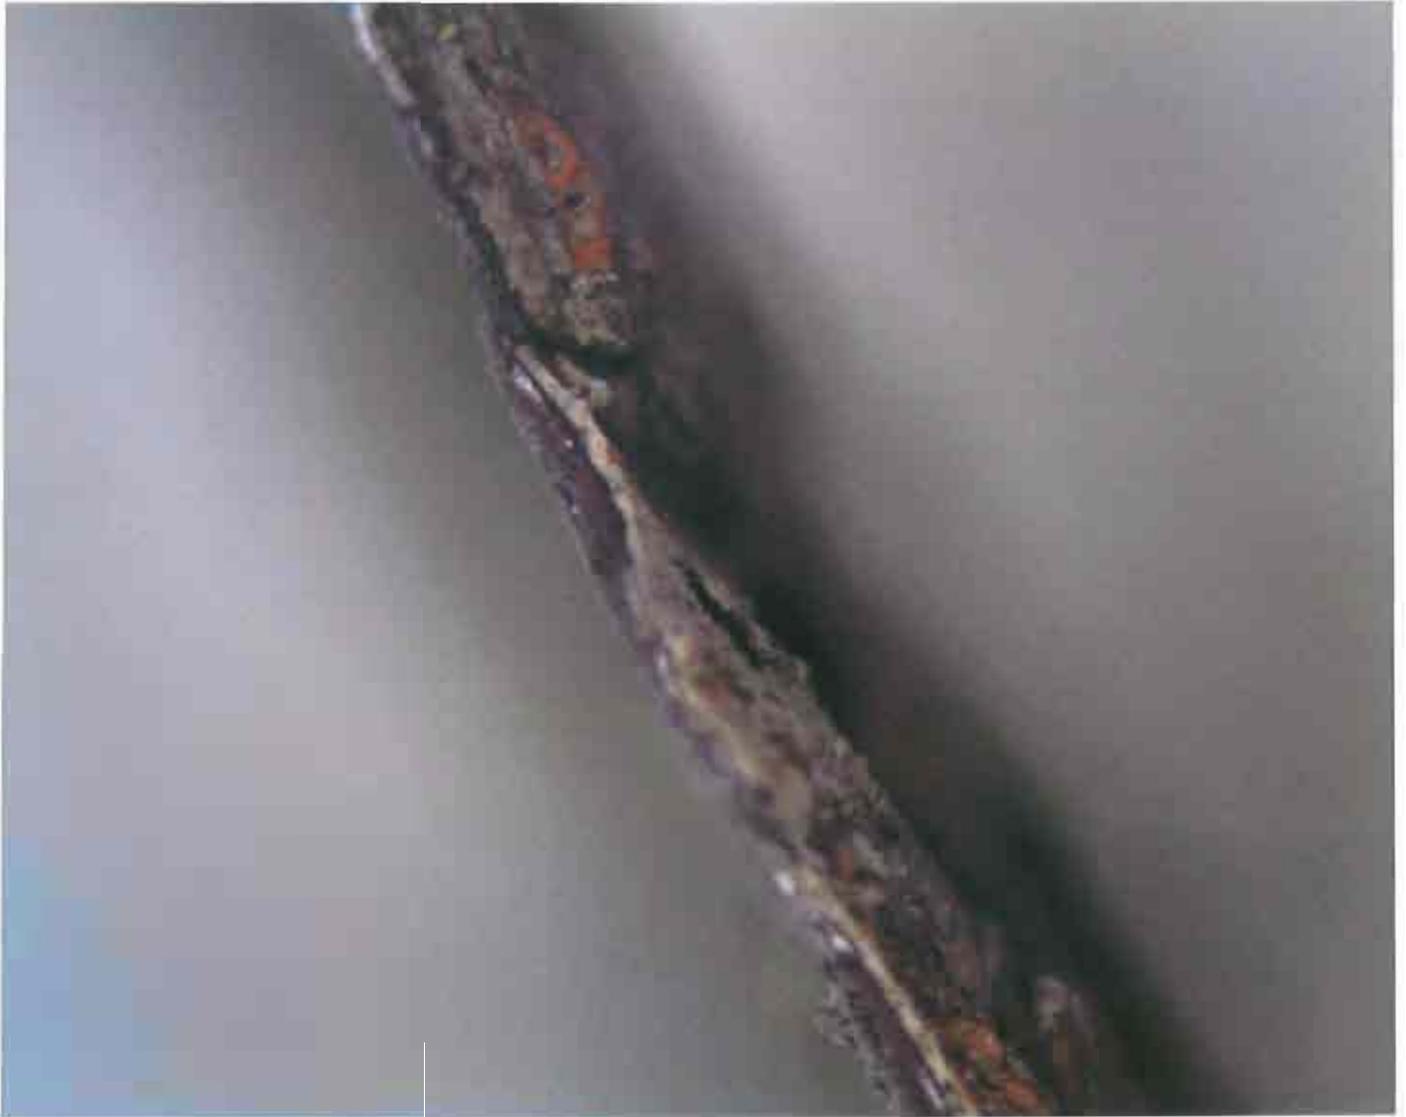
Element Code: Sample 4

Detail Photomicrographs:

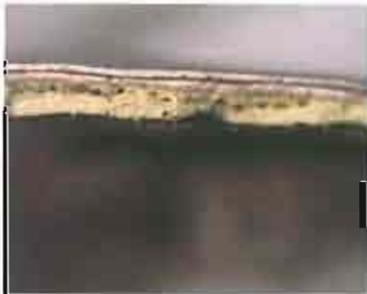
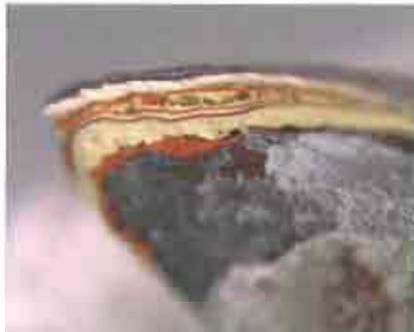
Element Code: Sample 5

Description: Marquee right of Mural

Paint Layer Chronology	Hue & Chroma Notation	Binder	Finish
1. black			
2. red orange	5 R 6/12-6/14		
3. orange red			
4. black			
5. off white			
6. red orange			
7. off white			
8. orange red			
9. off white with aggregate			
10. orange red			
11. tan with aggregate			
12. white skim coat			
13. dark blue violet			
14. skim coat			
15. dark blue violet

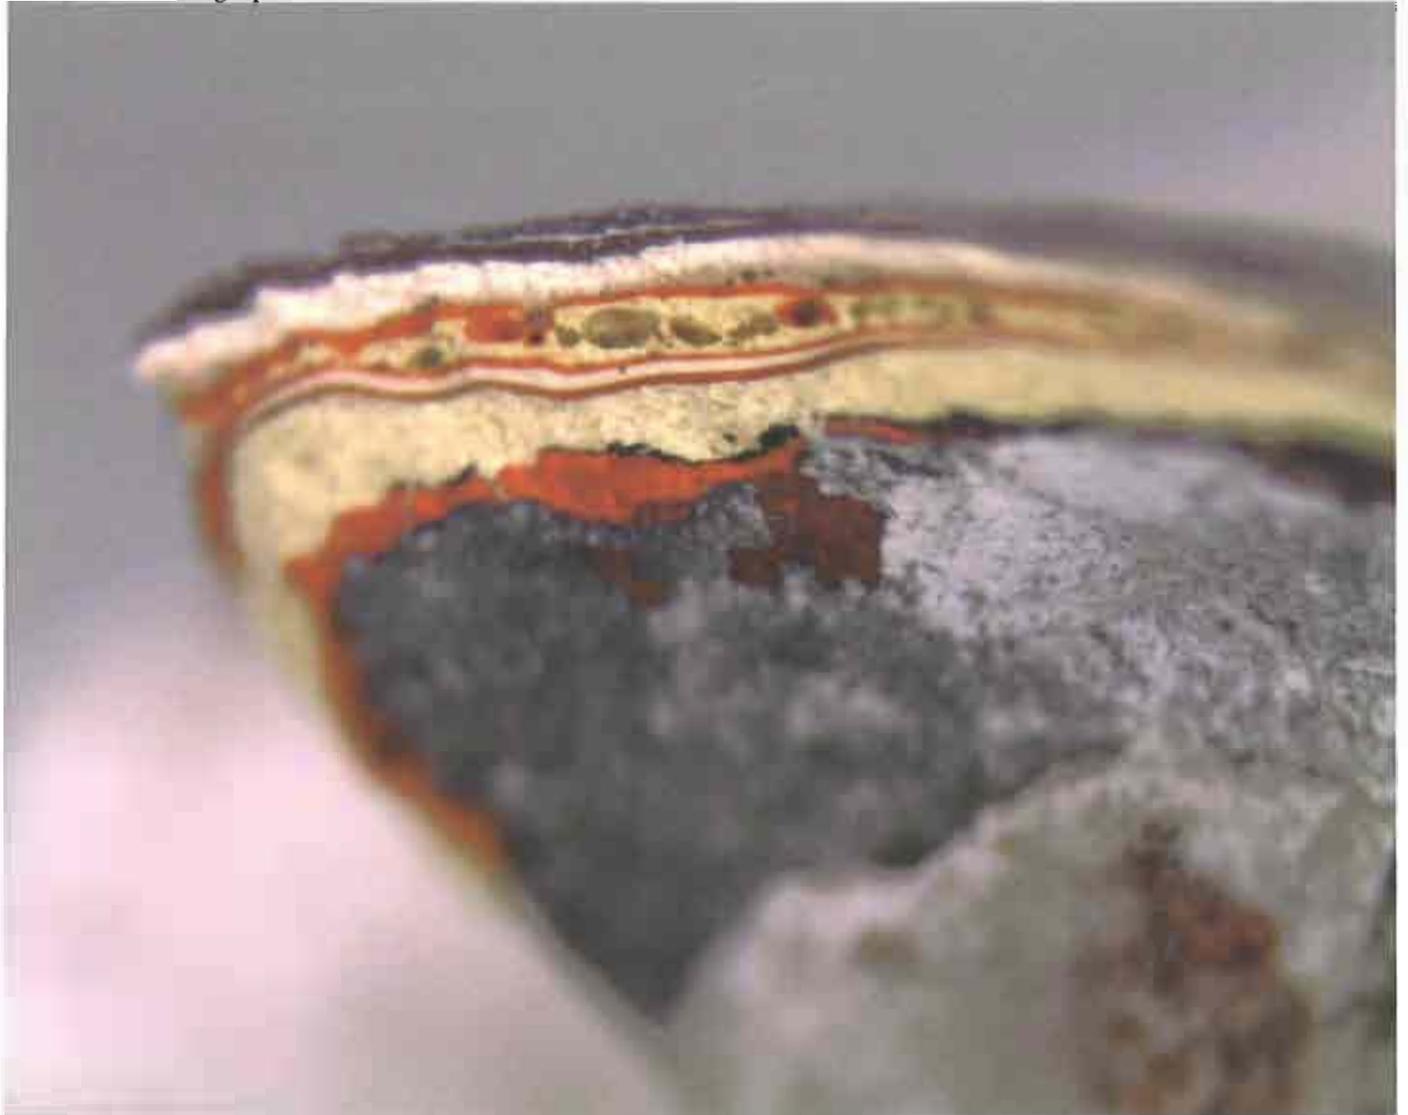
Element Code: Sample 5

Detail Photomicrographs:

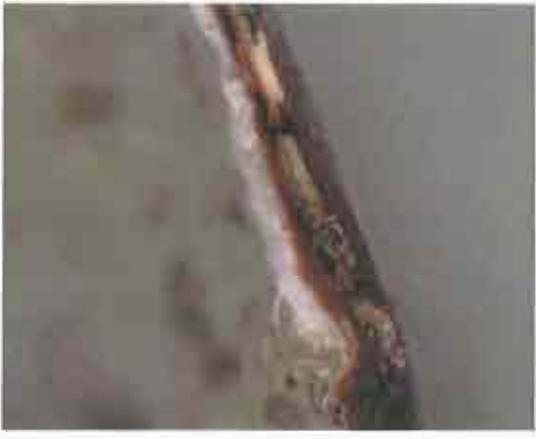
Element Code: Sample 6

Description: North Wing Wall

Paint Layer Chronology	Hue & Chroma Notation	Binder	Finish
1. orange red	7.5 5/12-6/12		
2. tan with aggregate			
3. off white			
4. dak blue violet			
5.			
6.			
7.			
8.			
9.			
10.			
11.			
12.			
13.			
14.			
15.

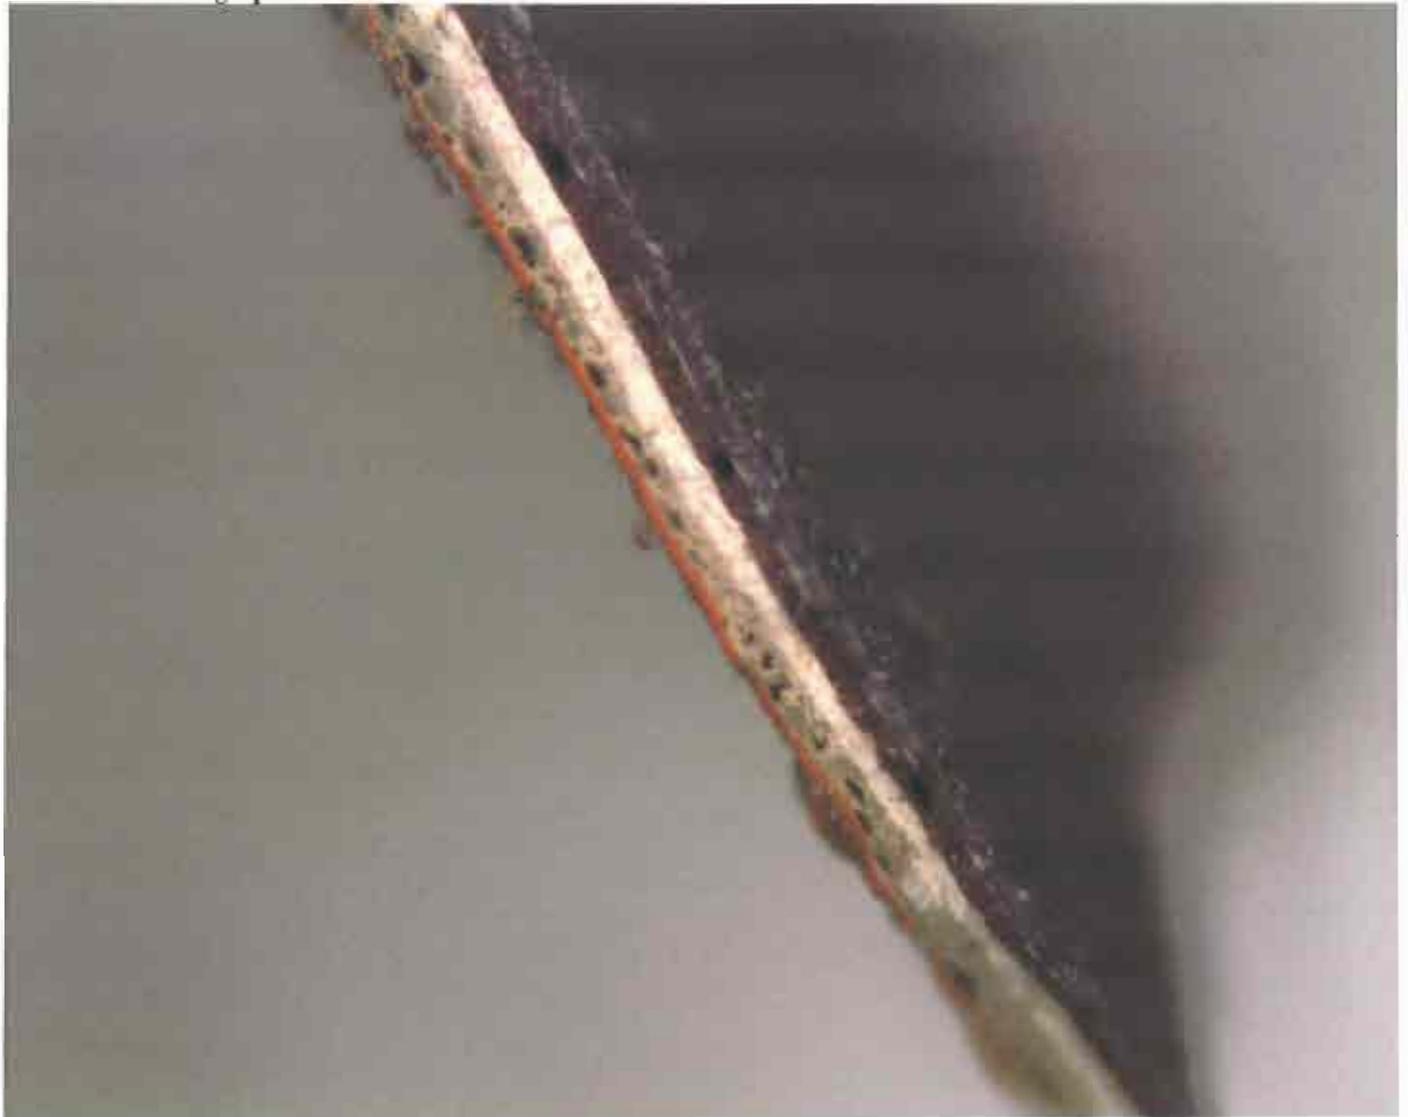
Element Code: Sample 6

Detail Photomicrographs:

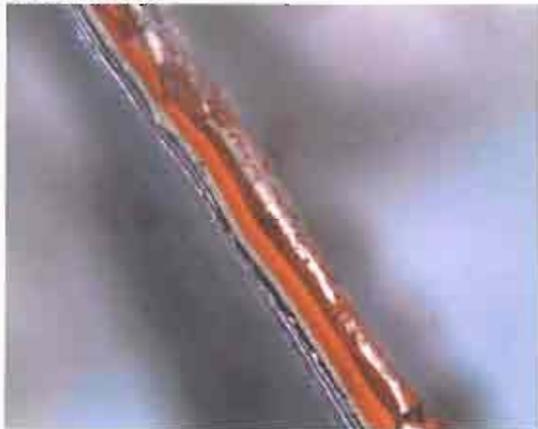
Element Code: Sample 7

Description: Niche

Paint Layer Chronology	Hue & Chroma Notation	Binder	Finish
1. orange red	7.5 R 5/12-6/12	oil	
2. white			
3. red orange			
4. dark red orange			
5. tan with aggregate			
6. black			
7. white			
8. blue violet			
9. white off white existing			
10.			
11.			
12.			
13.			
14.			
15.

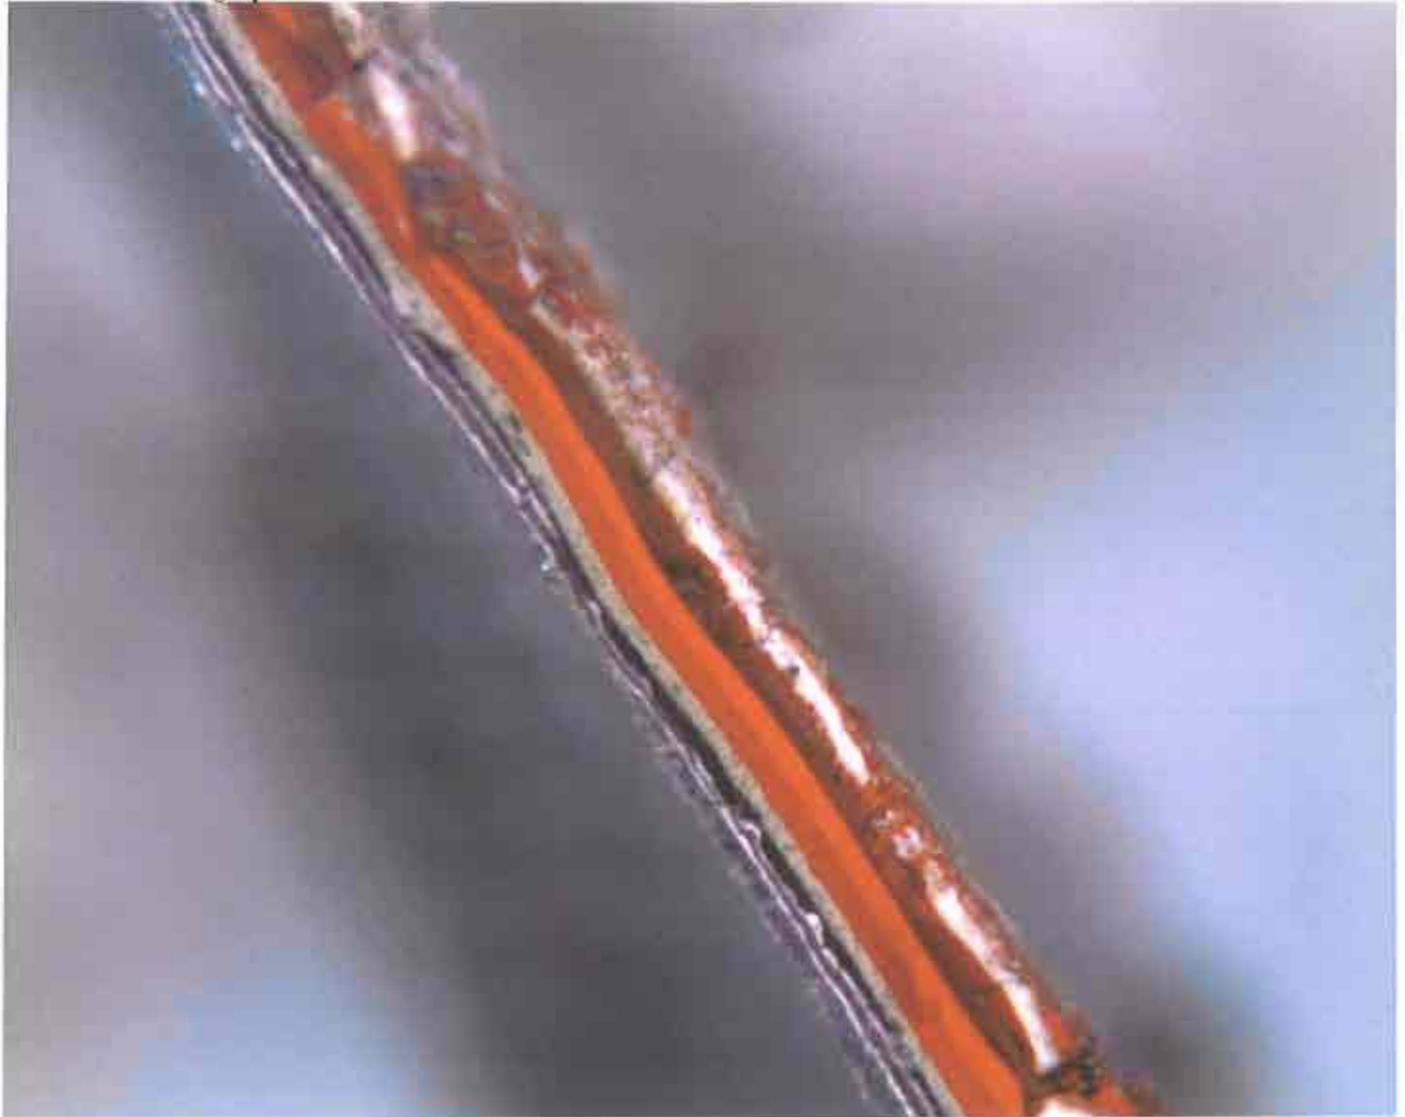
Element Code: Sample 7

Detail Photomicrographs:

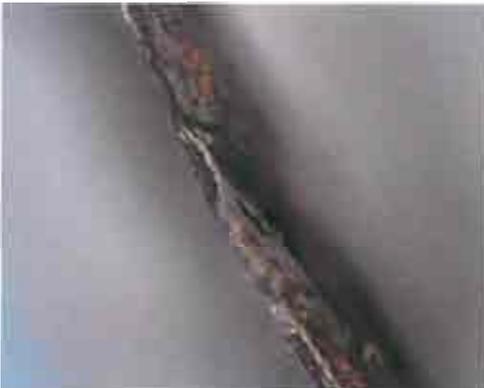
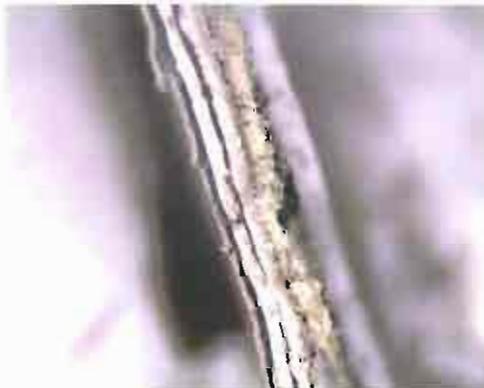
Element Code: Sample 8

Description: Niche

Paint Layer Chronology	Hue & Chroma Notation	Binder	Finish
1. Coral	5YR 8/6		
2. off white	10YR 9/2		
3. tan with aggregate			
4. cream			
5. black			
6. cream			
7. dark blue violet			
8. off white existing			
9.			
10.			
11.			
12.			
13.			
14.			
15.

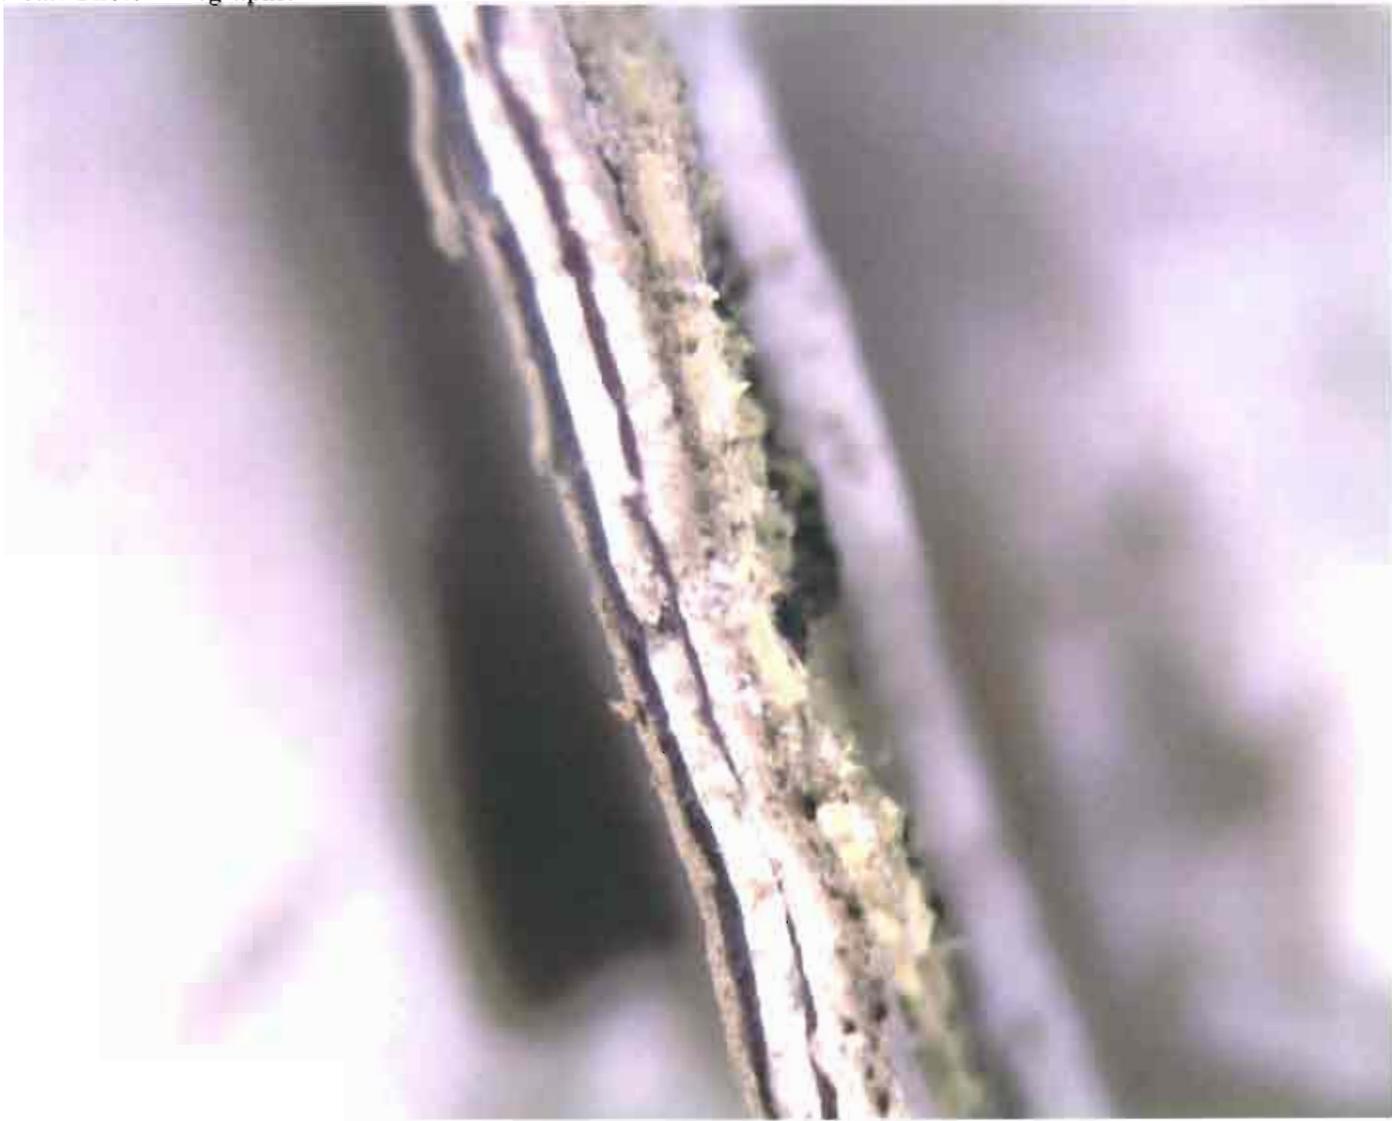
Element Code: Sample 8

Detail Photomicrographs:

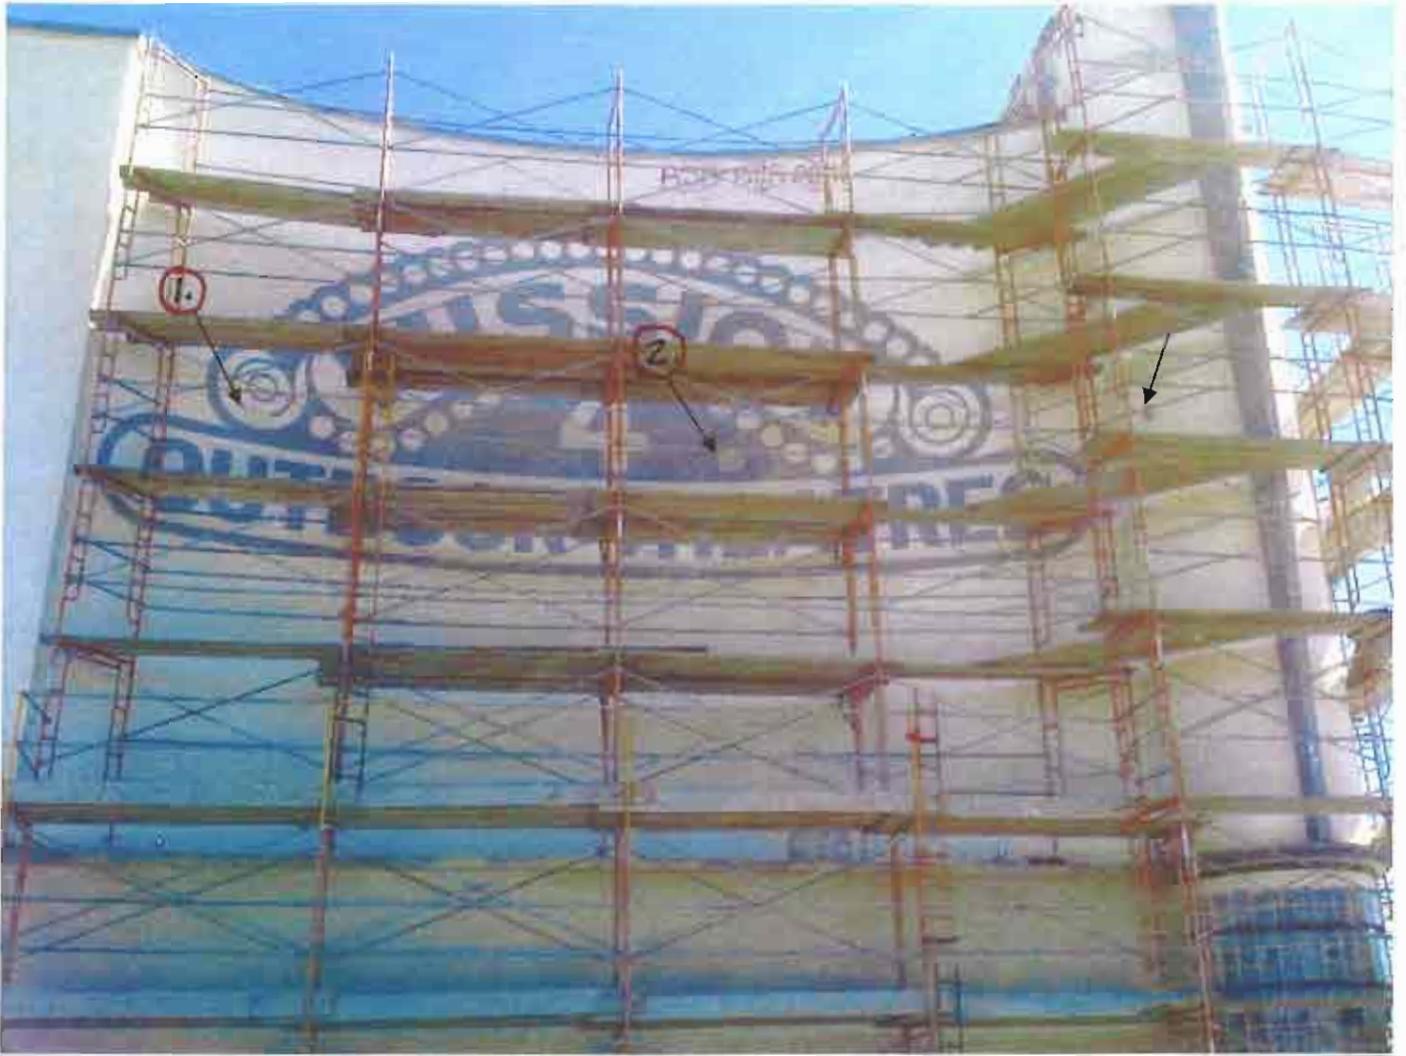
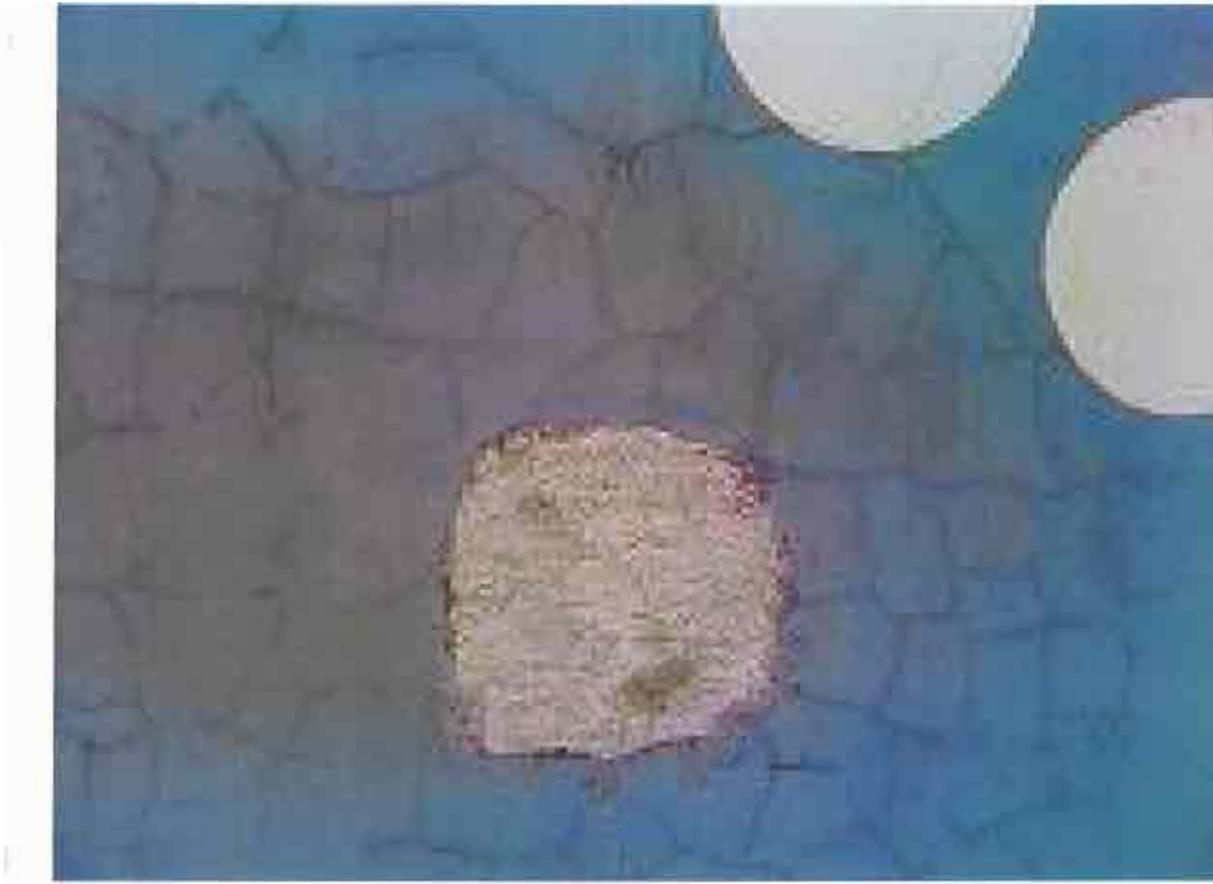
CHEMICAL REVEALS

Chemical reveal at face of mural. Findings were inconclusive

No conclusive evidence of the historic mural from the 2 chemical reveal areas examined was found. It should be noted that the 2 areas were only examined to the Keenes layer. Keenes is not soluble with normal chemical reveal techniques. No site material testing prior to our work was required in this scope.

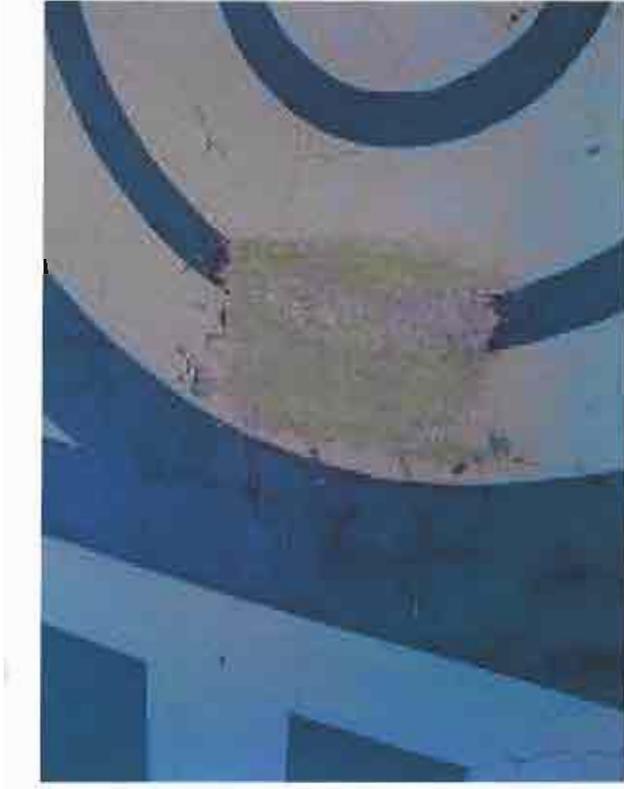
Mural Area of marquee. Notice Keenes partial patch .

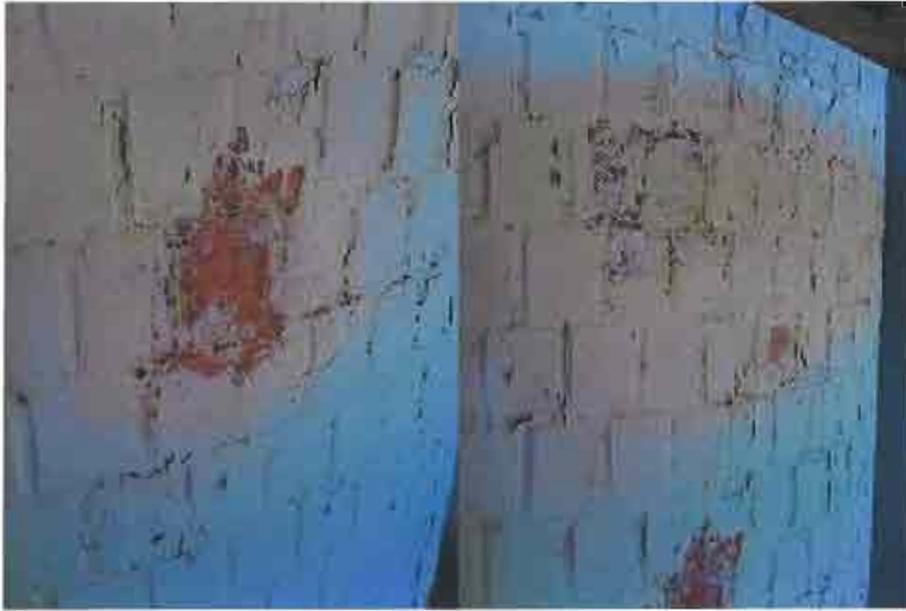
Marquee tower right. Extra Chemical reveals. Findings were as reported. Red orange layer Keenes and an inconclusive identification with no Keenes

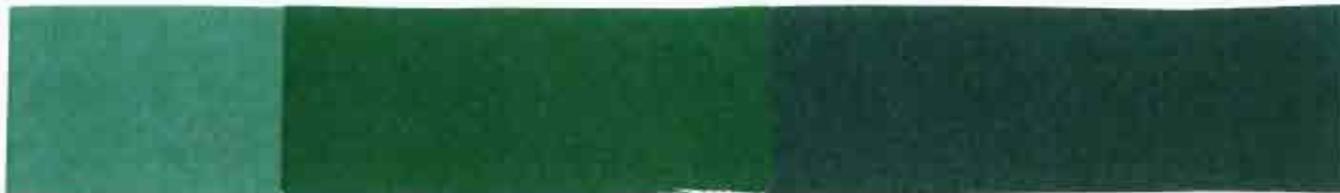
Location: West Elevation

Paint Layer Chronology	Hue & Chroma Notation	Binder	Finish
1. black			
2. Dark to Medium Blue Green	10G 3/4 - 7.5 G 4/4-5G 5/6		
3.			
4.			
5.			
6.			
7.			
8.			
9.			
10.			
11.			
12.			
13.			
14.			
15.

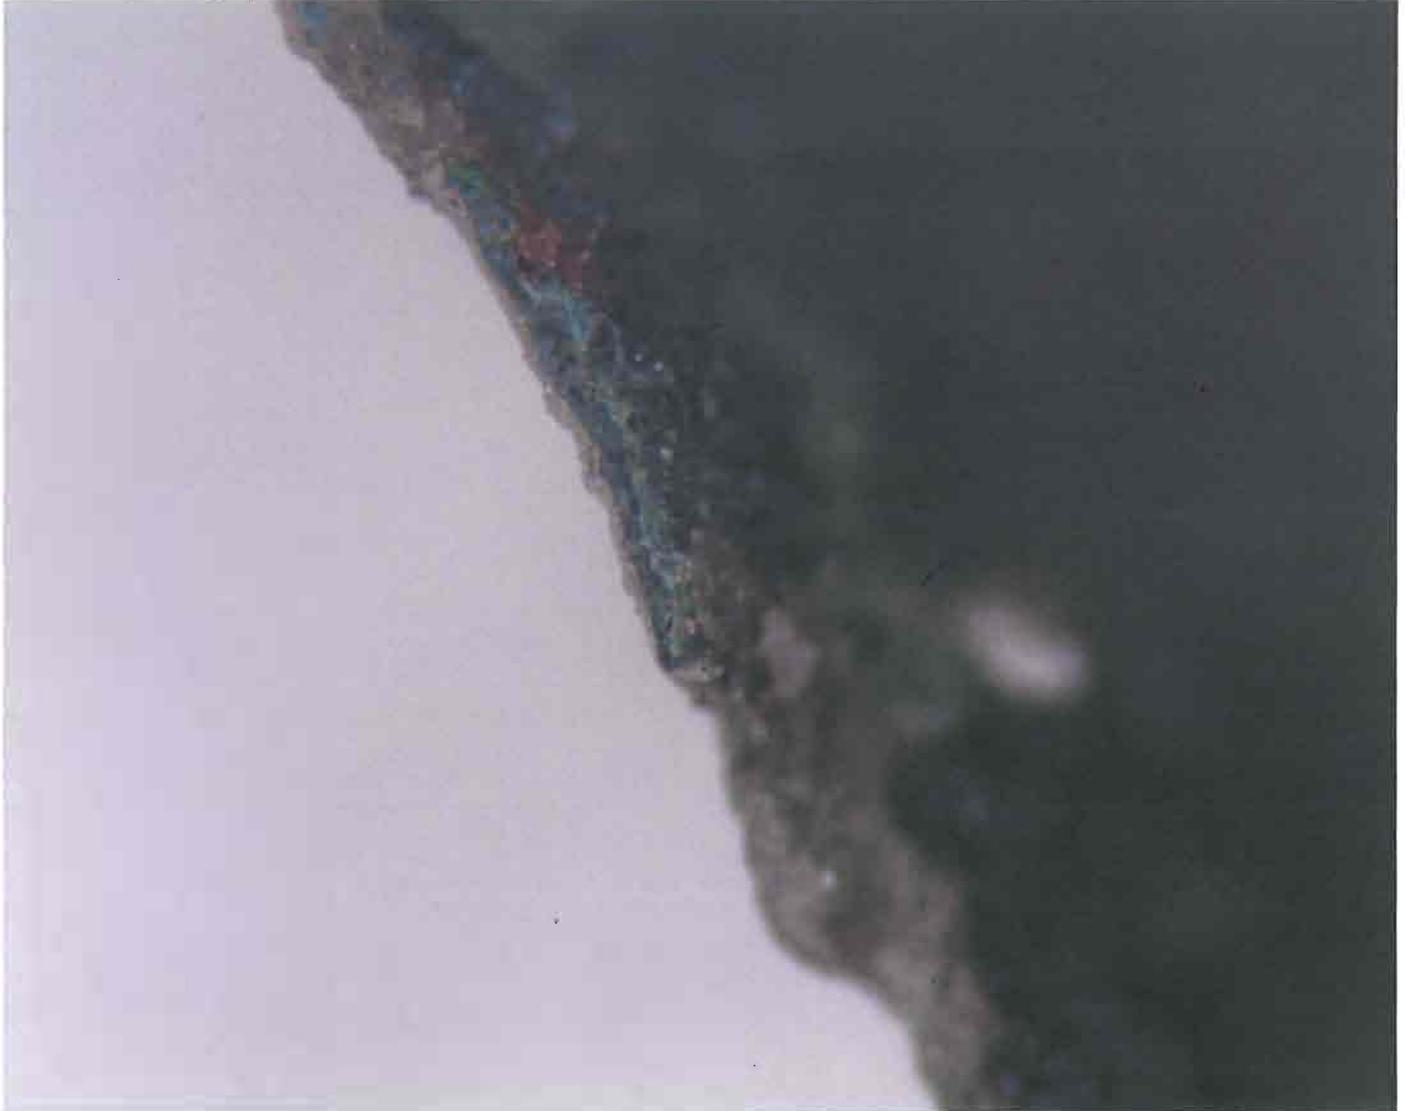
Element Code: Sample 9

Detail Photomicrographs:

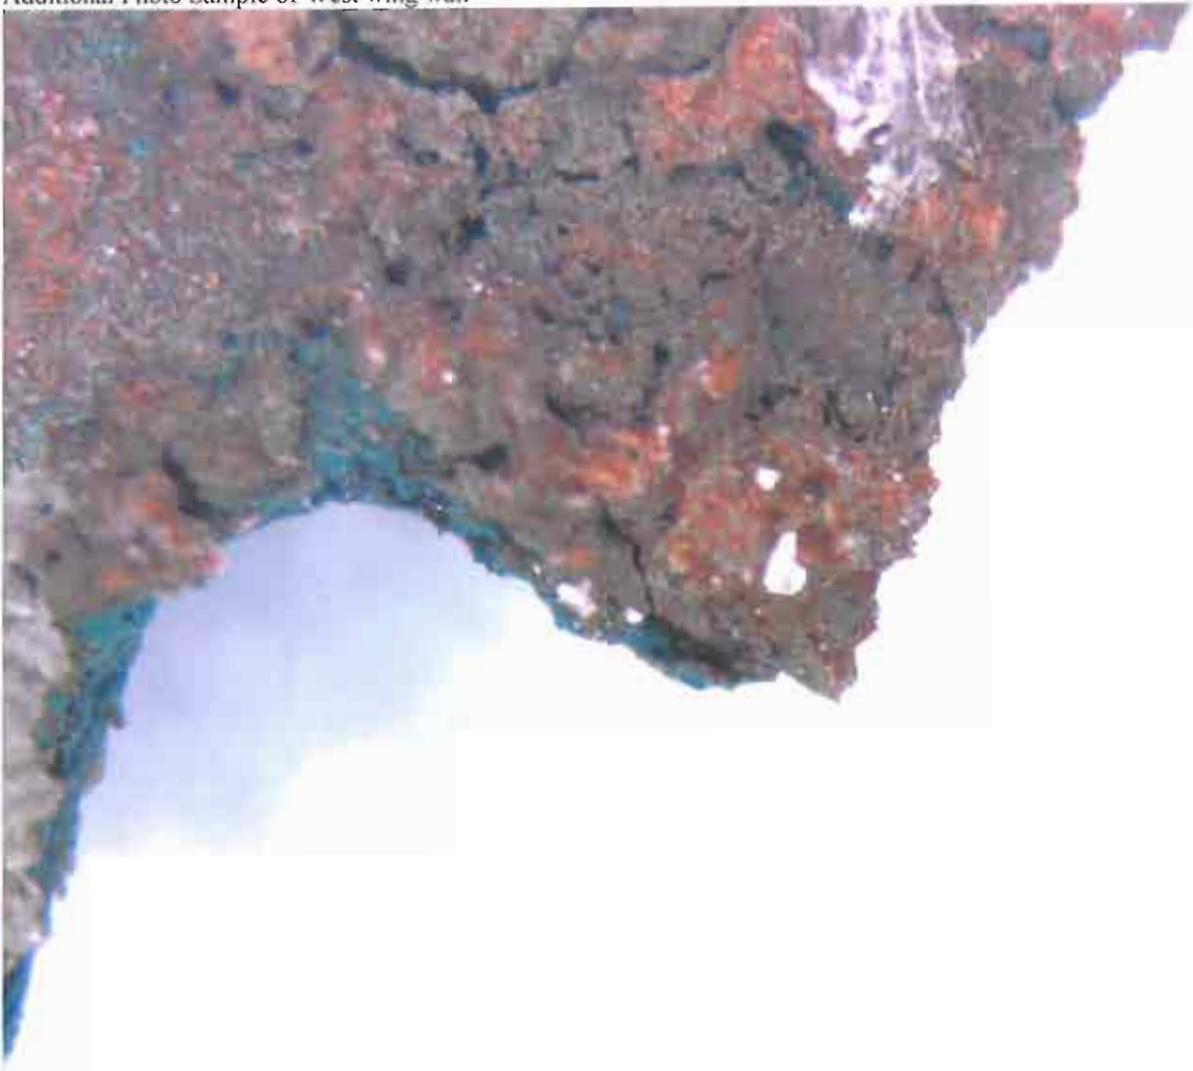
Additional Photo Sample of West wing wall

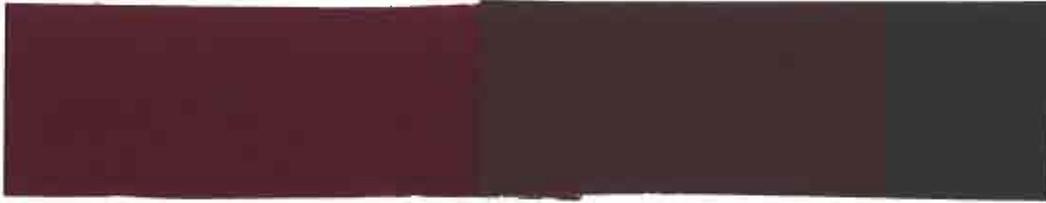
Location: East Elevation

Paint Layer Chronology	Hue & Chroma Notation	Binder	Finish
1. off white			
2. Aubergine	10 RP 3/6		
3. white			
4. red orange			
5.			
6.			
7.			
8.			
9.			
10.			
11.			
12.			
13.			
14.			
15.
