Runway and Taxiway Improvements
 San Antonio International Airport
 Bexar County, San Antonio, Texas

BORING LOCATION PLAN

CORE PHOTOS

Runway and Taxiway Improvements (2012)
San Antonio International Airport
San Antonio, Texas

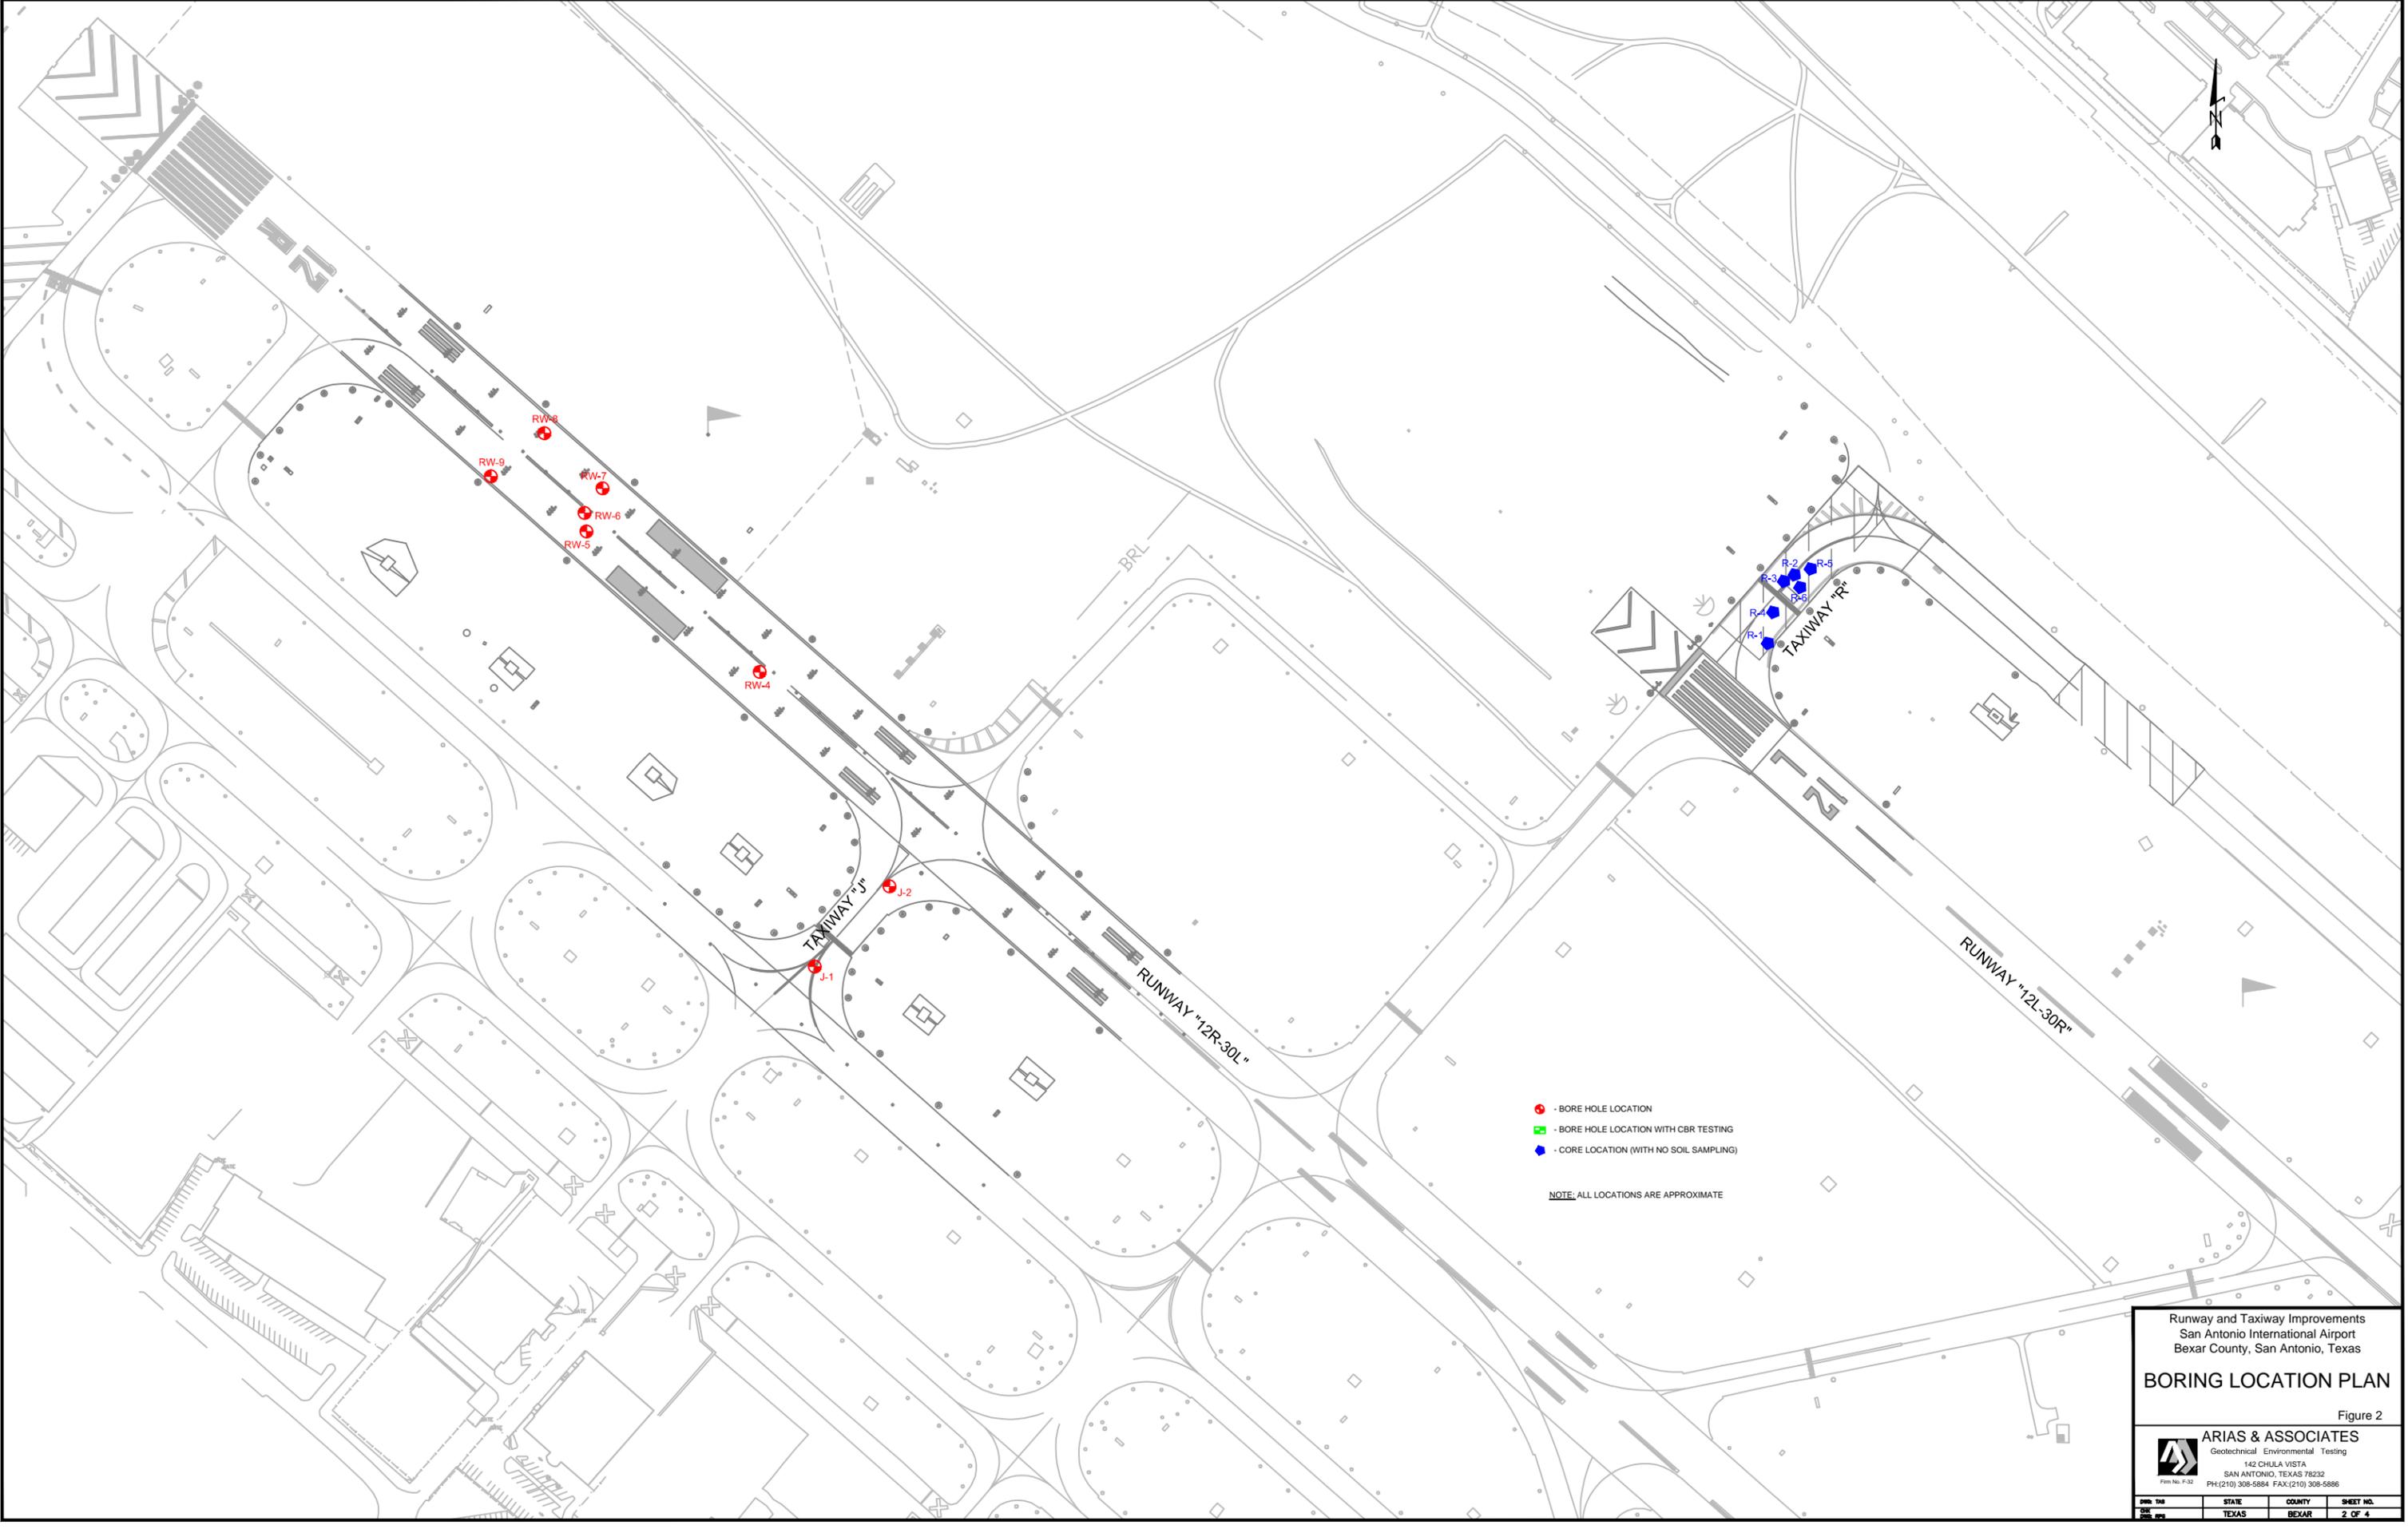
Figure 2

- - BORE HOLE LOCATION
- - BORE HOLE LOCATION WITH CBR TESTING
- - CORE LOCATION (WITH NO SOIL SAMPLING)

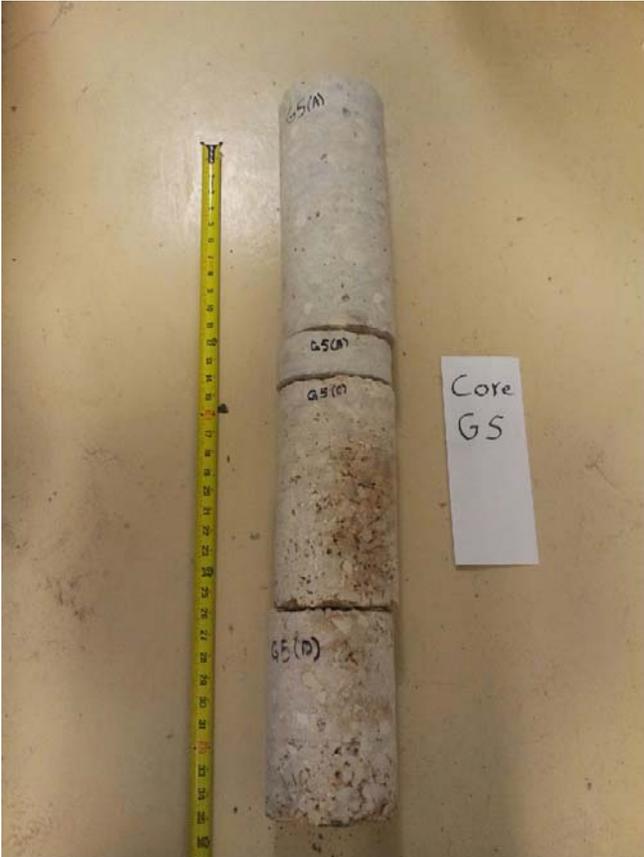
G5

CORE PHOTOS

Soil Description	Depth (ft)	SN	WC	PL	LL	PI	PP	N	DD	Uc
16.5" Concrete										
19" Cement Treated Base	2	CC								
FAT CLAY (CH), stiff, dark brown	4	SS	32					11		
	6	T	31				3.0		87	1.75
-with gravel below 6'										
LEAN CLAY (CL), very stiff, tan, with calcarous deposits	8	T	31	29	74	45	4.0			
	10	T	21				4.5+		110	4.41
Borehole terminated at 10 feet

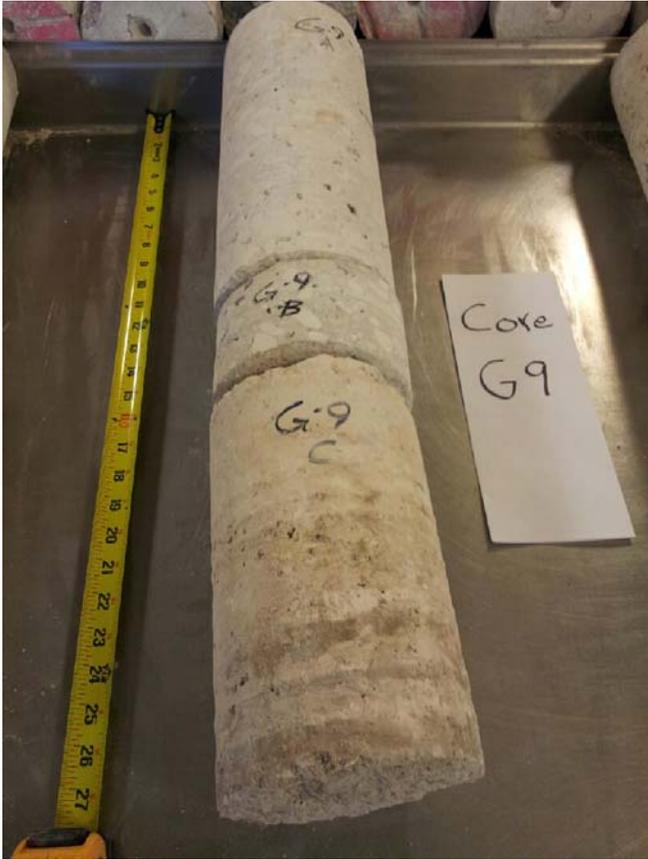
CORE PHOTOS

General Area Description	Boring No.	Approximate Concrete Thickness, inches	Sub-Base Description
Twy G	G1 and G2	17.5 to 18	20" to 24" CTB
	G3 thru G9	16.5 to 18	10" to 19" CTB
Twy J	J1 and J2	17	8.5" to 9" CTB
Twy N	N1 thru N 4	16 to 19	11" to 17" CTB
	N5 thru N8	16 to 17	2.5" to 3" HMA
Rwy 12R	RW 1 thru RW 3	15 to 16.5	3" to 3.5" HMA
	RW 4 thru RW 9	15 to 17.5	9" to 12" CTB
Twy E	F1, F2, E7	16 to 17	2" to 3.5" of HMA
	E8	16	10.5" CTB
Twy R	R1 thru R6	17 to 18	Subbase layer not observed

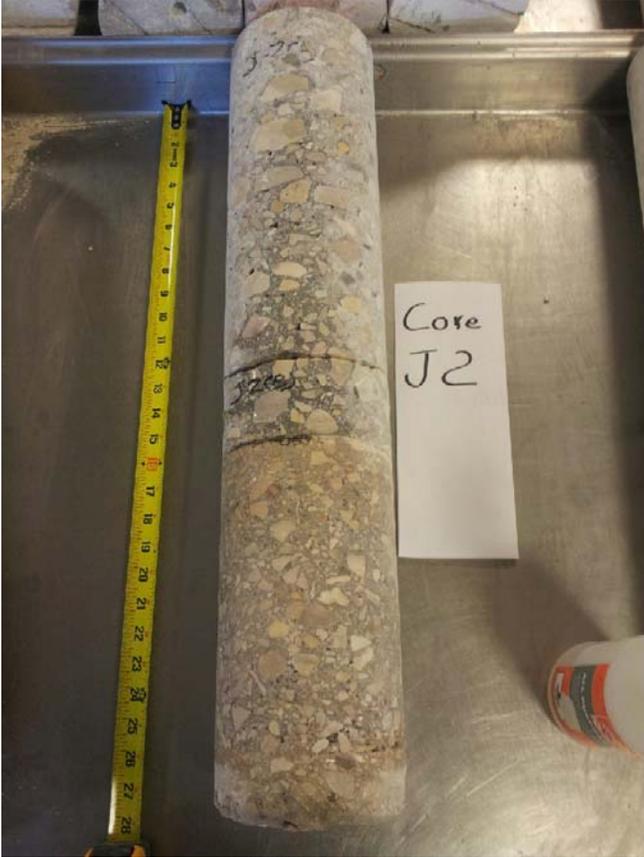
J2

CORE PHOTOS

Soil Description	Depth (ft)	SN	WC	PL	LL	PI	PP	N	-200	DD	Uc
17" Concrete		CC									
8.5" Cement Treated Base	2		11								
10" Crushed Limestone Aggregate Base											
FAT CLAY (CH), stiff, dark brown	4	SS	31					11			
		T	36				2.8			85	1.77
-tan and brown, with gravel, below 6'	6										
CLAYEY GRAVEL (GC), loose, tan and brown	8	T	19	23	69	46	3.3		60		
		T	22				4.3				
LEAN CLAY (CL), very stiff, light tan, with calcareous deposits	10										
Borehole terminated at 10 feet
