PLAZA DE ARMAS BUILDING ROOFING ASSESSMENT

SUBMITTED TO
CITY ARCHITECT'S OFFICE
ASSET MANAGEMENT DEPARTMENT
CITY OF SAN ANTONIO

JUNE 1, 2007

ROOFING ASSESSMENT

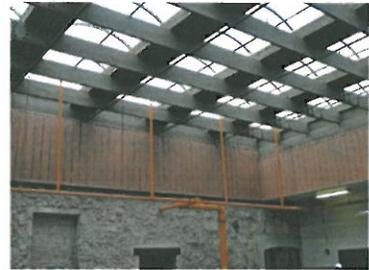
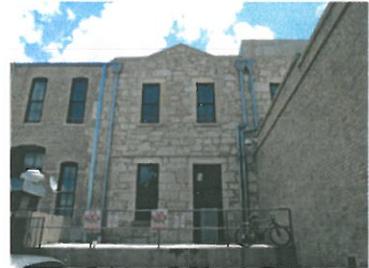
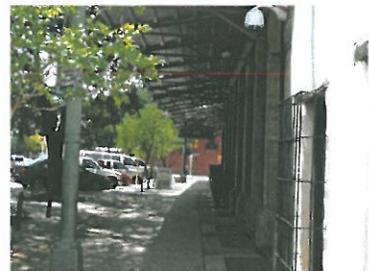
Existing Conditions Photos

Condition – Deterioration of granular roof surface, roof membrane, electrical panel stands as well as pitch pans. The roof area closest to the roof access has standing water. Metal flashing at skylights to roof are open and show signs of attempted repair. Areas around roof top curbs show signs of roof patch or repair. Electrical conduit at some locations is lacking proper anchoring, and wiring is exposed.

Replace all existing roofing, roof curbs and metal flashing. Create roof slopes as needed.

Replace all rusted kendorf for electrical panel stands and place all exposed electrical wire into conduit and on proper skids.

Cap all existing parapet roof conditions with sloped metal flashing.
