**LA VILLITA RESTAURANT RFP EXHIBIT 9
RESTAURANT (CATEGORY A & B) BUILDINGS
INFORMATION**

**MAVERICK PLAZA CONCESSION BUILDING
1982**

Bolivar Hall, c. 1939

Dosch-Rische House, c. 1880

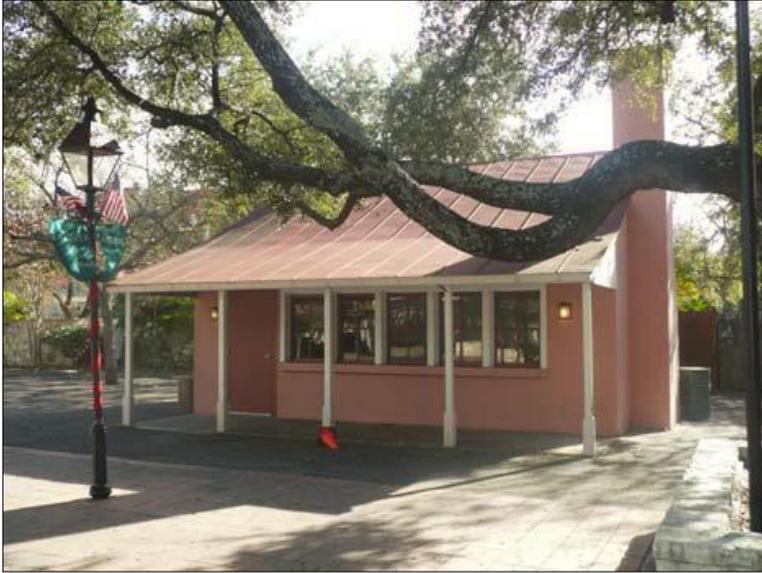
BUILDING 26

GENERAL ASSESSMENT RATING: 4-Good

Walls. Plastered and painted CMU walls are in good condition.

Roof. Metal roof appears to be in good condition.

Windows and doors. Good condition.

Ceilings. Stained wooden boards in good condition.

COMMENTS: Storage room contains shelving. Building could be expanded to south for more storage area.

Air-conditioning and heating. Not applicable, windows provide ventilation and operators reportedly bring portable fans to keep workers cool; permanent ventilation for worker comfort should be considered.

Plumbing. Kitchen sink with hot and cold water; drain reported to work well. Hot water provided by 6-gallon electric low-boy water heater. Ice bin drain functions, but foot pedal drain operator no longer works.

Electrical. Electrical appears to be in good working order. Counter-mounted receptacle near sink is not GFCI type.
