**RE: Forensic Study of Existing Foundation Components
Sterling Building
1432-1434 E. Commerce Street
San Antonio, Texas**

**THE STERLING BUILDING
1432 TO 1434 E. COMMERCE STREET
SAN ANTONIO, TEXAS**

PROJECT NO. ASR14-003-00

March 10, 2014

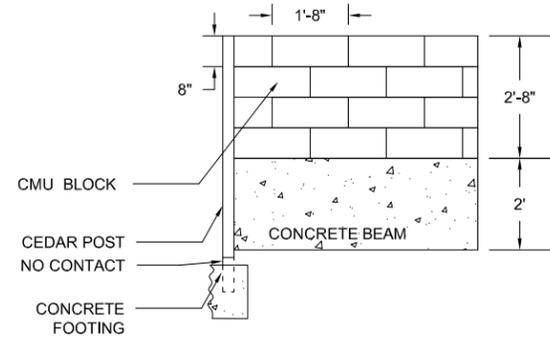
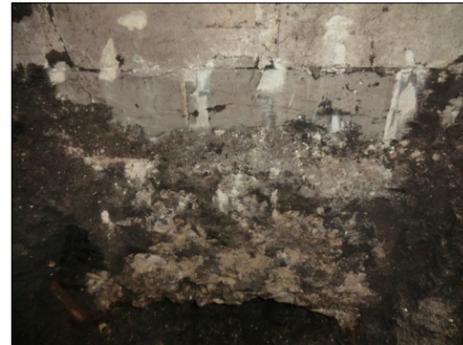
1 TEST PIT TP-1 (1432 E. COMMERCE)
SCALE: 1/4"=1'-0"

Test Pit TP-1 was excavated adjacent to the west wall of Suite 1432 to a depth of approximately 63-inches as shown in Photograph 1. Within this excavation, we observed foundation conditions that indicate Suites 1432 and 1434 have independent foundation systems.

- As observed from TP-1, the east wall of Suite 1434 is comprised of CMU block units that are supported on a 2-ft deep continuous concrete grade beam as shown in Photographs 1, 2, and 3. Each block is 20-inches long by 8-inches wide by 8 inches tall.
