RE: Frost National Parking Garage
San Antonio, Texas 78220

At the request of Mr. Dean Alderson, P.E. and with your approval, R-S-C-R, Inc. is pleased to provide you with the following structural report for the above referenced property. The purpose of this report is to provide a professional opinion as to the general condition of the property referenced above. This office conducted a site visits on June 15 and June 18, 2015. During this site visits; observations were performed on the Parking Garage and office building. Observations were generally performed on each level of the parking garage, including the cooling tower and the basement. Observations of the office building were performed where accessible areas existed; the eighteenth floor and mechanical level. Photographs were taken during the site visit. We also reviewed existing drawings provide by Frost National Bank. Since the occupancy and use of the building and parking garage will not change, a structural analysis and additional testing is not required for this report.

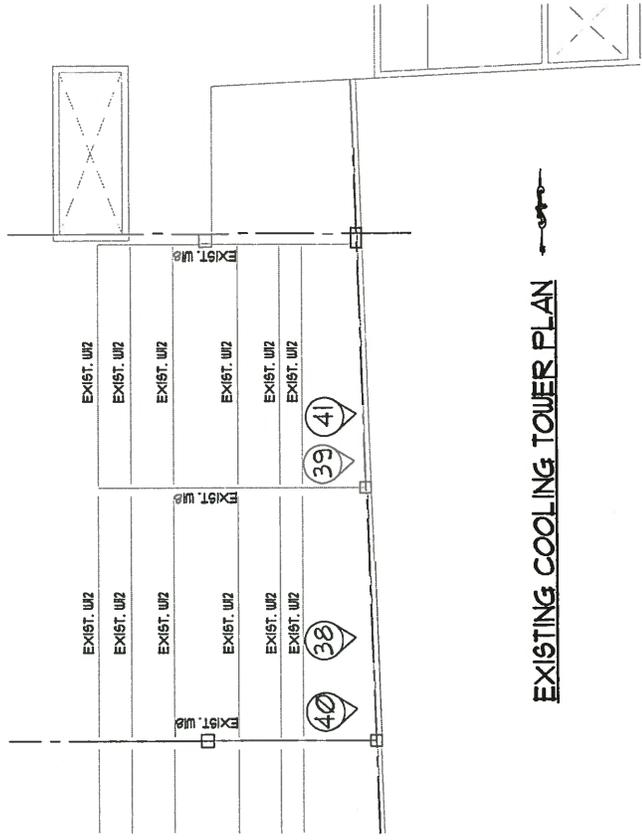
EXISTING COOLING TOWER PLAN

- Photographs 38 through 41 were taken of the cooling tower structure on top of the parking garage. They show oxidation occurring on the steel members. We recommend these areas be cleaned and repainted.

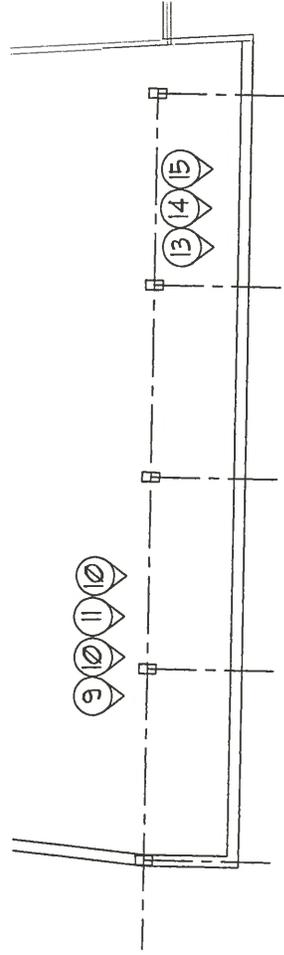
PARTIAL FOUNDATION PLAN

- Photographs 9 through 15 were taken in the basement. They show damage done to the slab and exposed reinforcing steel. We recommend repair of the slab and replacement of reinforcing steel, if required.
