**LA VILLITA RFP – EXHIBIT 11**  
**CATEGORY C – RETAIL SHOPS**  
**BUILDING INFORMATION**

**BUILDING 3**

**Hessler House, c. 1870**

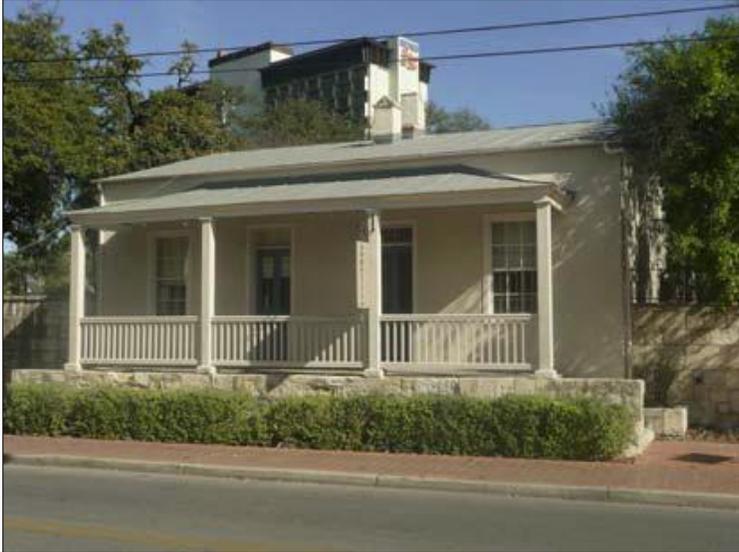
**GENERAL ASSESSMENT RATING: 3-Fair**

**Walls.** Masonry walls in good structural condition but plaster in poor condition. Plaster at south wall is mainly not adhered to masonry.

**Porch.** The front porch is limestone with brick paving; limestone is deteriorating and some of the paving is losing its mortar. Porch floor requires significant masonry repairs; otherwise, a wooden porch similar to the one at Building 7 should be built to replicate this building's original porch. Columns and railing in good condition.

**Roof.** Metal roof in fair condition. Repaint.

**Windows and doors.** Wooden windows and doors in fair condition but require repairs.

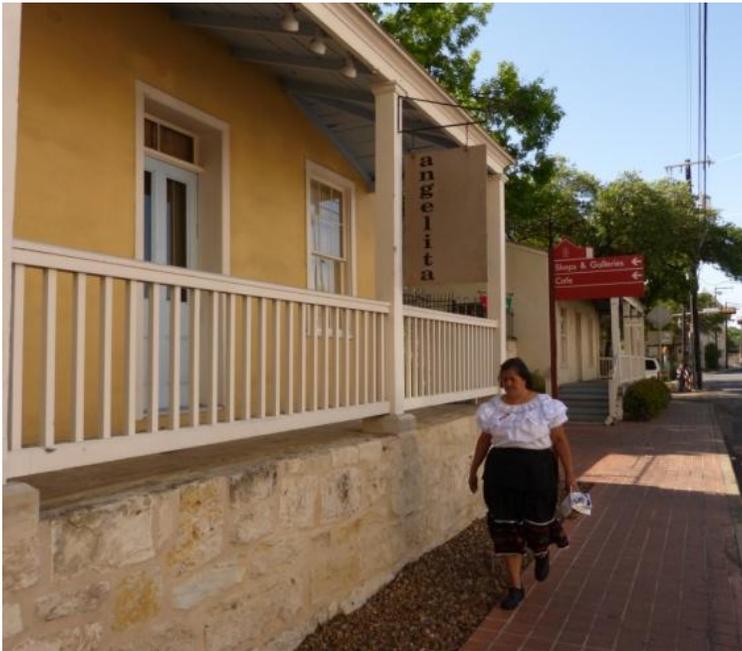
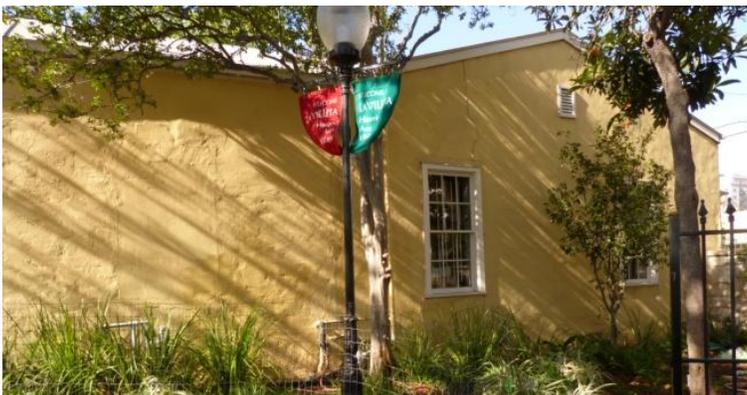
**Floors.** Combination of painted concrete, painted wood, and clay tile. Good condition.

**Ceilings.** Painted beaded boards. Some peeling of paint indicating possible roof leak, condensation problem, or heat-related issue.

**Walls.** Walls have been replastered with what appears to be an appropriate lime-based plaster. Moisture is causing some flaking in at least two spots. General appearance is good.

**COMMENTS.** House contains handsome original fireplace and wooden mantle. Good external condition.

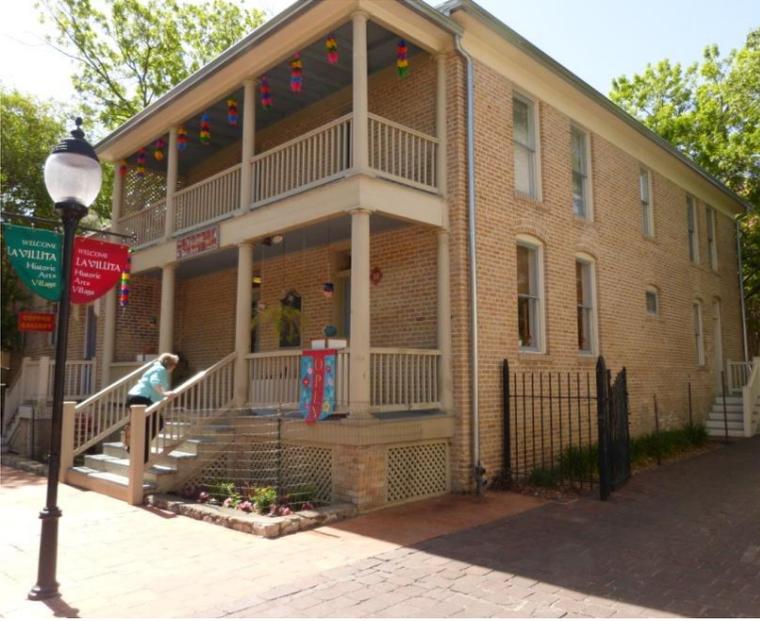
**BUILDING 10**

**Walls.** Brick walls repointed in 1982. In good condition, but an area on the west wall needs repointing. Brick is being repointed. Two-story wooden porch in good condition; decking requires repairs at first level and replacement at second level. Several columns need repairs or replacement. Deteriorated wood siding has been replaced.

**Roof.** In good condition.

**Windows and doors.** Wooden window frames and sash need general repairs and repainting. Three windows and door in stairwell should be replaced. Windows into basement have been repaired.

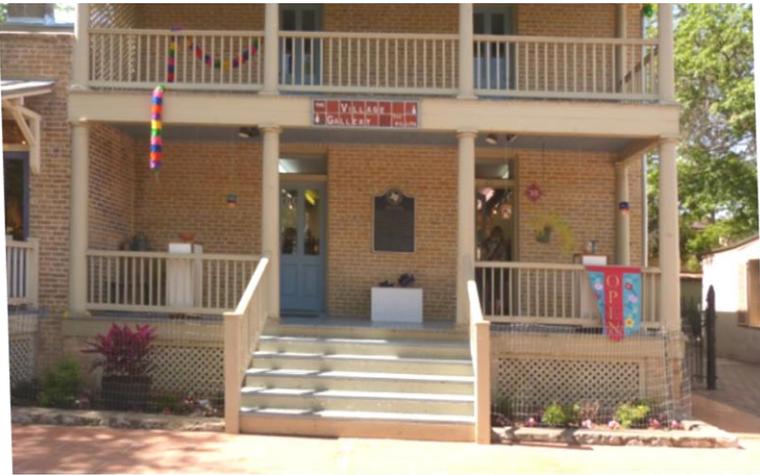
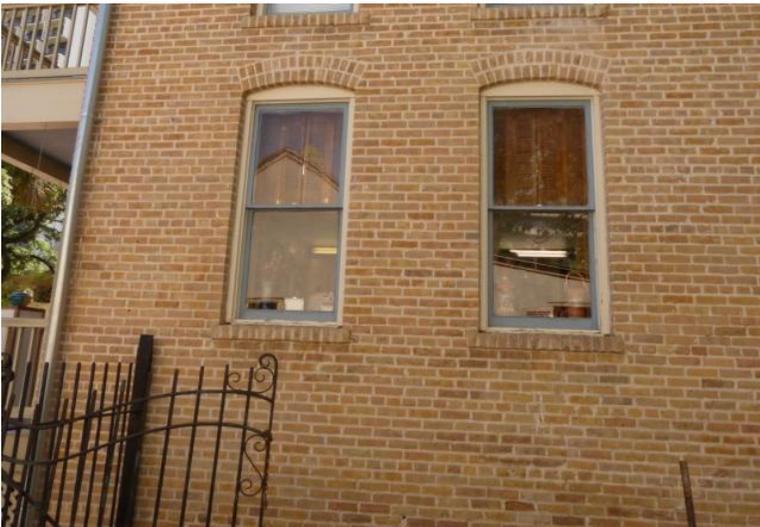
**Floors.** Pine boards in good condition but need to be revarnished or covered for preservation.

**Ceilings.** Painted gypsum board in good condition.

**Walls.** Painted plaster, painted gypsum board, painted brick, and painted siding in good condition.

**COMMENTS.** Rear doors have water damage. Doors need to be properly sealed, glazed, and painted or replaced. Oleanders should be removed from the planting bed along King Philip V Street and replaced with paving on a sand base to prevent further damage to masonry walls.

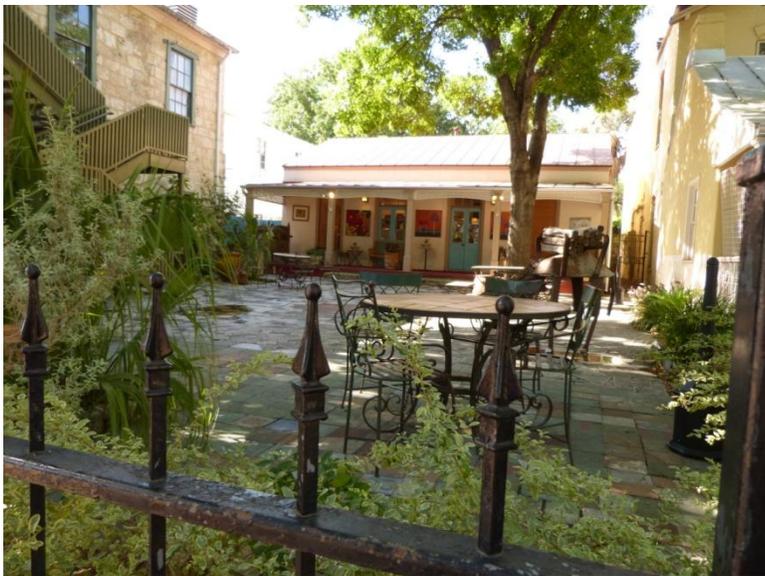
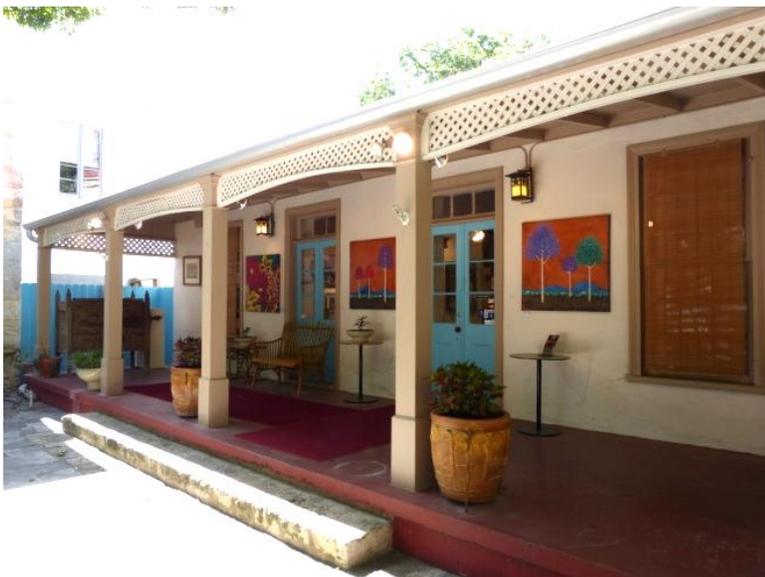
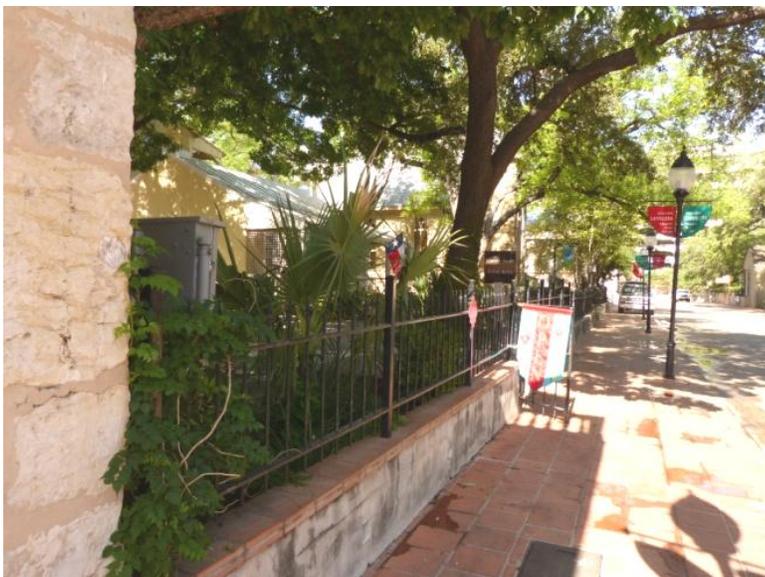
**Air-conditioning and heating.** Single five-ton chilled water cooling/electric heating fan-coil installed in 2006 would not adequately cool and heat this two-story space if not for a window unit installed in one of the upstairs rooms. The upstairs restroom does not have an exhaust fan.

**Plumbing.** Tank toilet and cold-water-only sink in a private restroom intended for tenants' use only. The toilet does not adequately flush toilet paper without regularly clogging. The cold water sink faucet drips.

**Electrical.** Several disconnects do not appear to have adequate clearance. First-level panel board appears modern and in good working order. Panel board on second level appears to be in working order but is an older model. It may become increasingly difficult to acquire new circuit breaker replacements.

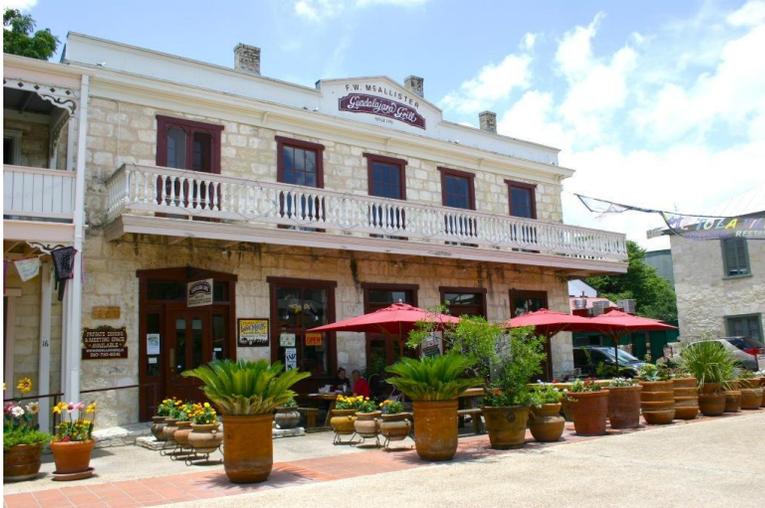
**Air-conditioning and heating.** Building is served by a five-ton residential gas furnace with duct-mounted chilled water coil, both located in the attic accessible through the storeroom. Presence of supplementary wall air-conditioning unit in a back room and conversation with tenant indicates capacity of the chilled water cooling/electric heating system in attic is insufficient. Front room temperature said to sometimes reach 95°F. Restroom exhaust fan does not work. A sign on the fan “on-off” switch indicates it nearly started a fire when it was once operated.

**Plumbing.** Toilet and cold-water-only sink in this private restroom are adequate.

**Electrical.** Exit signage did not appear to have means of illumination during power outage. Panel board appears to be in working order but is an older model and it may be increasingly difficult to acquire new circuit breaker replacements.

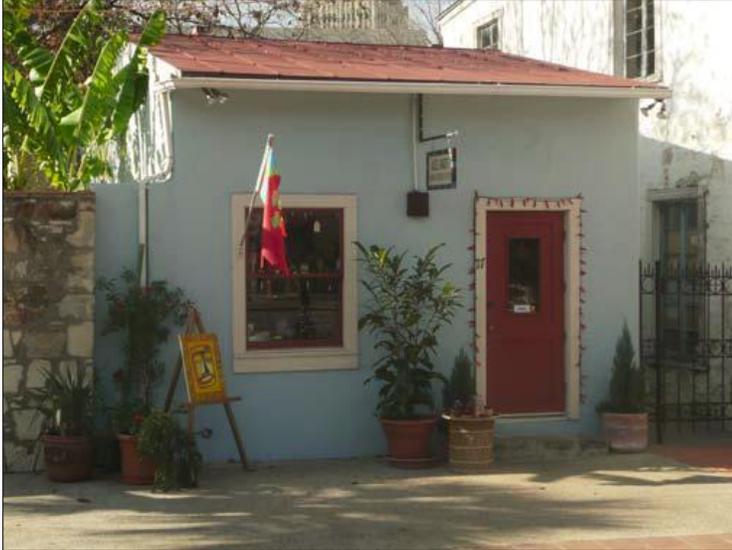
**Air-conditioning and heating.** Space served by single chilled water cooling/electric heating fan-coil that is said by tenant to be sufficient. The system brings in no outside air.

**Plumbing:** Toilet and cold-water-only sink in back room. Tenant says corner sink doubles as a receptor for primary condensation from air-conditioning unit.

**Electrical.** Interior panel board is modern and in good working order but does not have adequate front working clearance.

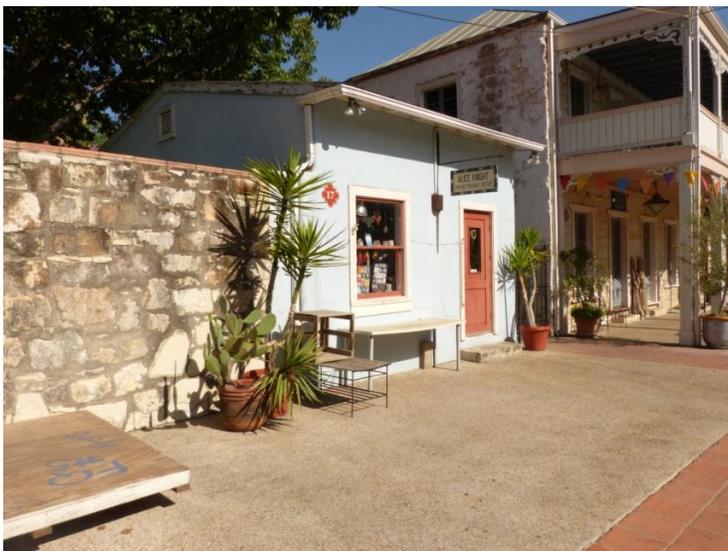
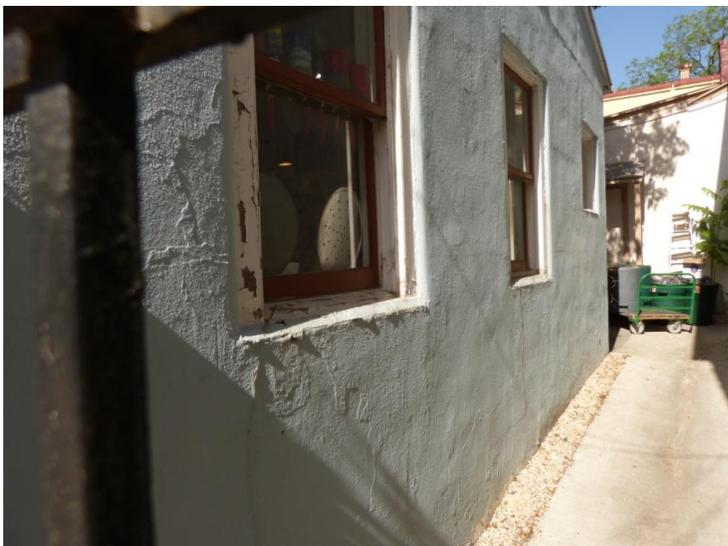
**Plumbing.** The private restroom has a toilet and cold-water-only sink. The sink is said to leak at times and should be replaced. Sometimes the toilet leaks at the wax ring when floor bolts come loose.

**Electrical.** Panel board appears to be modern and in good working order but front access is blocked by built-in cabinets.
