## **STRUCTURAL ASSESSMENT**

**Project:** 1432-1434 East Commerce St. **Job. No:** 122200  
**Location:** San Antonio, TX  
**Date:** Dec. 10, 2012 **Weather:** Sunny,  
Windy, 60 deg  
**Performed by:** Jeff Houghton and Frank Lamas,  
Alpha Consulting Engineers, Inc.

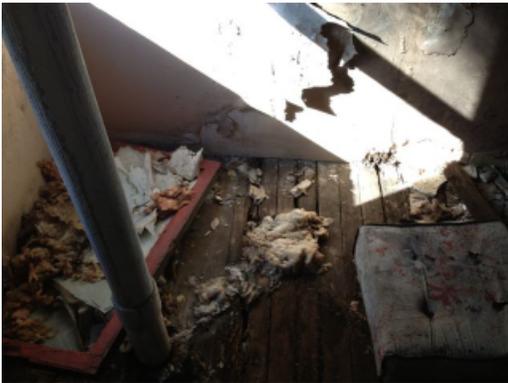
Fig. 1

Due to the long period of vacancy of the buildings and corresponding lack of maintenance, the interior and exterior finishes are, in general, in an extreme state of need of repair. In general, broken or missing windows and doors in addition to numerous roof leaks have severely damaged surrounding trim as well as ceiling and wall finishes. Wood floor boards are also rotted in isolated conditions due to open windows and roof leaks (See Figs. 1 and 2). The main structural components, however, appear to be less affected by water except as mentioned in this report. All exterior windows, doors and associated frames and trim are in need of replacement.

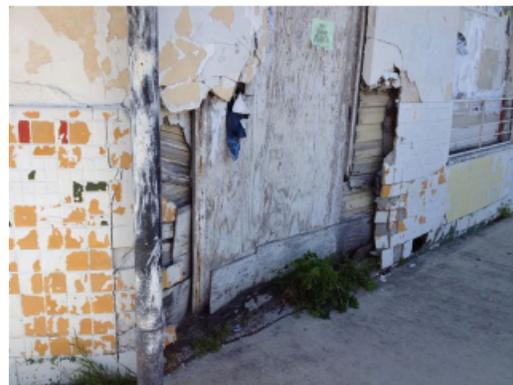
Fig. 10

There is severe distress in the exterior finished wall cladding at the north east end of the building. It appears that this location has been subject to vertical foundation movement and a large crack is located at the north wall (See Fig. 9). The cladding at this location is ceramic tile over stucco. There are no contraction joints along any walls to relieve any stress from movement and stucco being a rigid, low strength material, will tend to yield under relatively small movements. On the other hand, the wood framing components are more forgiving and can withstand greater movement without distress. The interior plaster walls at this location do not show signs of distress which also suggest to us that the structural framing is not damaged. The base of the walls at this location is also showing signs of bowing outward suggesting an upward pressure (See Fig.10). Such pressure likely came from vertical movement of the adjacent sidewalk responding to the subgrade taking in moisture.
