LA VILLITA RFP – EXHIBIT 10
CATEGORY B – GALLERIES
BUILDING INFORMATION

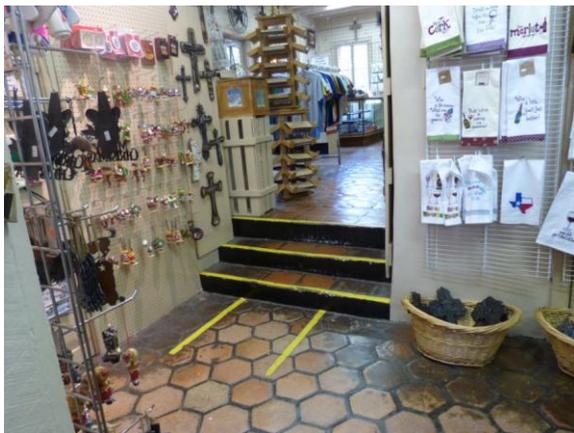
Building 2-Stairs into side gallery

COMMENTS. Accessible only at rear entrance; stairs within the house. Firebox and windows are covered with display

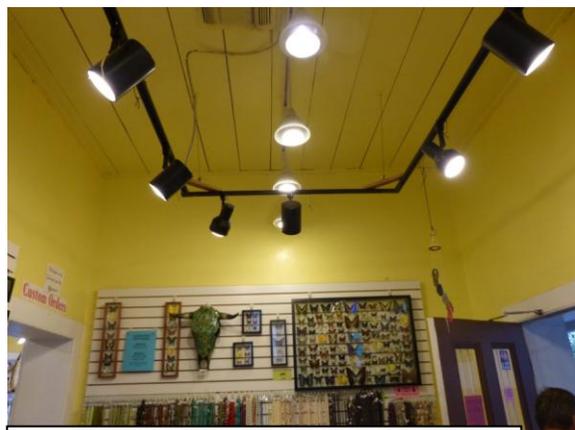
Building 7-Ceiling/Wall fixture

Ceilings. Painted boards at rear room in good condition. Front room has a painted Celotex fiberboard ceiling that is inappropriate and should be replaced with a proper material.

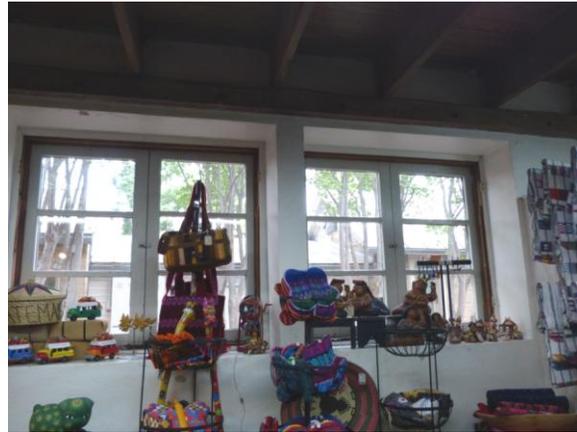
Building 8—Windows

Windows and doors. Windows and doors have been replaced or repaired.

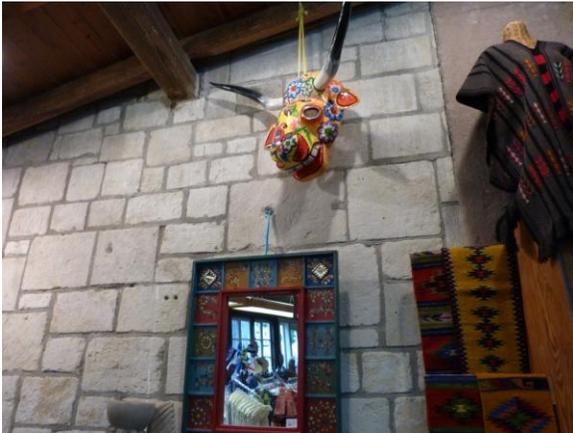
Building 8— Wall near window

Walls. Painted plaster in fair condition with deterioration at north wall and elsewhere.

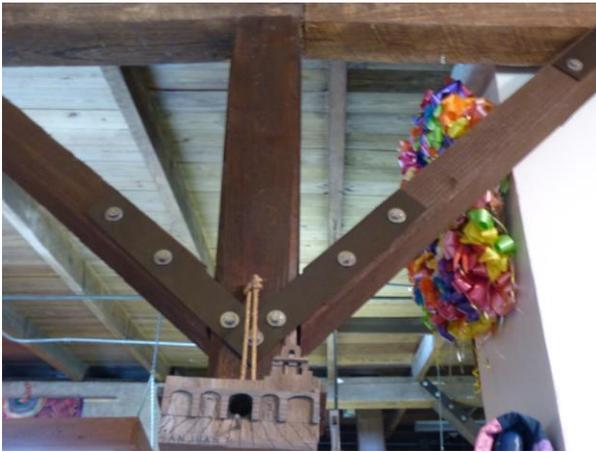
Building 8—Ceiling joist

Ceilings. Exposed beams and underside of roof decking. Beams have been replaced.

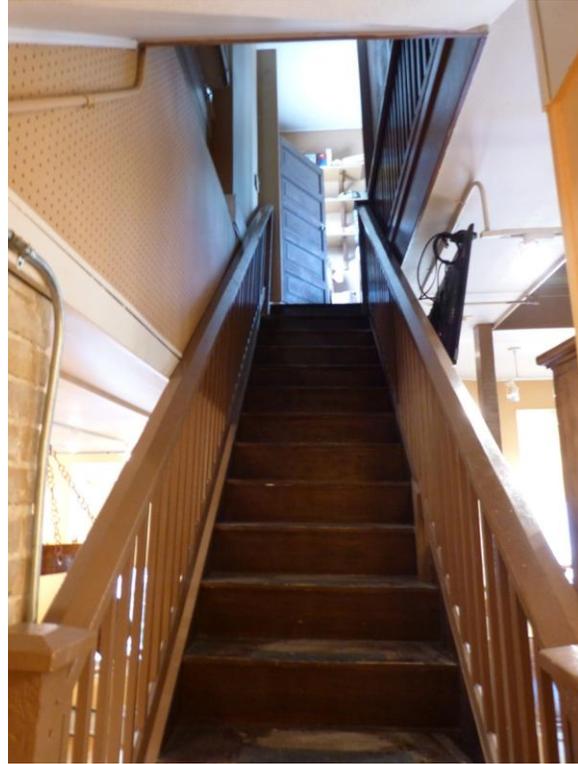
Building 11-Staircase

Building not ADA accessible because of raised floor at retail level. Second level (offices and work areas) only accessible by stairs.
