EXECUTIVE SUMMARY

Plaza de Armas

Culture and Creative Center

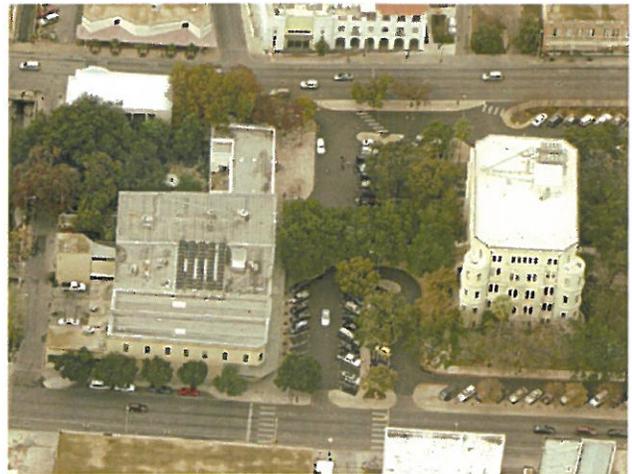
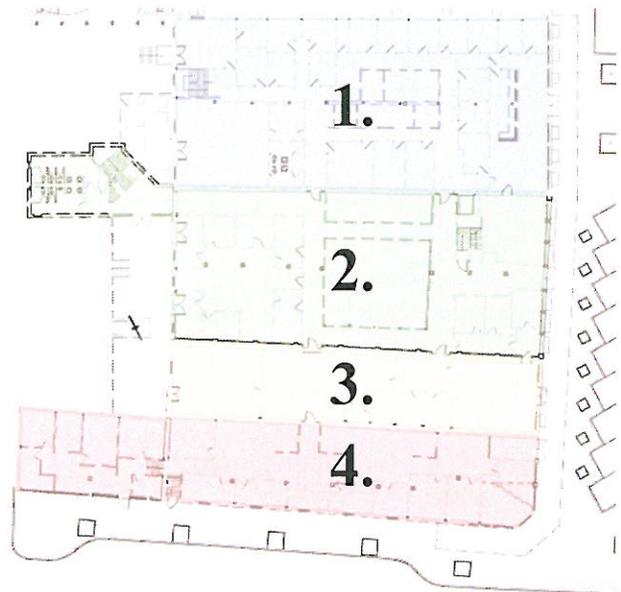
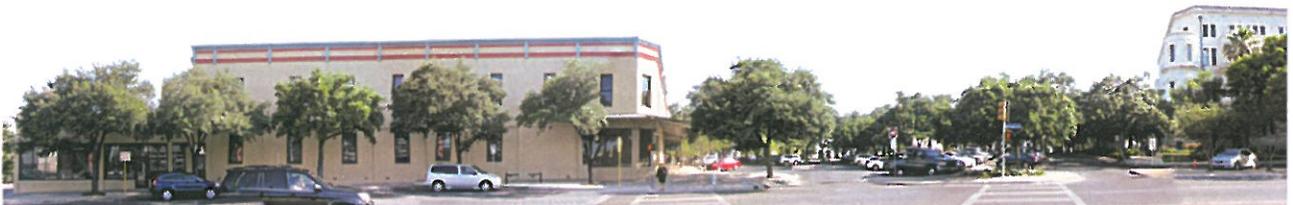
Numbering of Buildings for Reference

The Plaza de Armas Building complex is composed of four separate, linked buildings that share common demising walls, a common elevator, mechanical, electrical and plumbing systems as well as an automatic fire sprinkler system. In this report for clarity, the buildings have been numbered – one through four- beginning with the northern most building adjacent to the Spanish Governor’s Palace being Building #1 and the southernmost building adjacent to Dolorosa Street being Building #4.

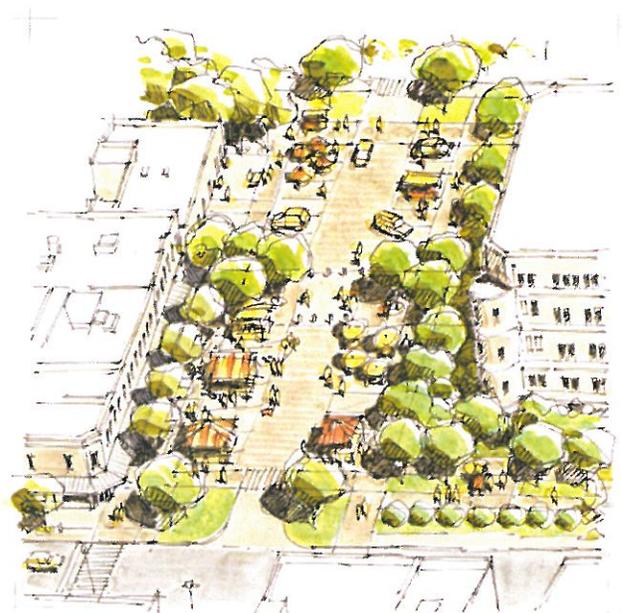
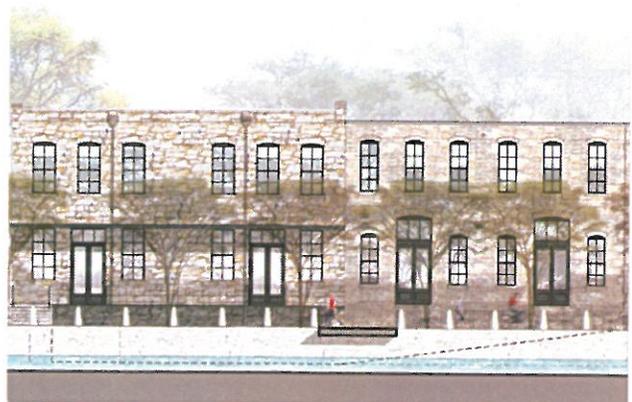
a cohesive and attractive design, that could serve both as parking and as a multi-use plaza venue for outdoor events. We are also recommending that the west side of the site be improved with the addition of a new courtyard which will bring natural day light and circulate air into the basement level as well as provide space for outdoor performances and art exhibits. We also believe that the Plaza de Armas should be linked to the courtyard of the Spanish Governor's Palace to take advantage of a beneficial relationship to both sites.
