PROJECT MANUAL

HISTORIC HOMES STABILIZATION AND REHABILITATION

ARCHITECT'S PROJECT NO. 1312 A1

BID DOCUMENTS
JULY 2, 2014

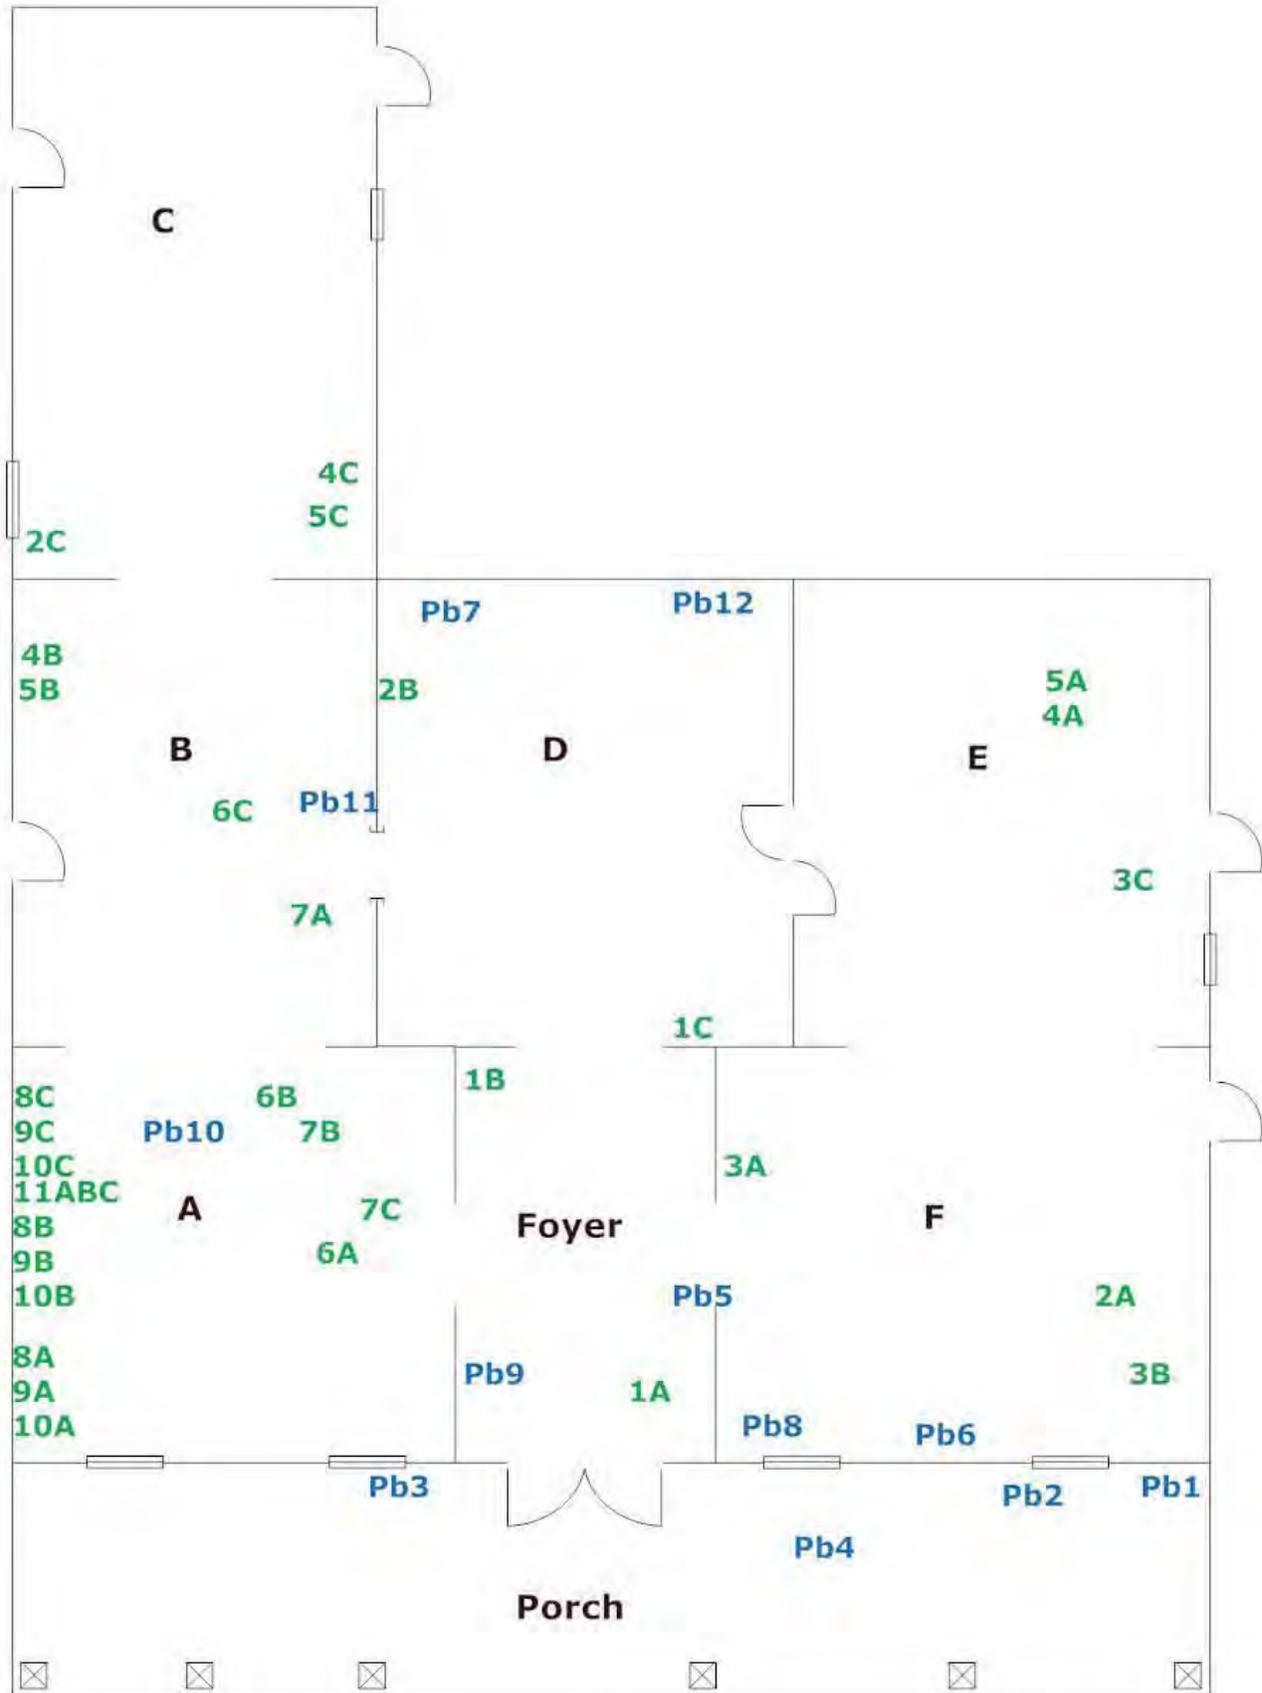
Sweney House #301

Blue - Lead Sample Locations

- Attachments:
- 1) EMSL Analytical, Inc.'s EPA 600 PLM Asbestos Sample Results 8/22/2013
 - 2) EMSL Analytical, Inc.'s Lead-Based Paint Sample Results 8/21/2013
 - 3) Floor Plan indicating sample locations

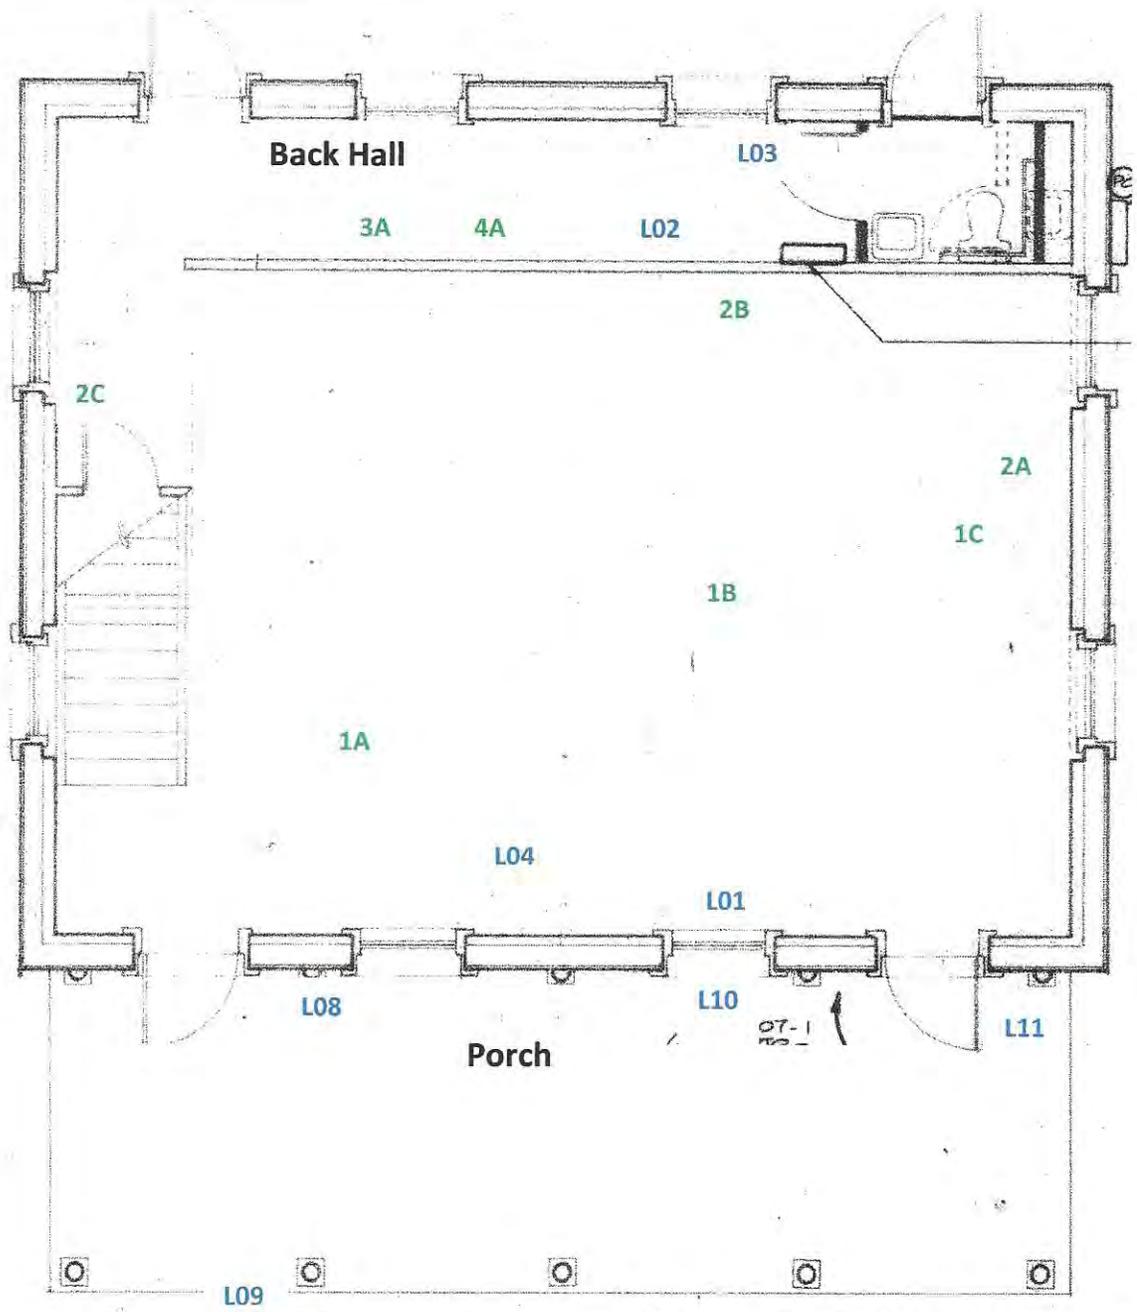
Schultze House #307

Legend
Green – Asbestos Sample Location
Blue – Lead Sample Location

1 First Floor Plan - E
E-4 1/4"=1'

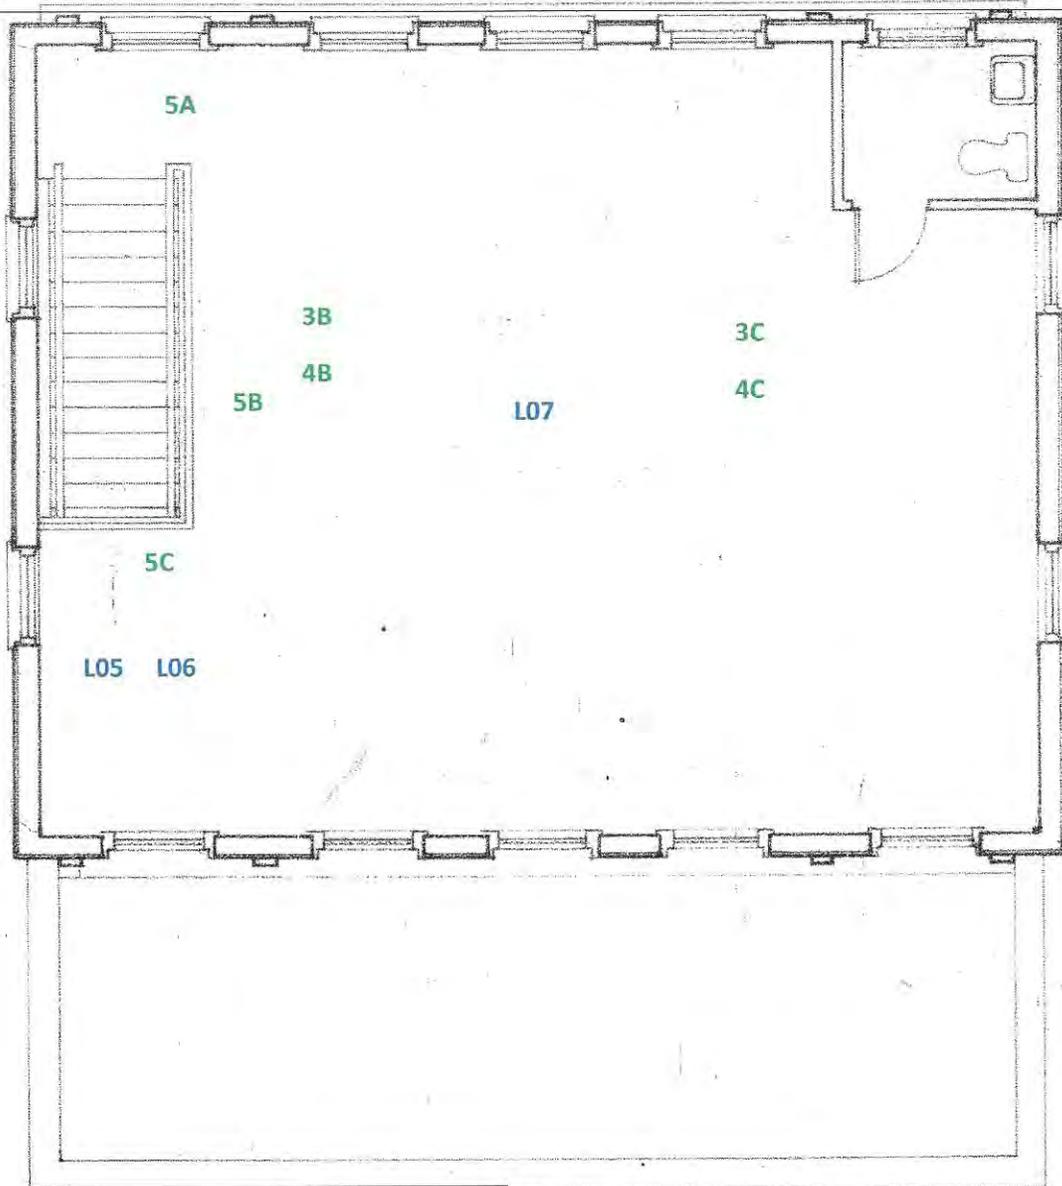
Schultze House #307

Legend
Green – Asbestos Sample Location
Blue – Lead Sample Location

Second Floor Plan
1/4" = 1'

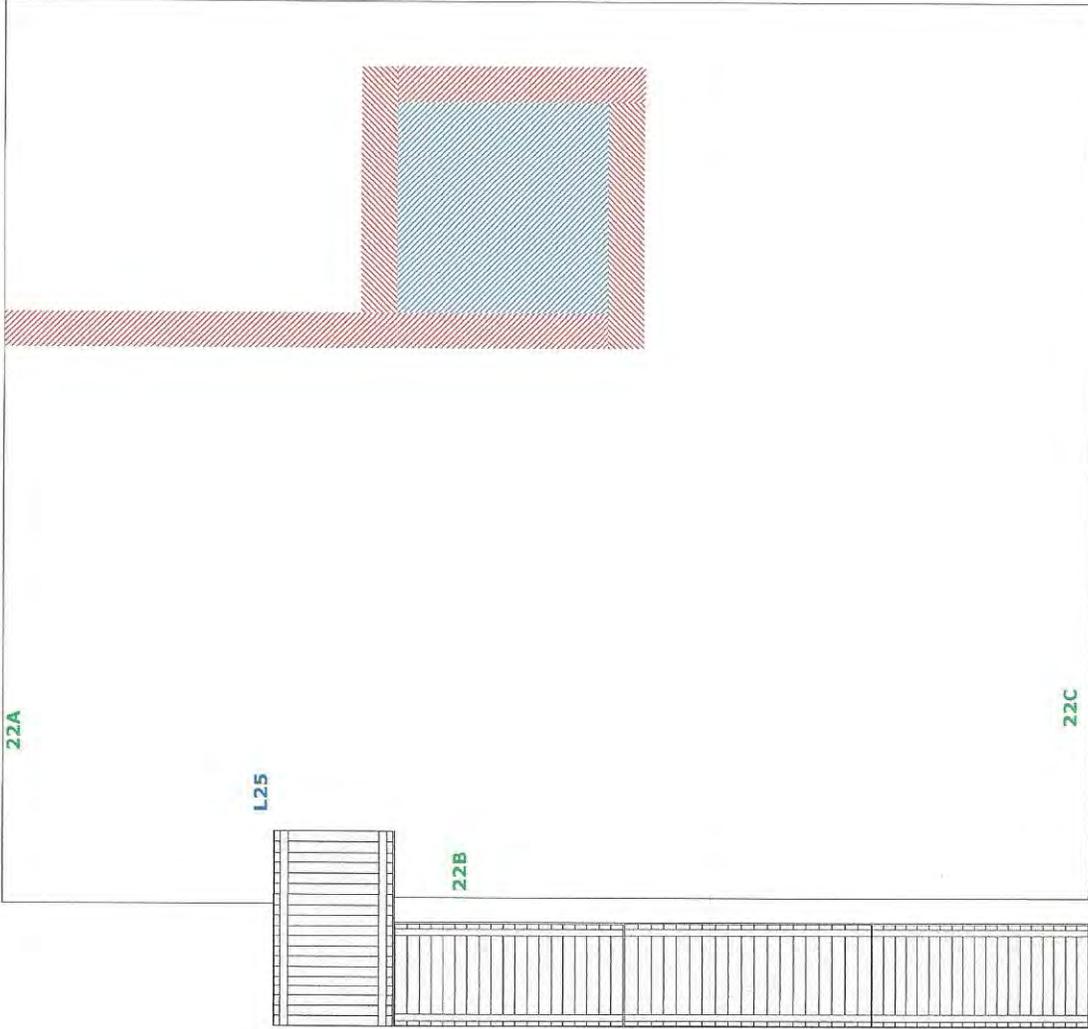
Mayer/Halff House #308 - Basement

- Green - Asbestos Sample Location
- Blue - Lead Sample Location
- Red Hatched - ACM Cream/white Thermal System Insulation (TSI): wrap, mastic, and yellow insulation
- Blue Hatched - ACM Black pipe mastic

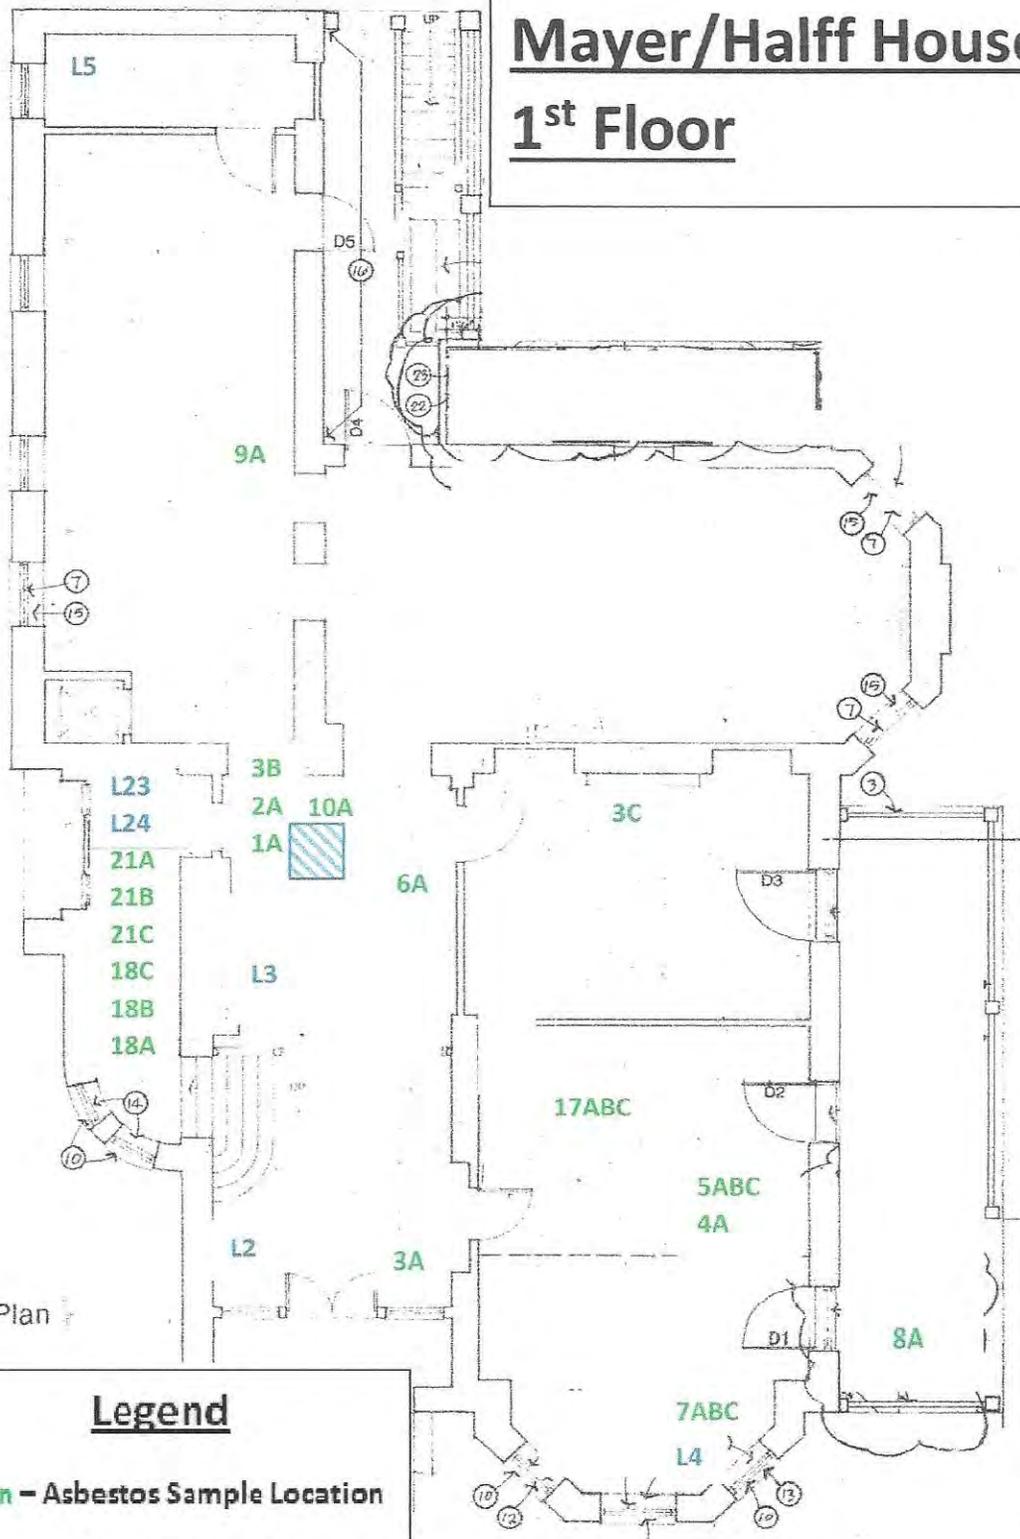
Mayer/Halff House #308 – 1st Floor

First Floor Plan
1/4" = 1'

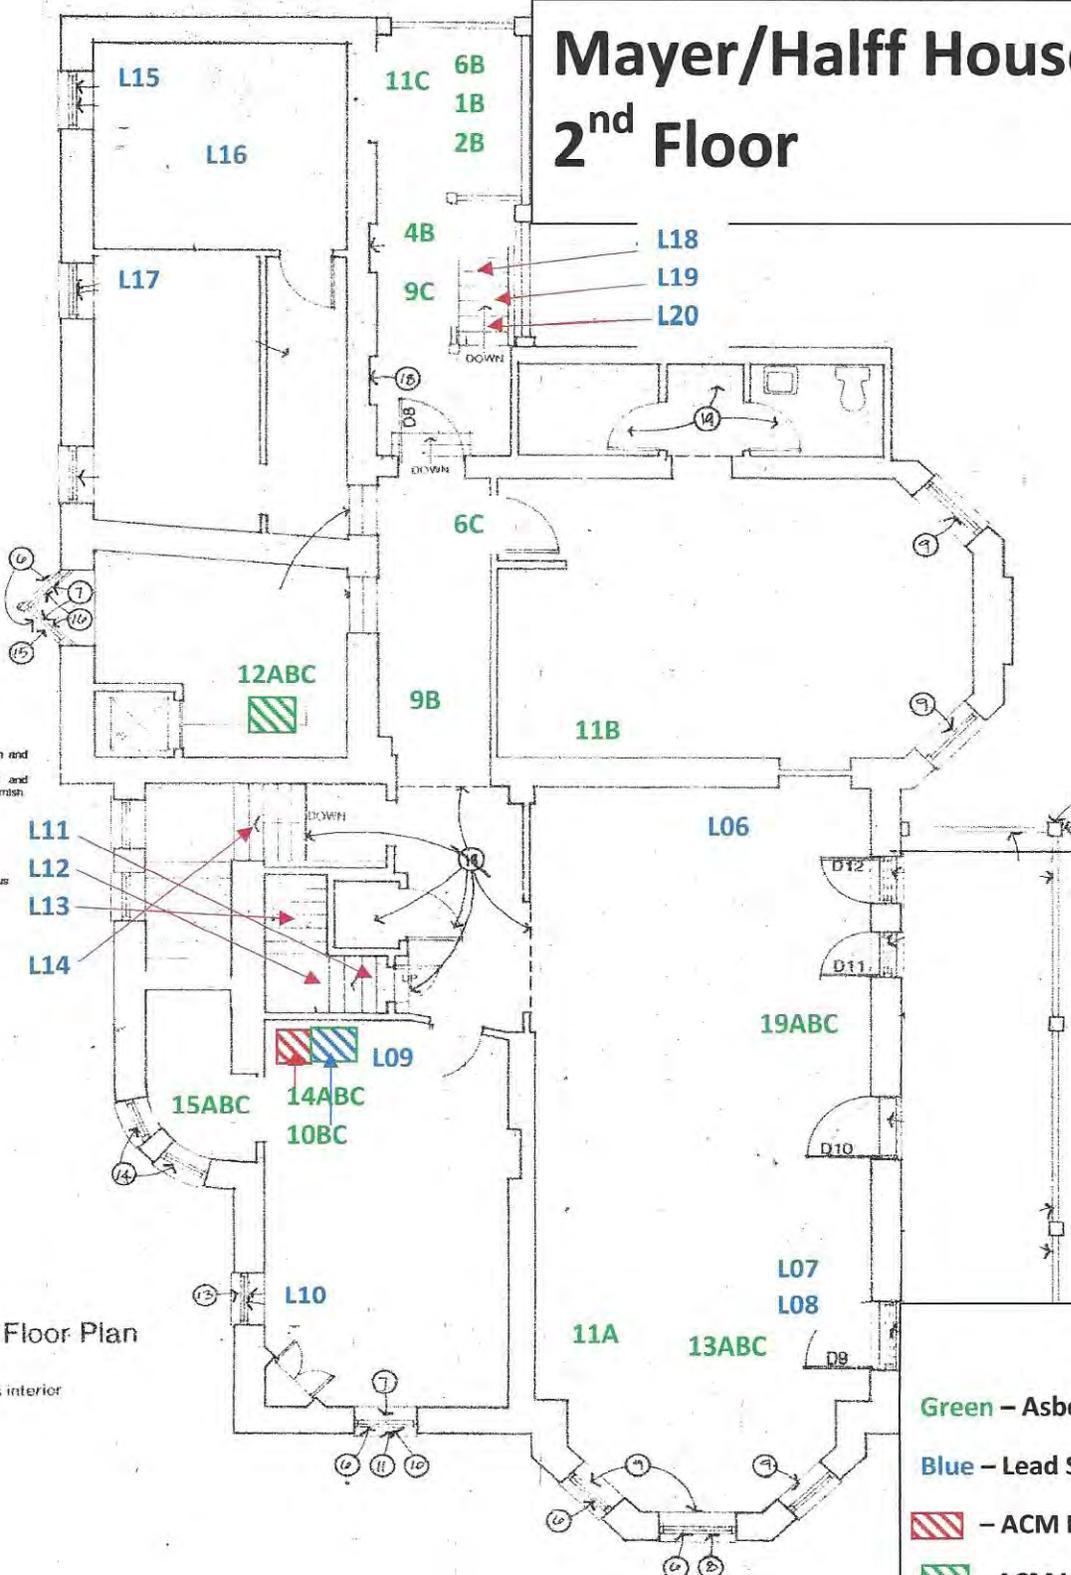
1 Second Floor Plan
1/4" = 1'

- Green – Asbestos Sample Location
- Blue – Lead Sample Location
- ▨ – ACM Black pipe mastic
- ▨ - ACM White sink undercoat
- ▨ - ACM Cream/white Thermal System Insulation (TSI): wrap, mastic, and yellow insulation

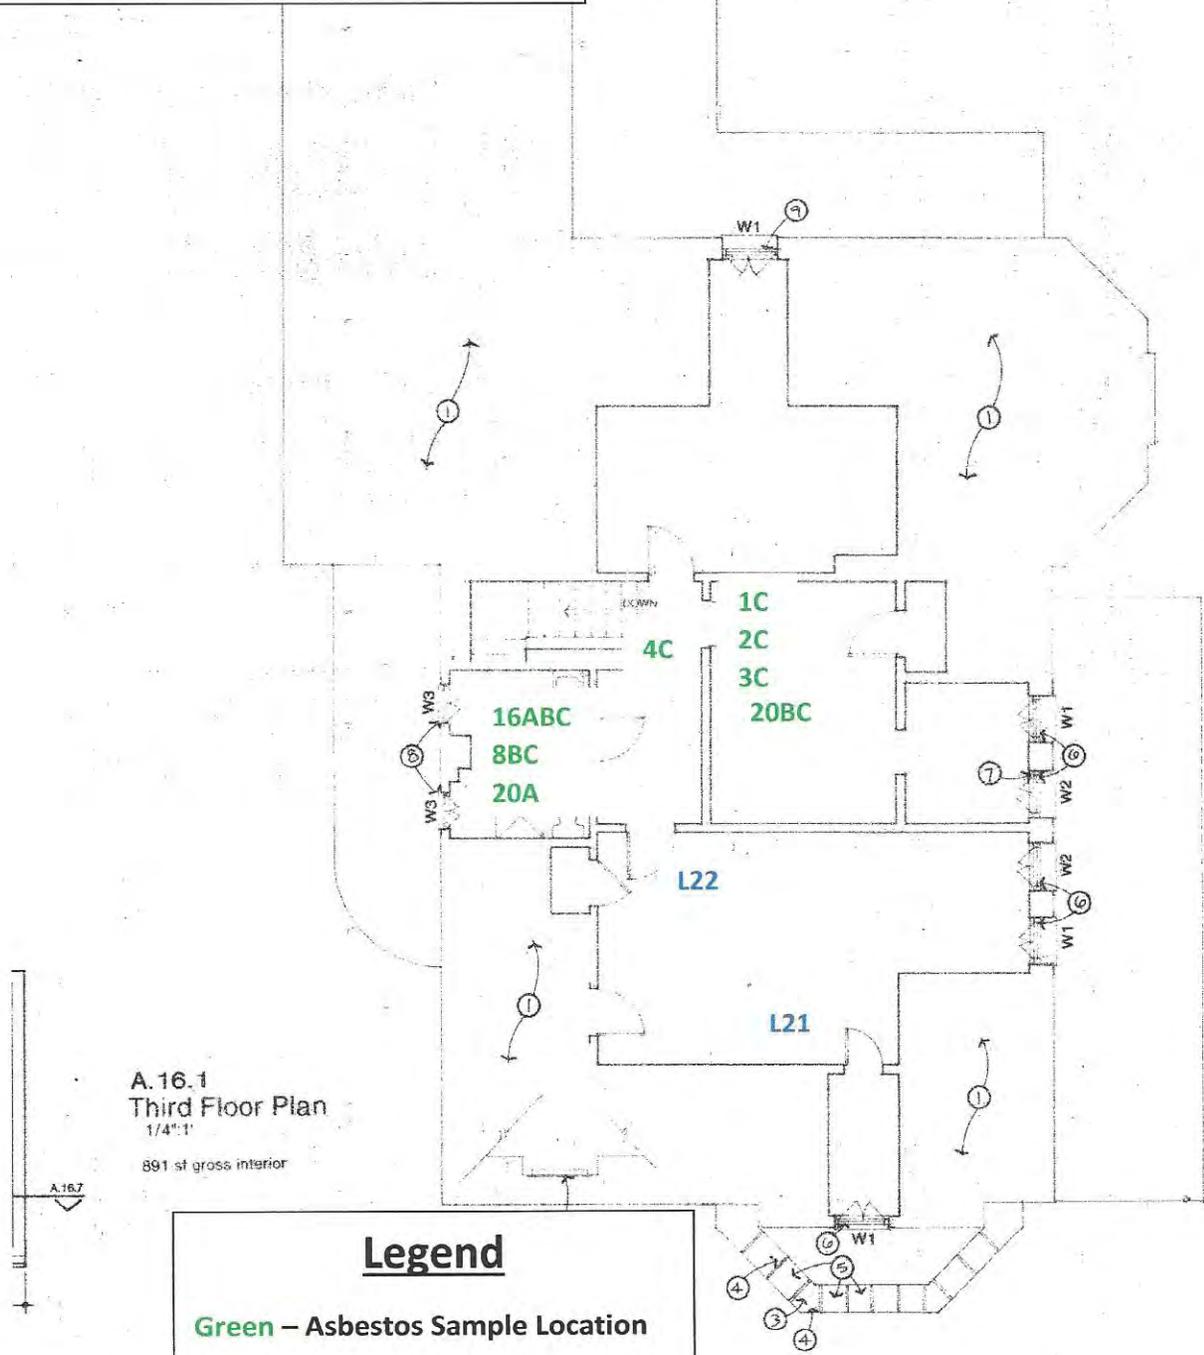
Mayer/Halff House #308 – 3rd Floor

A.16.1
Third Floor Plan
1/4"=1'
891 sq gross interior

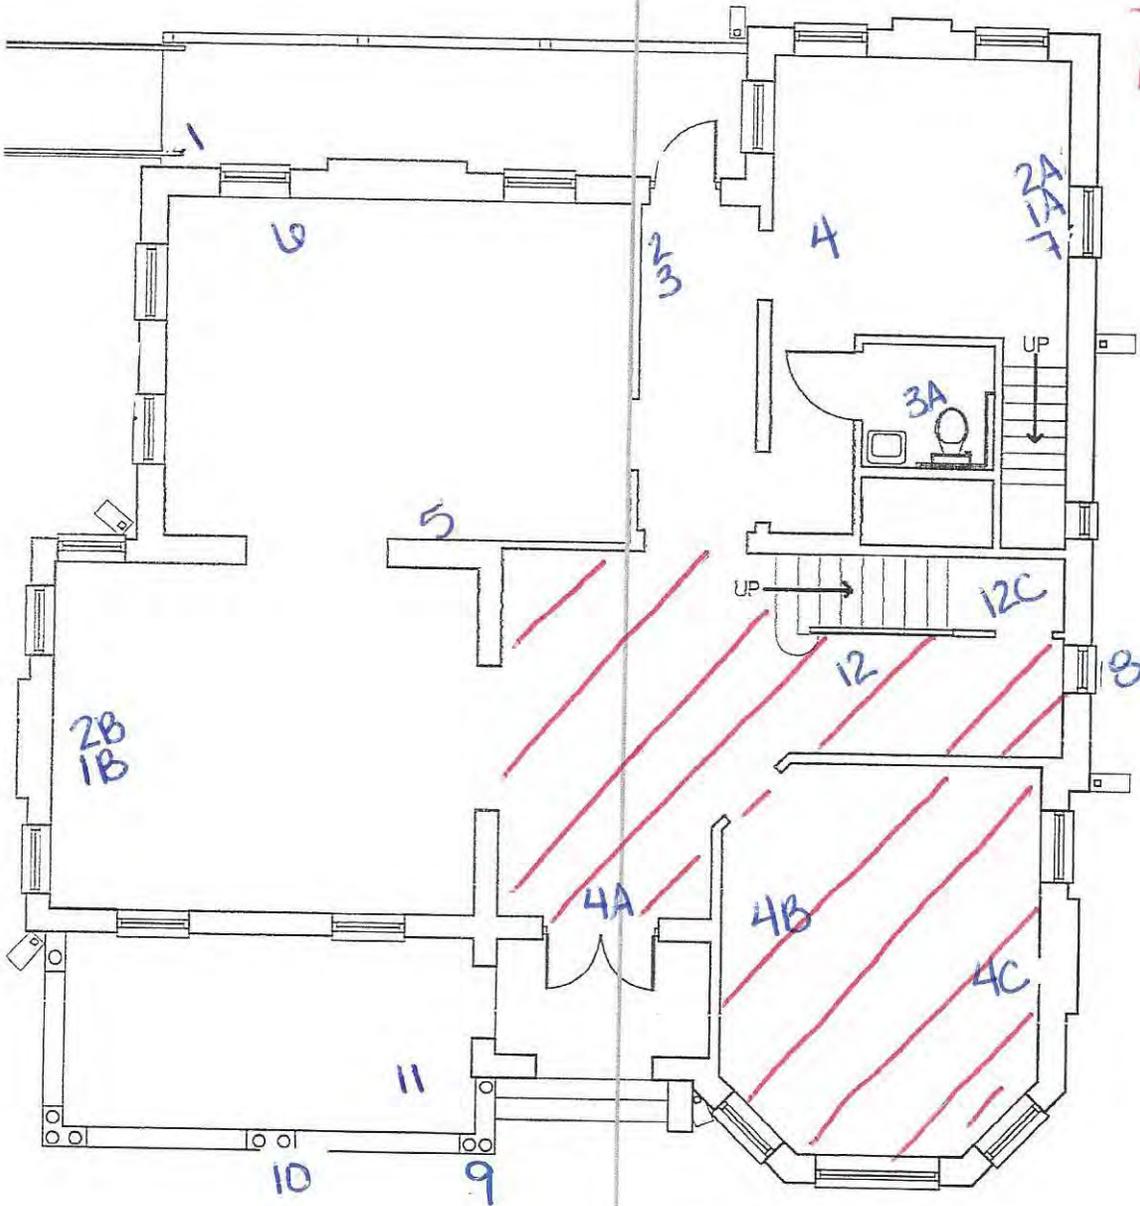
FIRST FLOOR PLAN
1/8" = 1'-0"

LEGEND
III - ACM
Joint
Compound

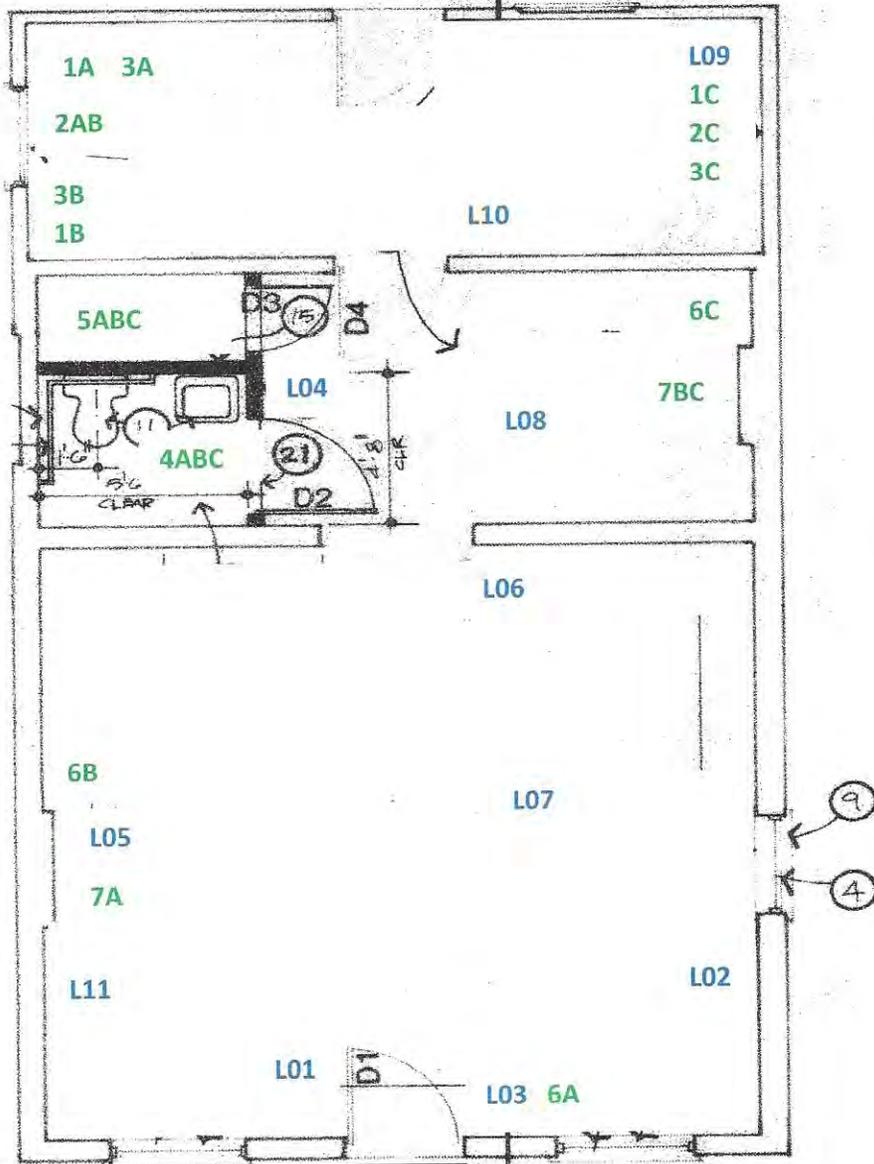
Smith House #251

Green – Asbestos Sample Location
