Aviation Maintenance Building Re Roof

At San Antonio International Airport

Project No. 33-00085

EXISTING ROOF PLAN
& SECTION DETAILS

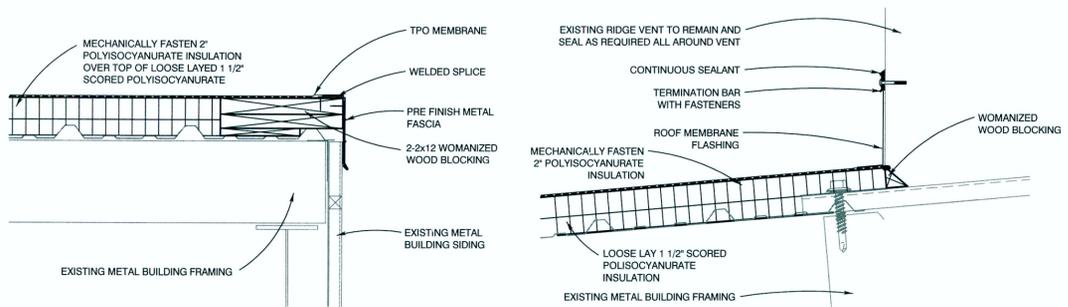
2 SECTION DETAIL
AT NEW FASCIA
1 1/2" : 1"

3 RIDGE SECTION
AT EXISTING RIDGE VENT
1 1/2" : 1"

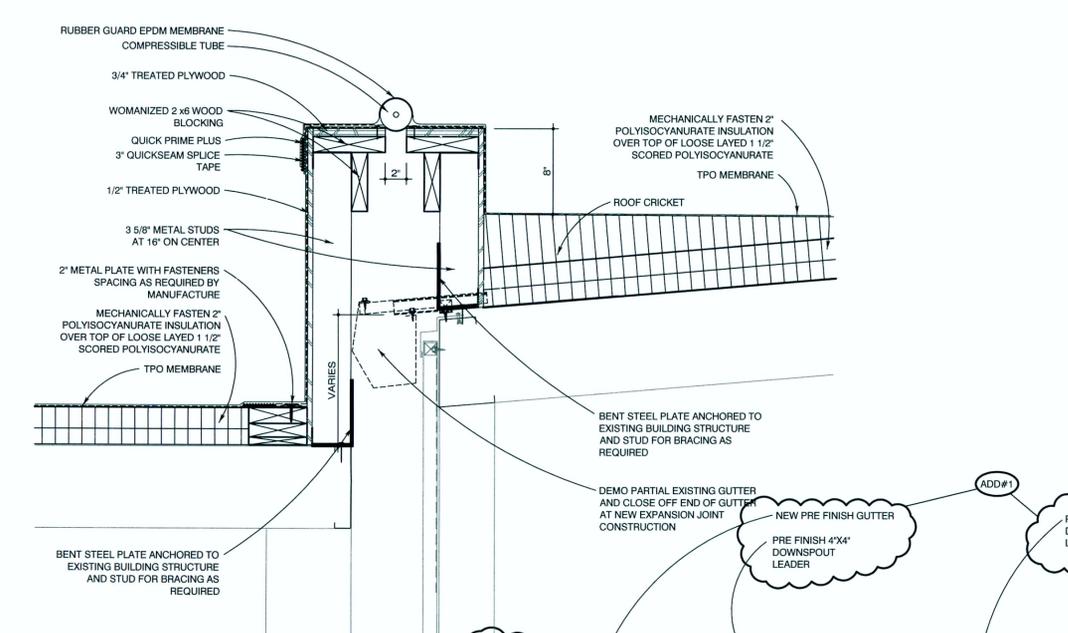
4 EXPANSION DETAIL
AT EXISTING GUTTER
1 1/2" : 1"

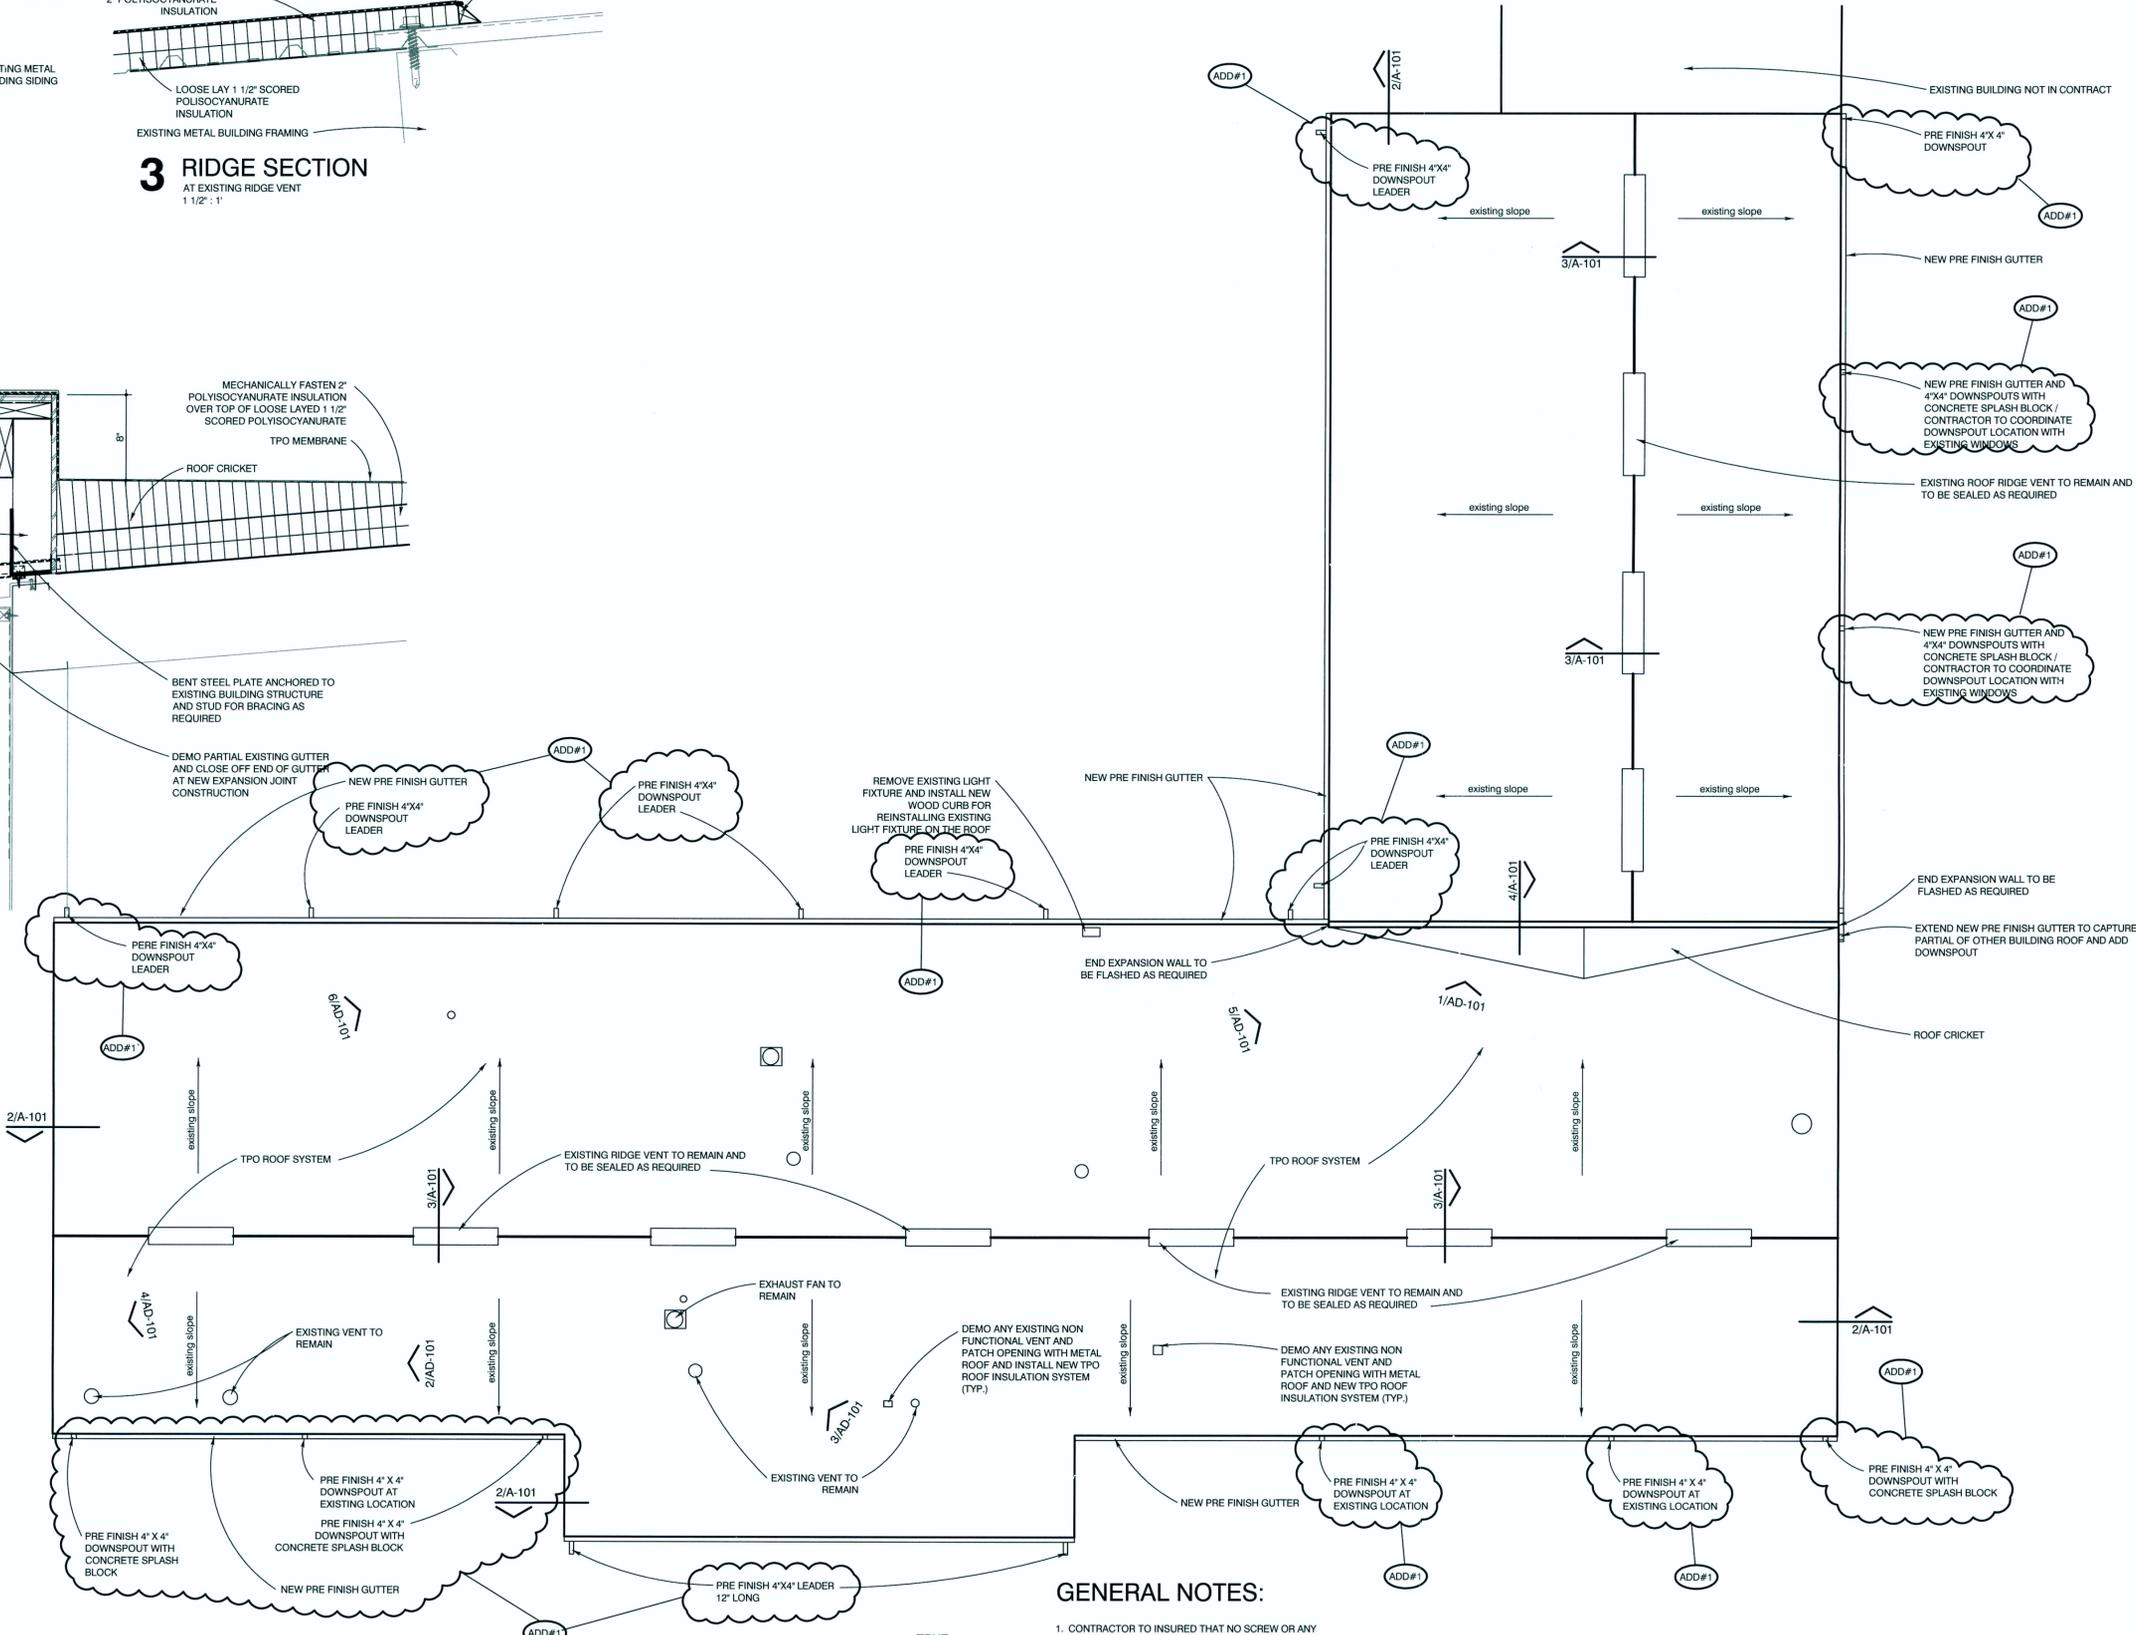
1 ROOF PLAN
EXISTING MAINTENANCE BUILDING
1" : 10"
