Due Diligence Study
of
Frost Bank Tower and Parking Garage
100 W. Houston St.
San Antonio, TX 78205

For the
City of San Antonio

April 24, 2015

Alderson & Associates, Inc.
MEP Consulting Engineers | TBPE Firm No. F1008
7700 Torino, Suite 101
San Antonio, TX 78229
P: (210) 614-1110

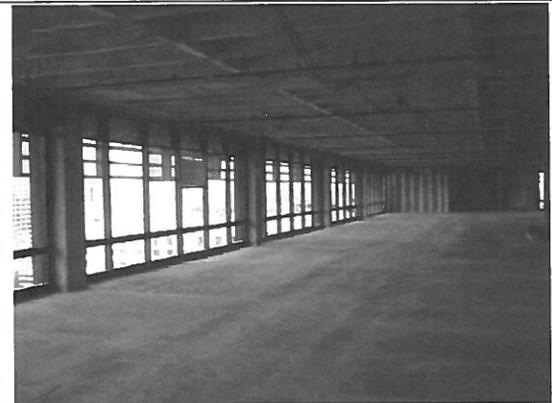
<p>Photo 1.1.03: Wet Pipe Sprinkler System Upgrade Added on Floor Under Renovation</p>	<p>Photo 1.1.04: Fire Riser Assembly (left) and Fire Pump Supply Tap (right)</p>

- The existing floors that are not currently sprinklered will require sprinkling as they are renovated. Refer to Fire Code Analysis in Appendix 2.1.
- The fire pump will require replacement due to the pump not providing sufficient pressure at the penthouse level. Refer to Fire Code Analysis in Appendix 2.1.
- Diesel tanks should be constructed on the roof of the parking garage to remove the quantities of fuels presently from inside the building.

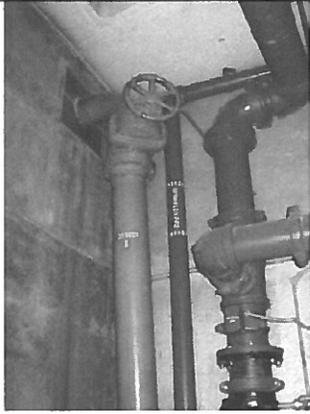
<p>Photo 1.2.01: Domestic Water Entry into Basement Mechanical Room (Green Pipe)</p>	<p>Photo 1.2.02: Domestic Water Backflow Preventer</p>

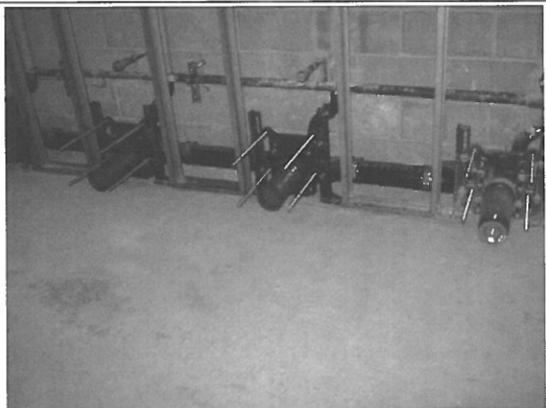
<p>Photo 1.2.09: New Sanitary and Domestic Water Piping for Renovated Restroom</p>	<p>Photo 1.2.10: Existing PVC Sanitary Piping System on 17th Floor</p>

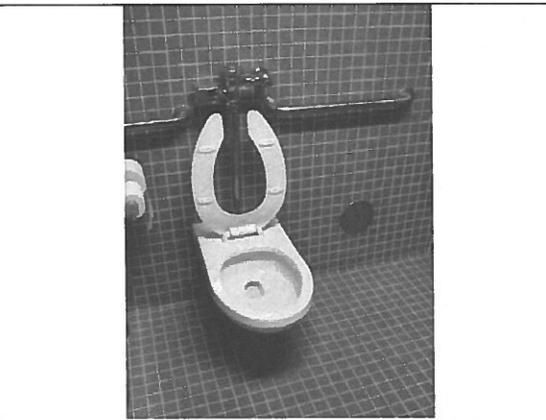
<p>Photo 1.2.11: Typical Water Closet Serving Public Restrooms</p>	<p>Photo 1.2.12: Typical Lavatories Serving Public Restrooms</p>

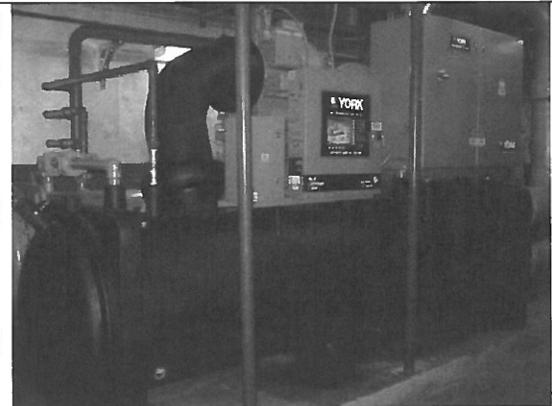
The three chillers are York water-cooled centrifugal chillers. All three utilize R-134a refrigerant and all three are equipped with VFDs. The west chiller (CH-1) is a 530 ton machine and was installed in 2001. The east chiller (CH-2) and south chiller (CH-3) are both 550 ton machines and were both installed in 2014. The chillers operate on a 6 deg. temperature differential between the entering and leaving chilled water temperature. (This is considered low and inefficient in comparison to industry standards)

A black and white photograph of a refrigerant monitoring system. It features a central control panel with several gauges and digital displays, mounted on a wall. Two large vertical pipes run parallel to the panel, with various valves and fittings.
<p>Photo 1.3.01: Typical Water Cooled Chiller</p>	<p>Photo 1.3.02: Refrigerant Monitoring System in Basement Mechanical Room</p>

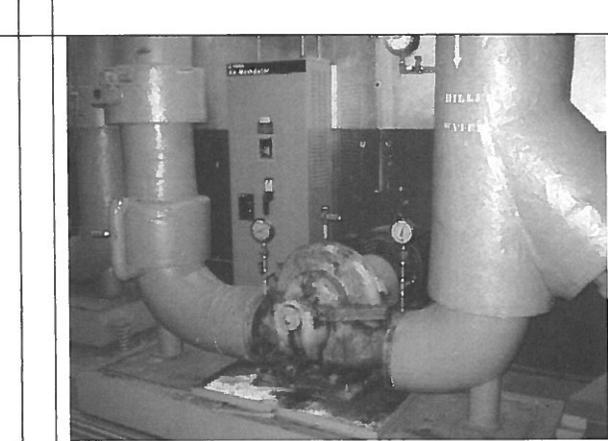
pumps (CWP-4, CWP-5) are all fitted with VFDs, however, the VFD is only utilized for soft start procedures, both the chilled water and condenser water flow is based on constant volume flow conditions. A swing pump (SWP-1) is provided in the headered systems such that it can be operate as an emergency chilled water pump or an emergency condenser water pump depending on the valving arrangement.

A black and white photograph of a chilled water pump. The pump is a large, horizontal, cylindrical unit with various pipes, valves, and gauges attached. It is mounted on a concrete base.
<p>Photo 1.3.05: Cooling Tower Basin Fill</p>	<p>Photo 1.3.06: Typical Chilled Water Pump with VFD (beyond)</p>

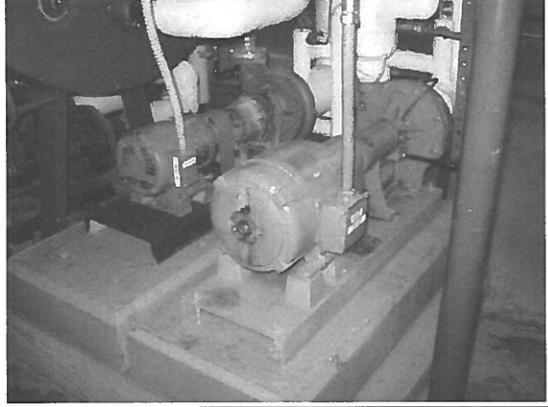
Photo 1.4.08: Heating Hot Water Circulation Pumps

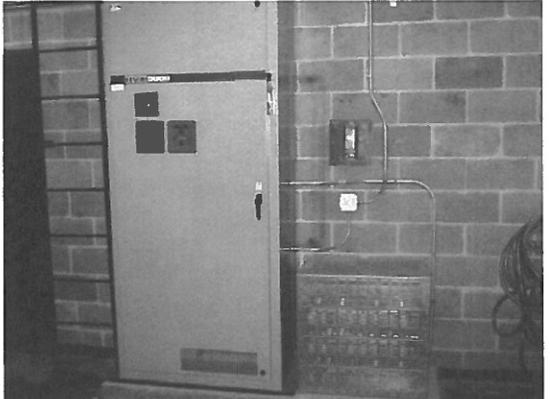
<p>Photo 1.5.01: VFD Serving Penthouse Built-up Air Handling Unit</p>	<p>Photo 1.5.02: B-2 – Cooling Coil of Penthouse Built-up Air Handling Unit</p>

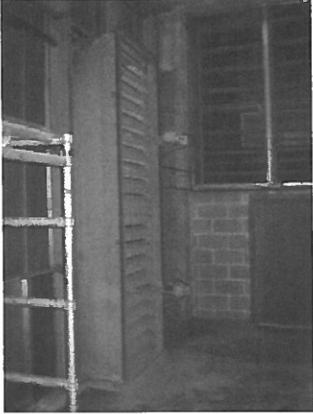
<p>Photo 1.5.05: Outside Air Louver/Damper (left) and Return Air Damper in Penthouse</p>	<p>Photo 1.5.06: Tower Air Handler #8 – Serves Tower Basement and Street Level</p>

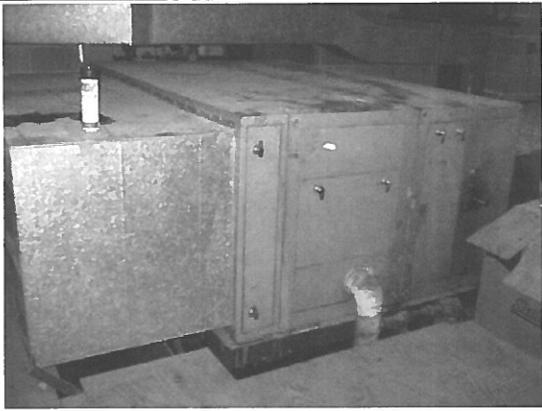
Photo 1.5.07: Plaza Club Kitchen Air Handling Unit

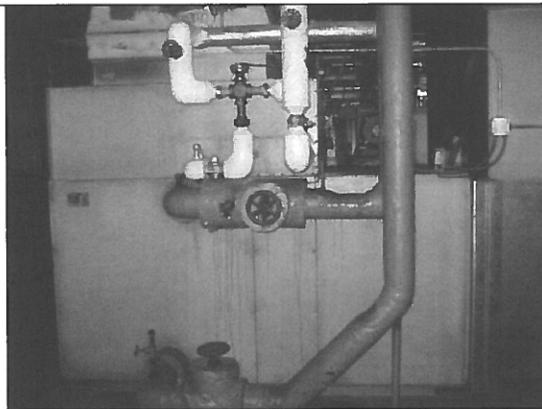
Photo 1.5.09: Parking Garage Air Handler #1 - Serves Basement Bank Lobby

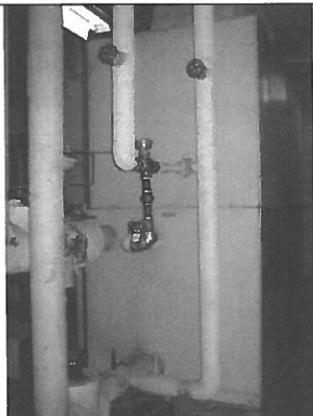
Photo 1.5.11: Parking Garage Air Handler #5 - Serves Old Kitchen and Portion of Dining

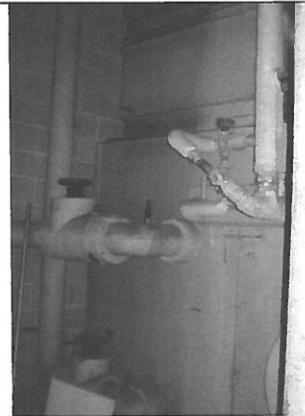
Photo 1.5.12: Parking Garage Air Handler #6 - Serves Portion of Dining Room and Founders Room

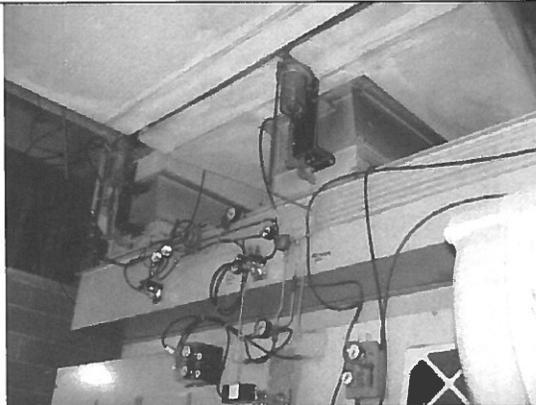
<p>Photo 1.5.15: Parking Garage Air Handler OLD #7 – Serves Southwest Street Level Offices and Basement Commercial Tellers</p>	<p>Photo 1.5.16: Parking Garage Air Handler OLD #7 – Serves Southwest Street Level Offices and Basement Commercial Tellers</p>

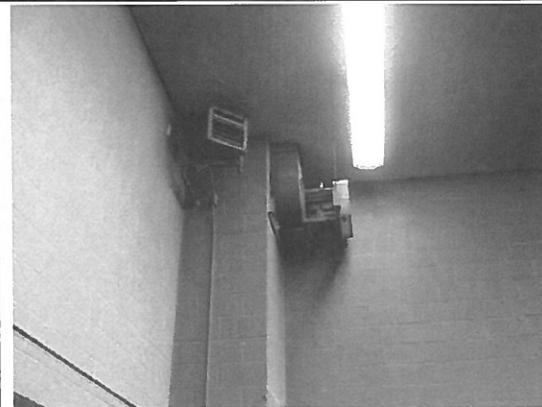
Photo 1.6.06: Abandoned Loading Dock Exhaust Fan (right).

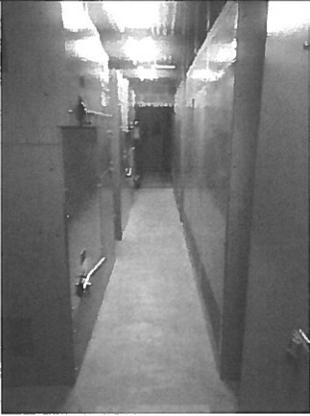
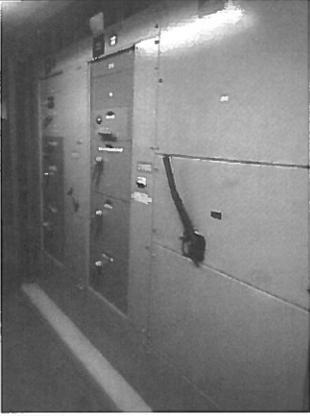
<p>Photo 1.9.01: Service Aisle Between Switchboards in Basement</p>	<p>Photo 1.9.02: Switchboard 'MSC'</p>

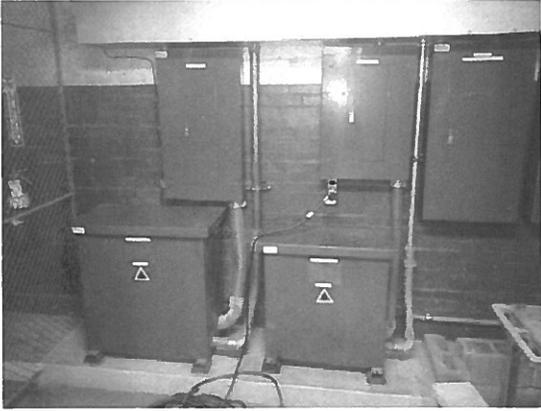
<p>Photo 1.9.03: 208Y/120V Electrical Distribution</p>	<p>Photo 1.9.04: Motor Control Centers '1D' and '1E'</p>

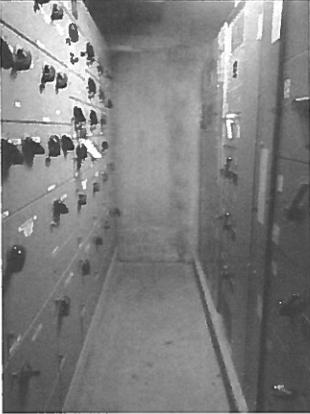
<p>Photo 1.9.05: Service Aisle Between Switchboard & MCC in Basement</p>	<p>Photo 1.9.06: Motor Control Centers 'MCCLA' and 'MCCLB'</p>

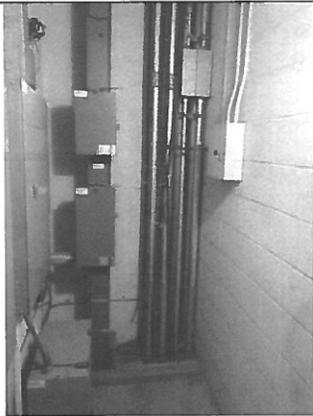
Photo 1.9.09: Renovated Tower Electrical Room
